Section 19 Flood Investigation

23 December 2020

Lavernock Road, Vale of Glamorgan

Version 4

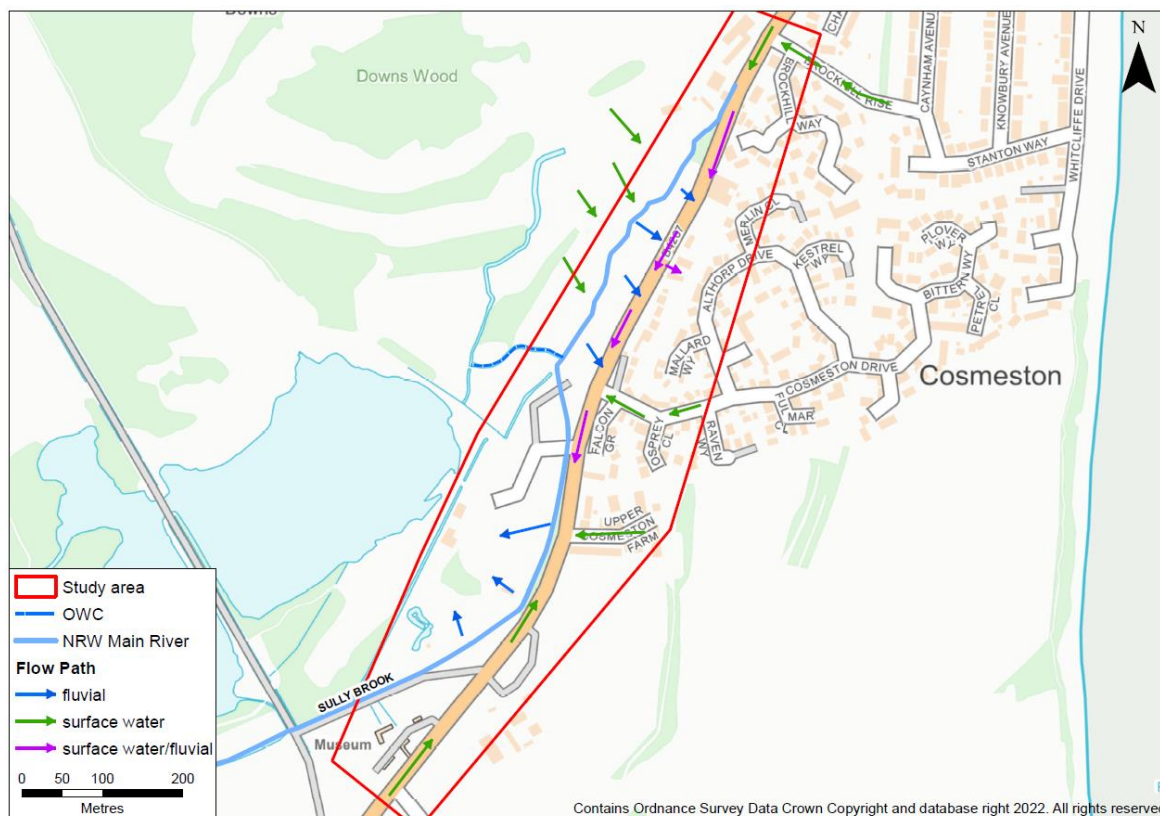
Figure 7-2: Flood water pathways

The depth of flooding on Lavernock Road increased until the floodwater overtopped the kerb and flowed towards the residential properties on the eastern side of the highway. Cars travelling along the road through the flood water also created bow waves (as shown in Figure 7-3) which exacerbated the movement of water towards the properties on the eastern side of the road.

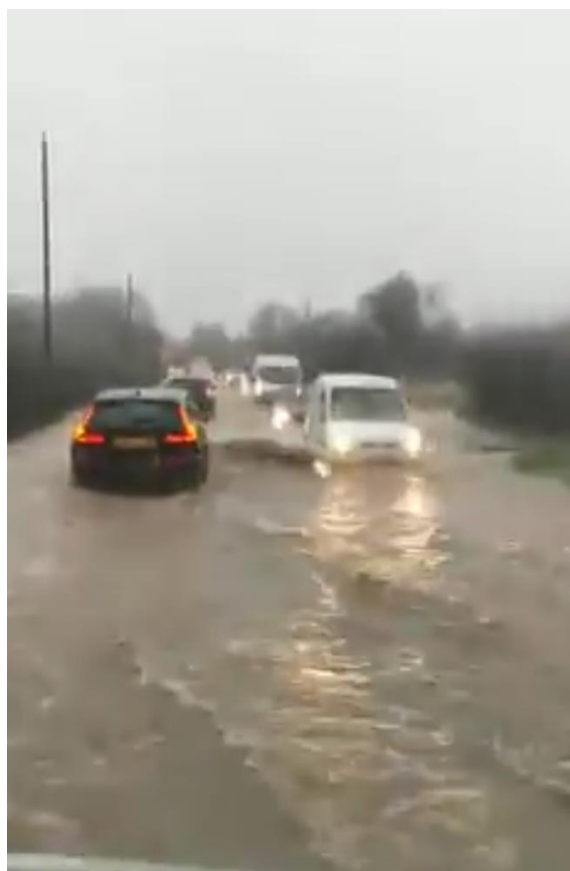
Evidence collected by VoGC identified that the Cosmeston Country Park car park and a 1km stretch of Lavernock Road were impacted by the flooding. A combination of surface water runoff, exceedance of the drainage system and the overtopping of the Sully Brook resulted in flood depths of approximately 300-500mm on the main road.

Figure 7-3: Lavernock Road at Farm Entrance (Facebook Video Still)

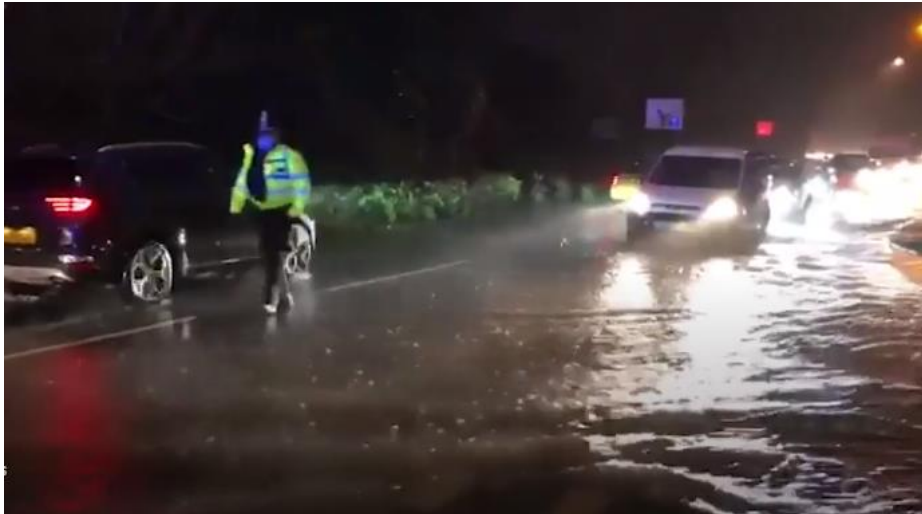
Figure 7-4:Wales Online Video Still at Brockhill Rise

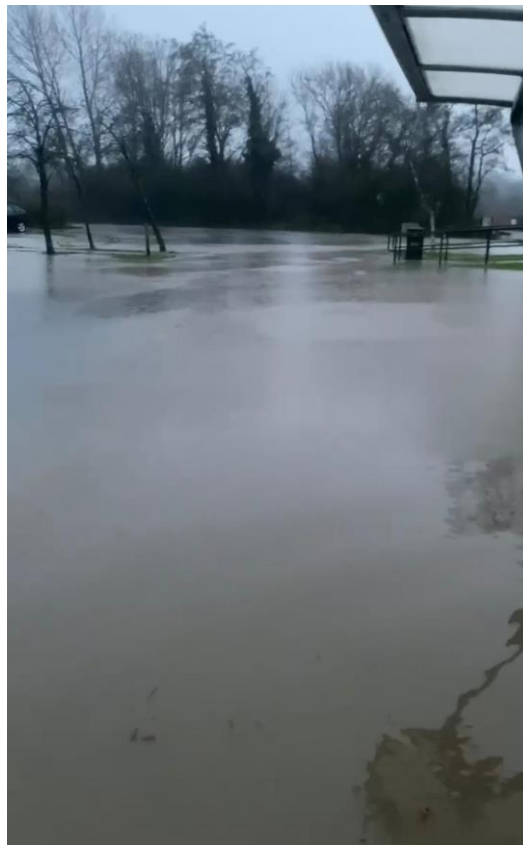
Figure 7-5:Cosmeston Country Park Car Park Looking South
(Ranger Photo)
