Section 19 Flood Investigation

23 December 2020

**Sully Moors Road, Vale
of Glamorgan**

December 2023

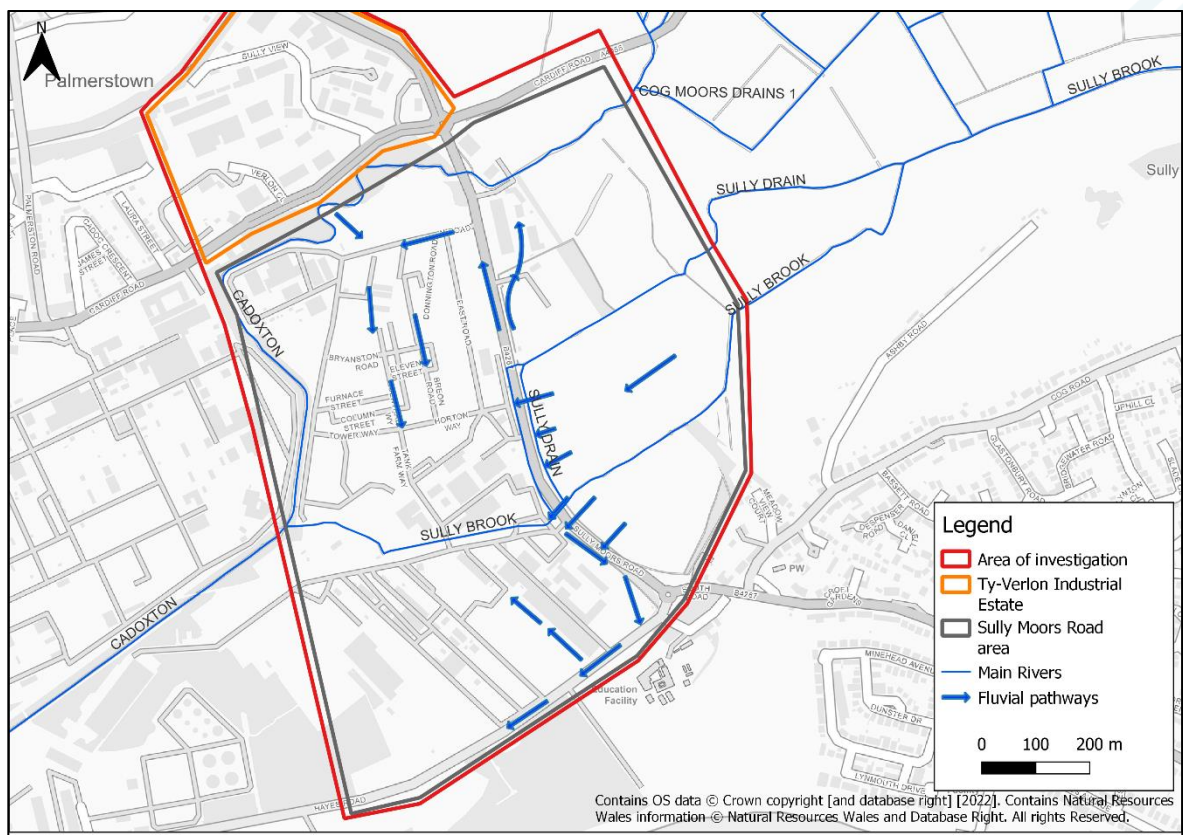
Figure 7-3: Fluvial flood water pathways

Flood water from the Sully Brook and Sully Drain flowed in a westerly and northerly direction from the watercourse onto the moors and subsequently onto Sully Moors Road. Water flowed overland to the commercial premises located on the eastern side of Sully Moors Road, resulting in 6 properties flooding internally. Flood water flowed along Sully Moors Road onto North Road and Horton Way, and an un-named road (all access roads of the industrial estate to the west of Sully Moors Road). From this location, flood water entered the wider industrial estate, resulting in widespread flooding. Flood water flowed into a southerly direction onto Hayes Road at the southern extent of the investigation area.

Fluvial flood water pathways were not a direct causal factor in the flooding of the Ty- Verlon Industrial Estate. However the high level of water in the River Cadoxton, and its tributaries, did cause hydraulic locking of the surface drainage system across this area. This, in turn, resulted in flooding of the Ty- Verlon Industrial Estate.

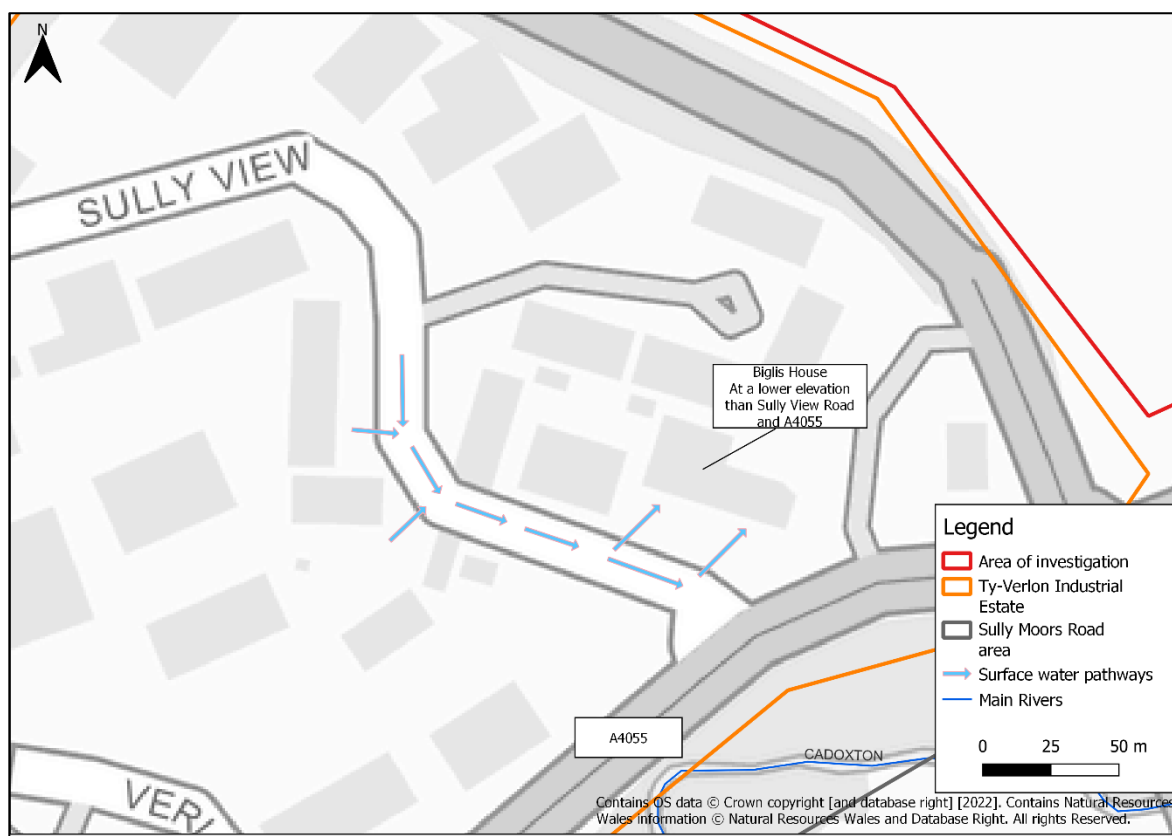
Figure 7-4: Surface water flood water pathways in the Ty-Verlon industrial estate

In the Ty-Verlon Industrial Estate investigation area, water flowed along the main access route of Ty Verlon Industrial Estate (Sully View Road) and into the lower units (units 1-5) of Biglis House (located on the north east corner of the junction of Sully View Road and the Barry Dock link road). Due to the high intensity of rainfall on the day, surface water pooled directly on impermeable surfaces, such as roads and pavements within the industrial estate and flowed downhill to Biglis House. Reports indicated that water backed up through the drainage system into the units. It is unknown as to whether this was the highway system, or public surface water system in this area.

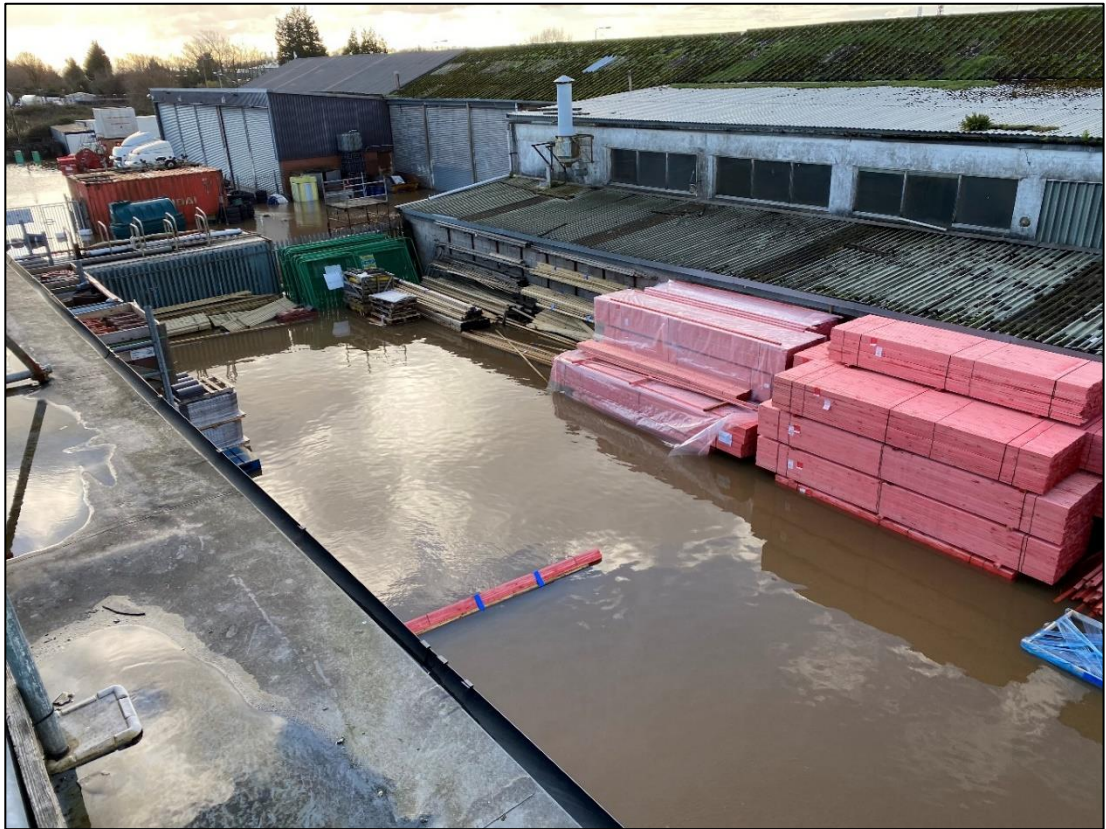
An additional two businesses recorded external property flooding in Flood Incident Reports, generally to storage units and yards, with serious damage to assets being recorded (Figure 7-5, Figure 7-6).

Figure 7-5: Flooding of commercial property in the north east of the area of investigation.

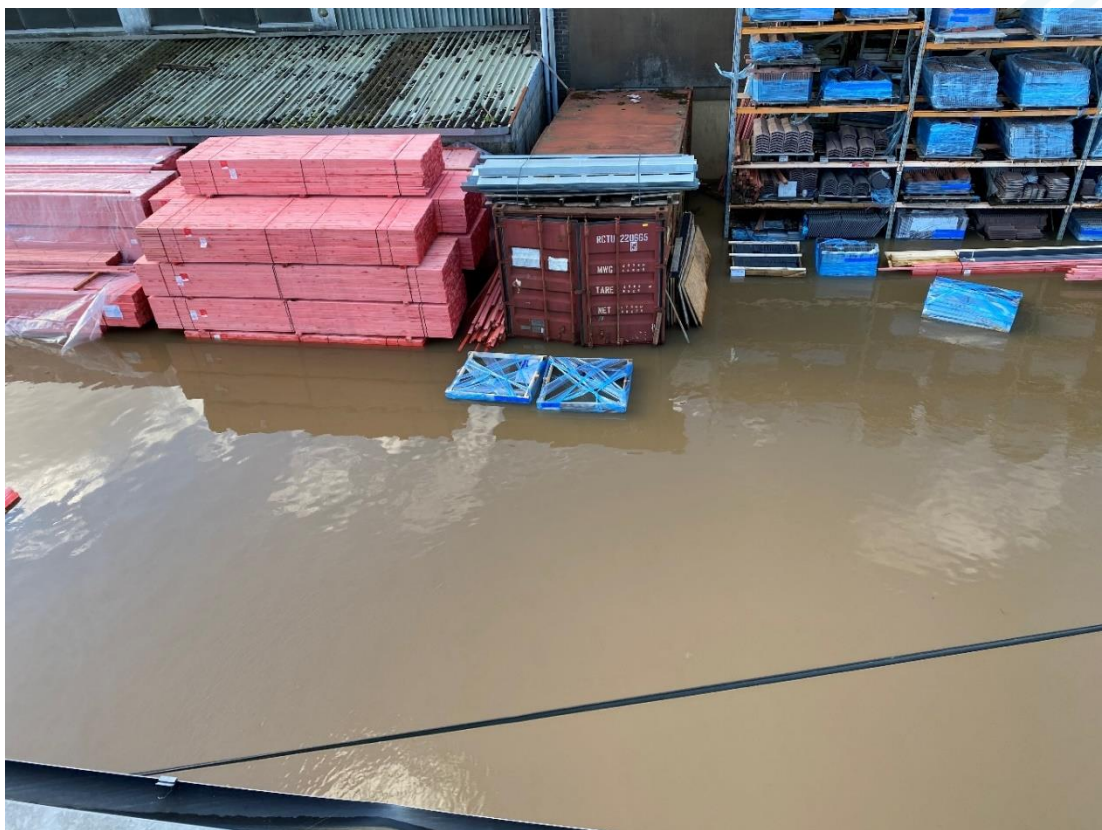
Figure 7-6: Flooding of commercial property in the north east of the area of investigation.

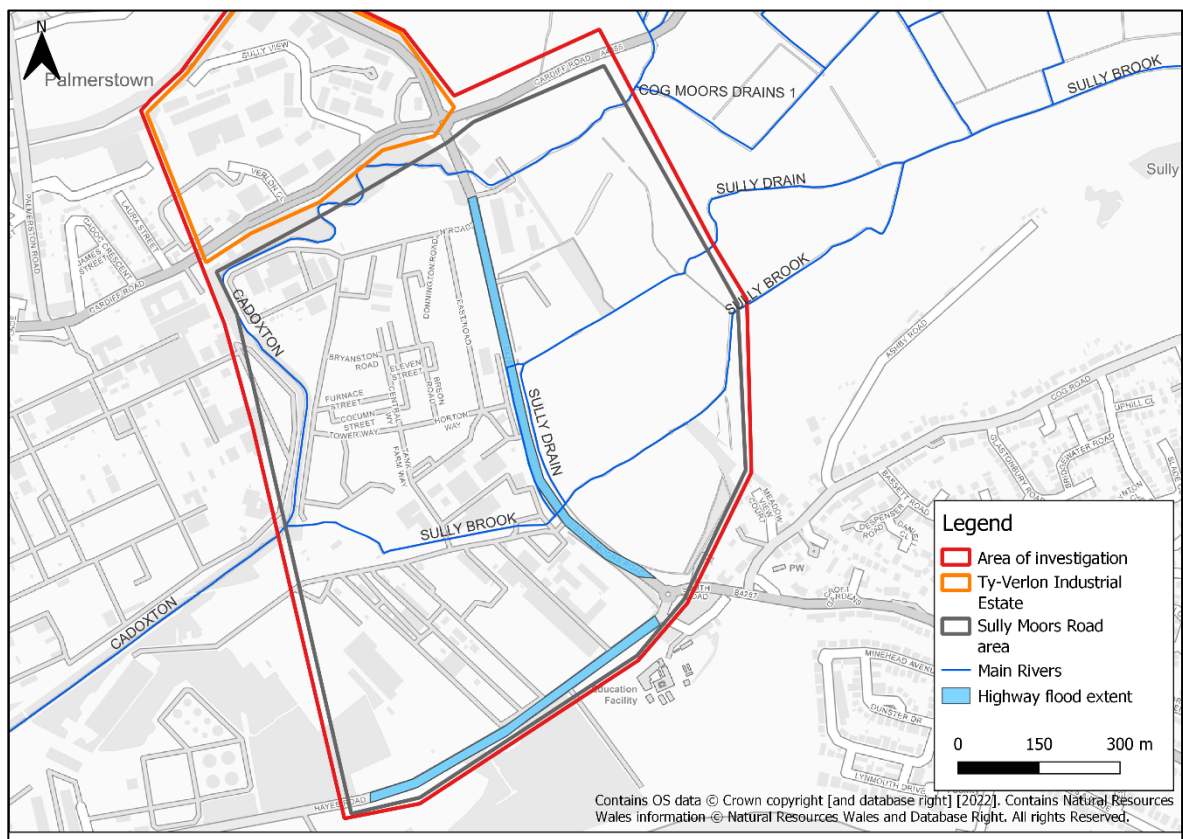
Figure 7-7: Highway flooding

Sully Moors Road (B4267), the main road linking Barry to Sully and Penarth, was flooded and closed over a length of approximately 800m between the roundabout at the junction of the Barry Dock link road (A4055) in the north and the Hayes Road roundabout in the south; Hayes Road was flooded and closed west of this roundabout, but the total distance cannot be ascertained from the data supplied. Indicative flood extents along Sully Moors Road and Hayes Road are shown in Figure 7-7. Flood depths have not been formally reported. Due to the timing of the event, exact details are unknown, however there are reports of the flood duration being 3-4 days in some areas of the industrial estate.

Road access into Sully and to the important industrial and commercial estates in the Sully Moors Road area was severely restricted due to flooding and closure of Sully Moors Road, resulting in loss of business and widespread traffic problems. The loss of business was reduced by the timing of the event over the Christmas holiday period.

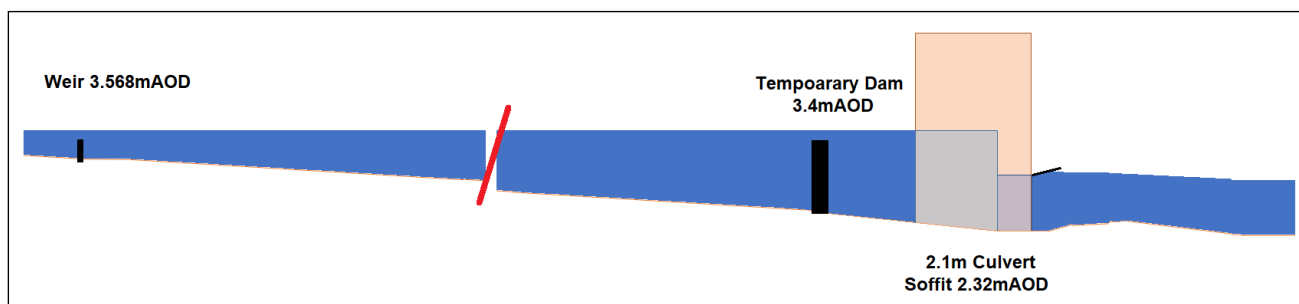
Figure 3- Indicative River Schematic Feb 2020

In 2019 the contractor had removed the upstream debris screen and the downstream rubble weir. The proposed penstock had not been installed. Without the penstock in place the contractor deemed the risk of saline intrusion or tidal ingress upstream was too great to remove the old top hung flap and 2.1m culvert.

In the winter of 2019/20, when no construction works were being undertaken, the contractor withdrew the over pumping arrangements, however the temporary dam was not removed from the river.

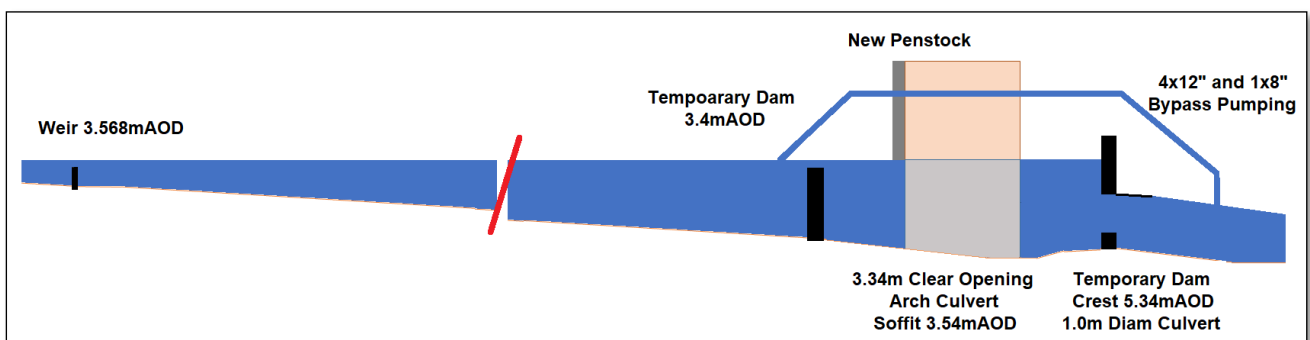
Figure 5 - Indicative River Schematic Dec 2020

During the flood events of December 2020, the contractor was monitoring the site. No works were planned for the period between 18th December 2020 and 4th January 2021. As there was limited activity on site the contractor informed Natural Resources Wales that they had arranged an out of hours rota to ensure the site was monitored over the period and teams could respond to site. Between the 18th December 2020 and 4th January 2021, predicted tides would not exceed 11.44mACD, as such the contractor deemed there was no requirement to operate the penstock thereby removing the chance of failure and human error of operating the penstock at high tides, leaving the penstock to act as a backup structure should the temporary flap fail.

On 22nd December 2020, the contractor had arranged for servicing of the pump generators to ensure they were fully operational for the Christmas period. Following the issue of an amber weather warning for rainfall in the area, the contractor visited site at 11:00am on the 23rd, to check that the temporary system was fully functional, and the pumps were working and fuelled. Tides that night were neap tides (8.67mACD or 2.57mAOD), that would be lower than both the downstream and upstream temporary works. Once all checks were completed the contractor left site at around 02:00pm, just after high tide had passed.

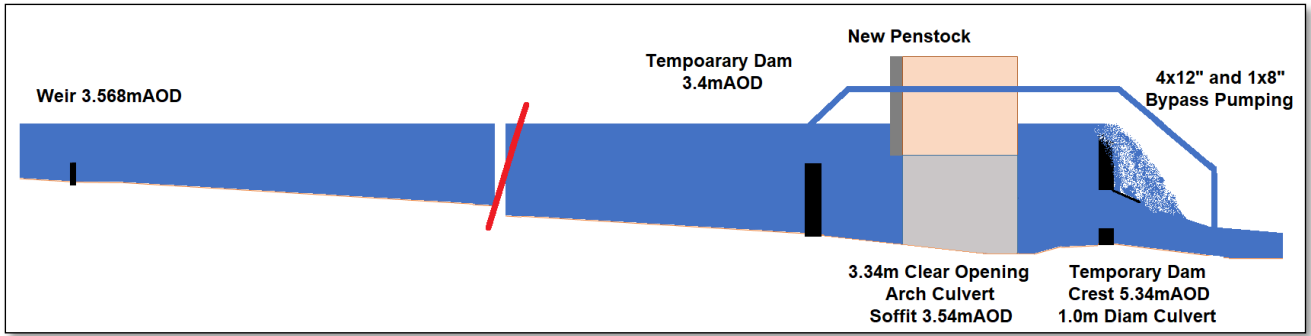
Figure 6 - Indicative River Schematic 24th Dec 2020 at 09:00am.

Telemetry records show, that at approximately 09:00pm on the 23rd, river levels exceeded the contractors previously stated level that correlates to out of bank flow upstream. At approximately 01:30am on the 24th, the contractor who was monitoring the telemetry reported river levels higher than any previously recorded since the telemetry was installed. The contractor reported to site on the morning of the 24th. The contractor stated that pumps were fully operational, the dams were in place and overtopping, there were no signs of blockages or failures with the temporary works systems but river levels at the site were the highest they had observed. The contractor organised for a concrete breaker attachment to be delivered to site. When it arrived, it was connected to an excavator and used to partially demolish the tidal dam, removing approx. 350mm from the crest. The partial demolition was completed by 11:00am.

Telemetry records show that river levels peaked at 07:50am, remained stable until 09:40am at which point they began to fall.

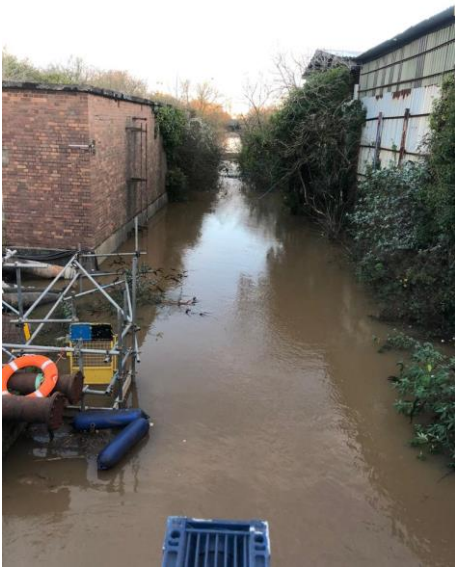
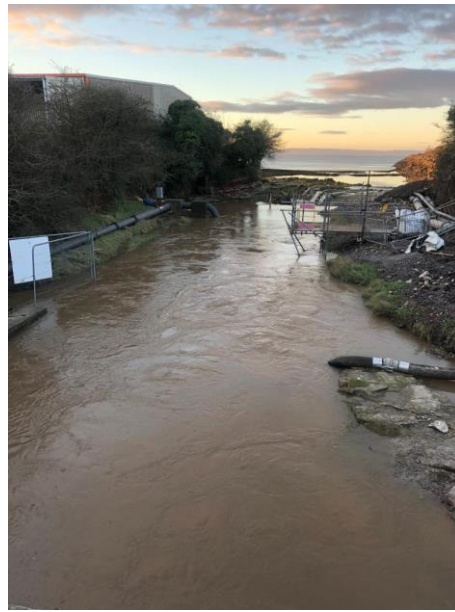
Photograph 5 – 24th Dec View Looking Upstream of the Bridge Photograph 6 – 24th Dec View Looking Downstream of the Bridge

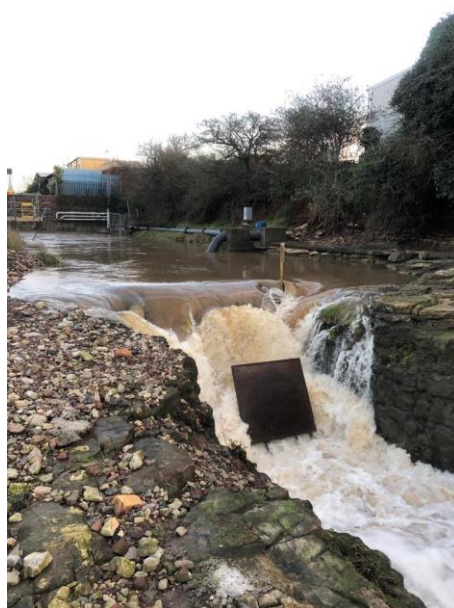
Photograph 7 – 24th Dec View Looking Upstream Toward the Bridge
