# **Section 19 Flood Investigation**

## **February 2020 – Storm Jorge**

### **Sully Moors Road, Vale of Glamorgan**

**March 2023**

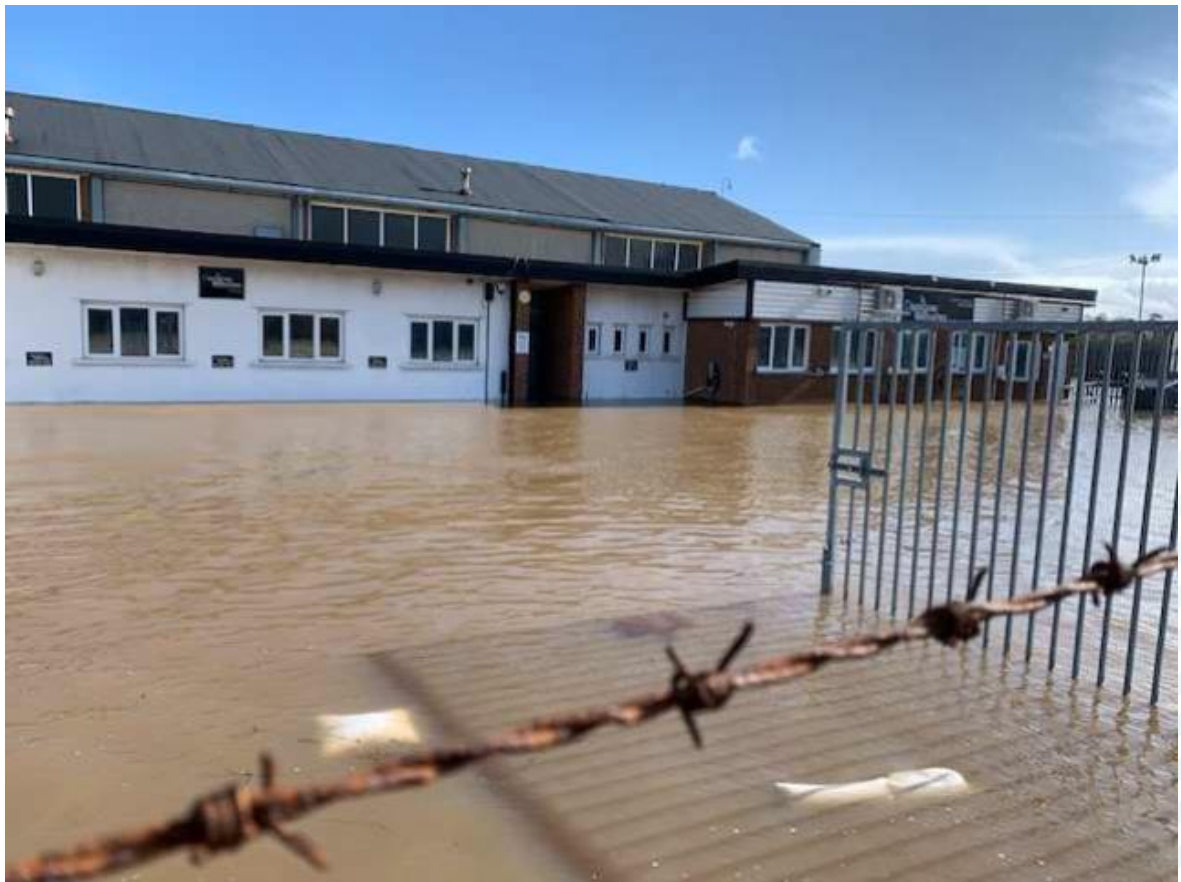
A range of commercial property was directly flooded with 6 businesses reported to have flooded internally as a result of this flood event. Flood depths varied between 450mm and 900mm. Serious external property damage as a result of the flood event has also been reported. No information on the extent and cost of the damages is known to inform this report.

Figure 6-3: Flooding of commercial property in the north east of the study area.

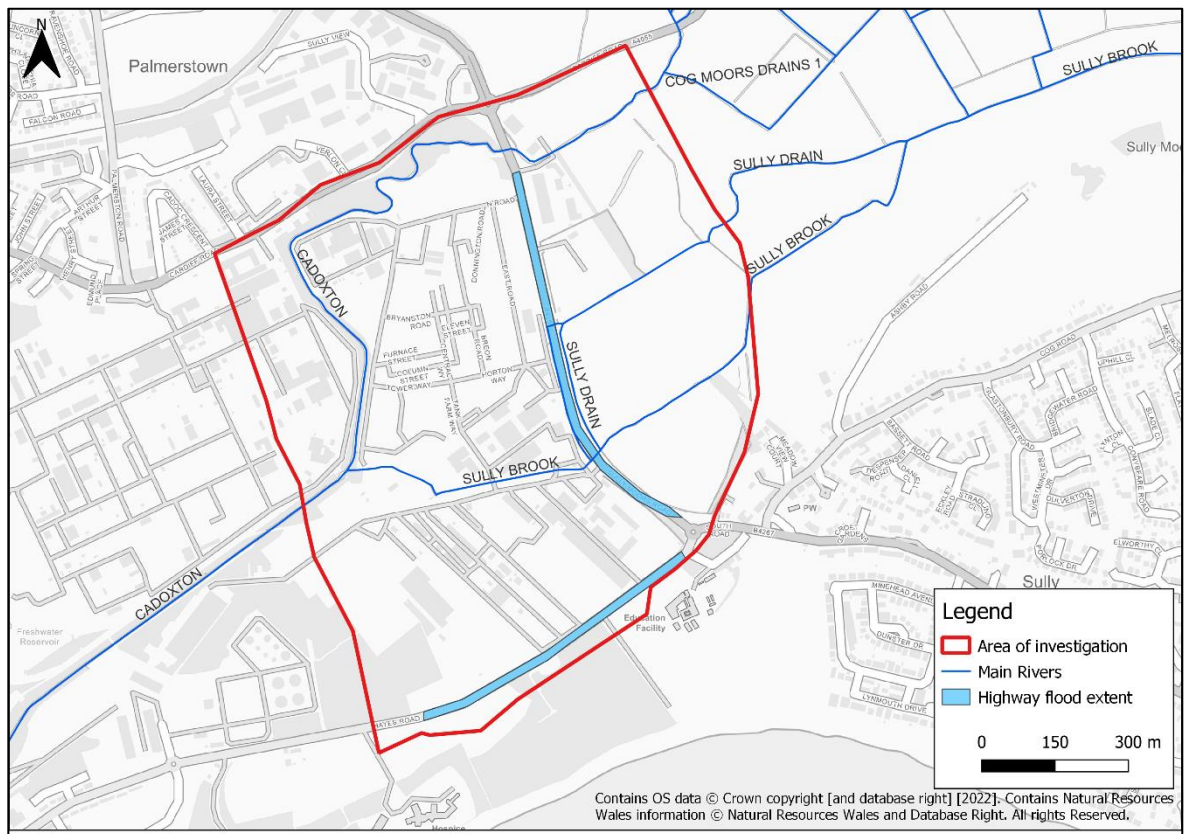
Sully Moors Road (B4267), the main road linking Barry to Sully and Penarth, was flooded and closed over a length of approximately 800m between the roundabout at the junction of the Barry Dock link road (A4055) in the north and the Hayes Road roundabout in the south; Hayes Road was flooded and closed west of this roundabout but the total distance cannot be ascertained from the data supplied. Indicative flood extents along Sully Moors Road and Hayes Road are shown in Figure 6-4. Flood depths have not been reported. Road closures remained in place from 29<sup>th</sup> February to 2<sup>nd</sup> March.

Figure 6-4: Highway flooding

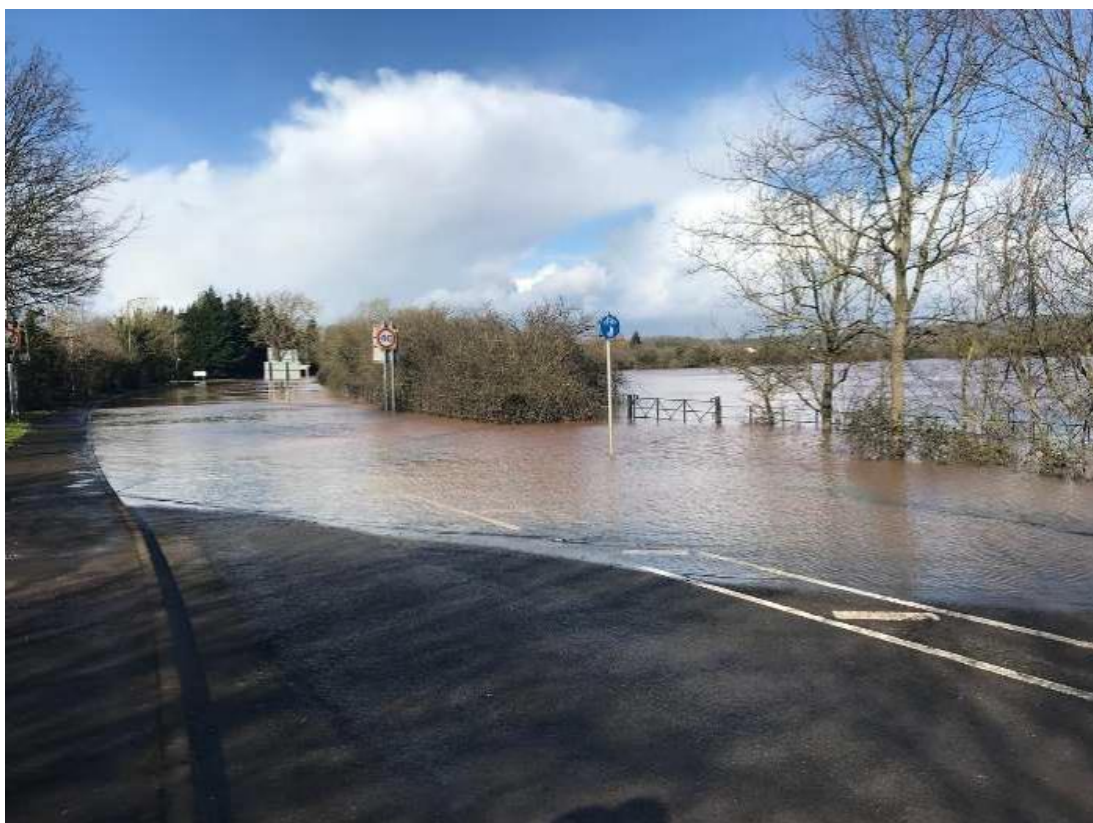
Figure 6-5: Flooding of Sully Moors and Sully Moors Road in the south east of the study area, looking north west.

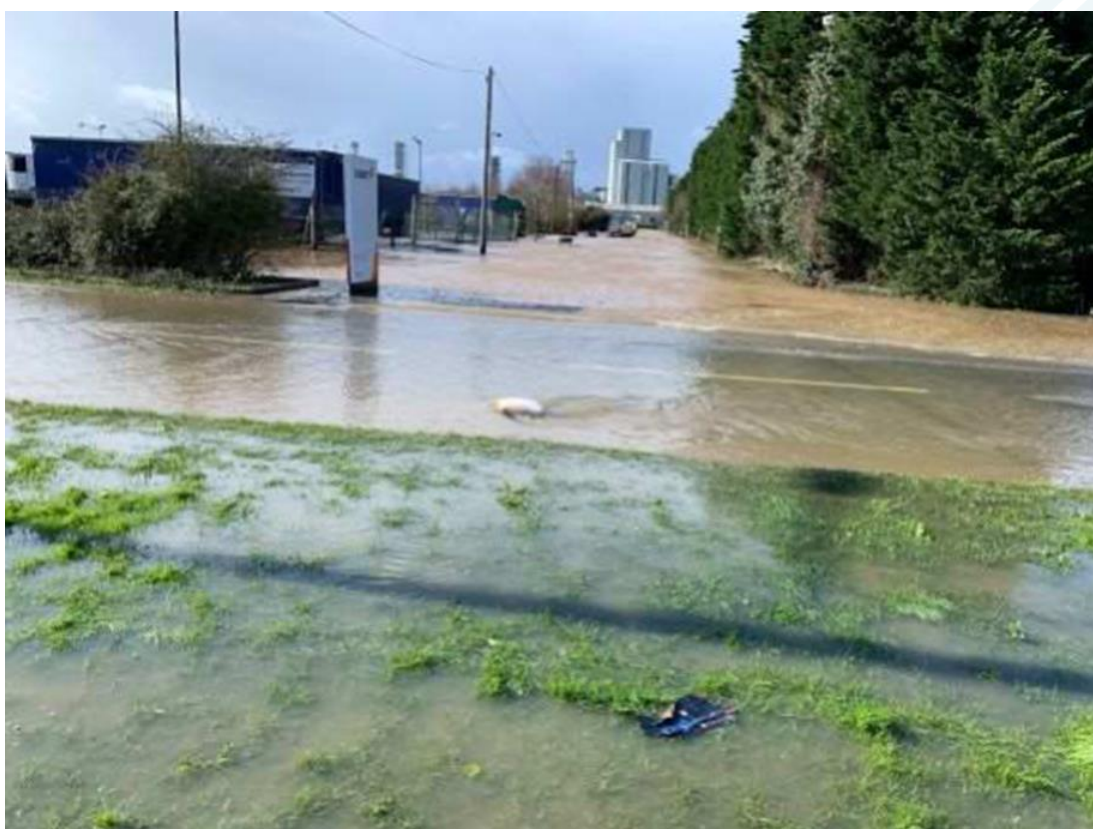
Figure 6-6: Flooding of Sully Moors Road and North Road, looking west.
