# **Section 19 Flood Investigation**

**23<sup>rd</sup> December 2020**

**Sully, Vale of  
Glamorgan**

**Final Report**

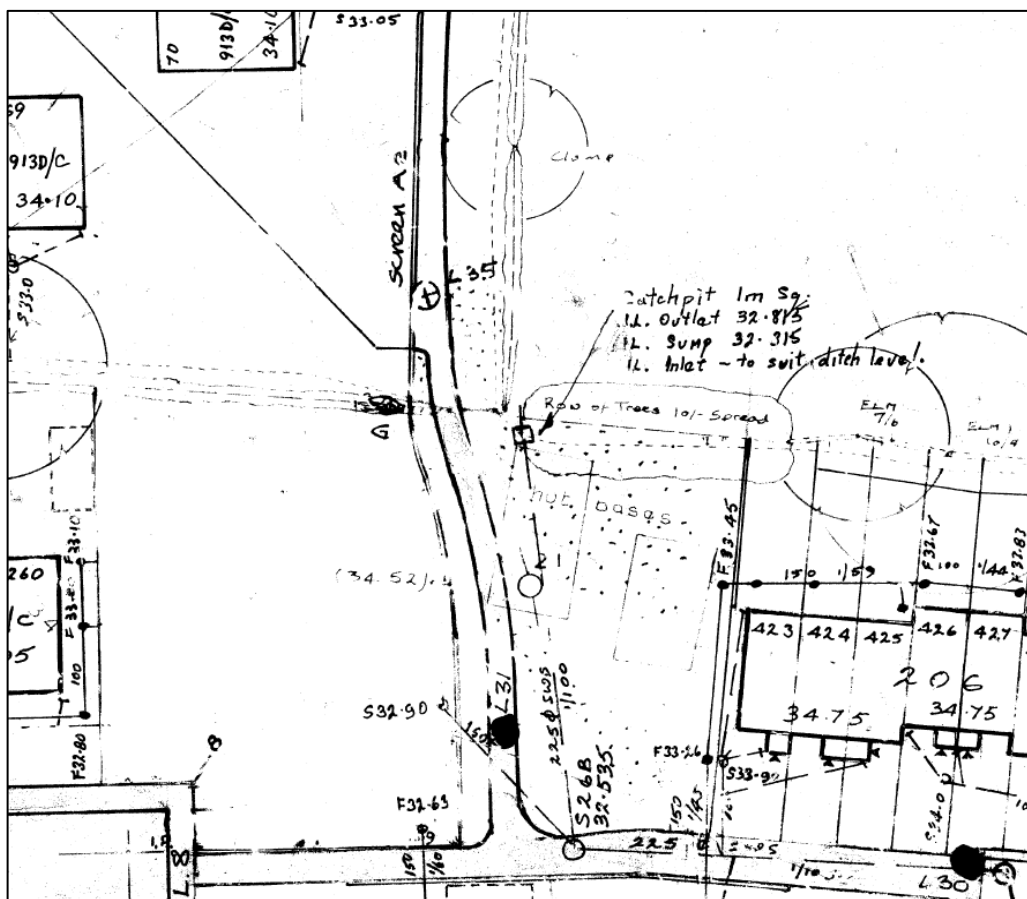
### Figure 4-5 Original Sully development plans

A perched gully inlet that connects to a DCWW surface water sewer is located at the south-west corner of the Coneybeare Road residential area. This asset is designed to allow surface water to pool around it and the sediment contained within to settle. As the level of water surrounding the gulley rises sufficiently to require draining, water free from sediment enters the inlet. Whilst the DCWW sewer maps do not show this inlet, design drawings from the original development in 1984 show this inlet as an original feature which joins to the DCWW surface water sewer to the north of Brean Close (Appendix C). An extract of this plan is shown in Figure 4-5 below, and the DCWW drainage network is shown in Figure 4-4 above. Due to the impact that a blockage of the inlet could have on the adjacent community, adhoc repairs have been undertaken by VoGC on a reactive basis. However, ownership and maintenance responsibilities for this asset remain unconfirmed.

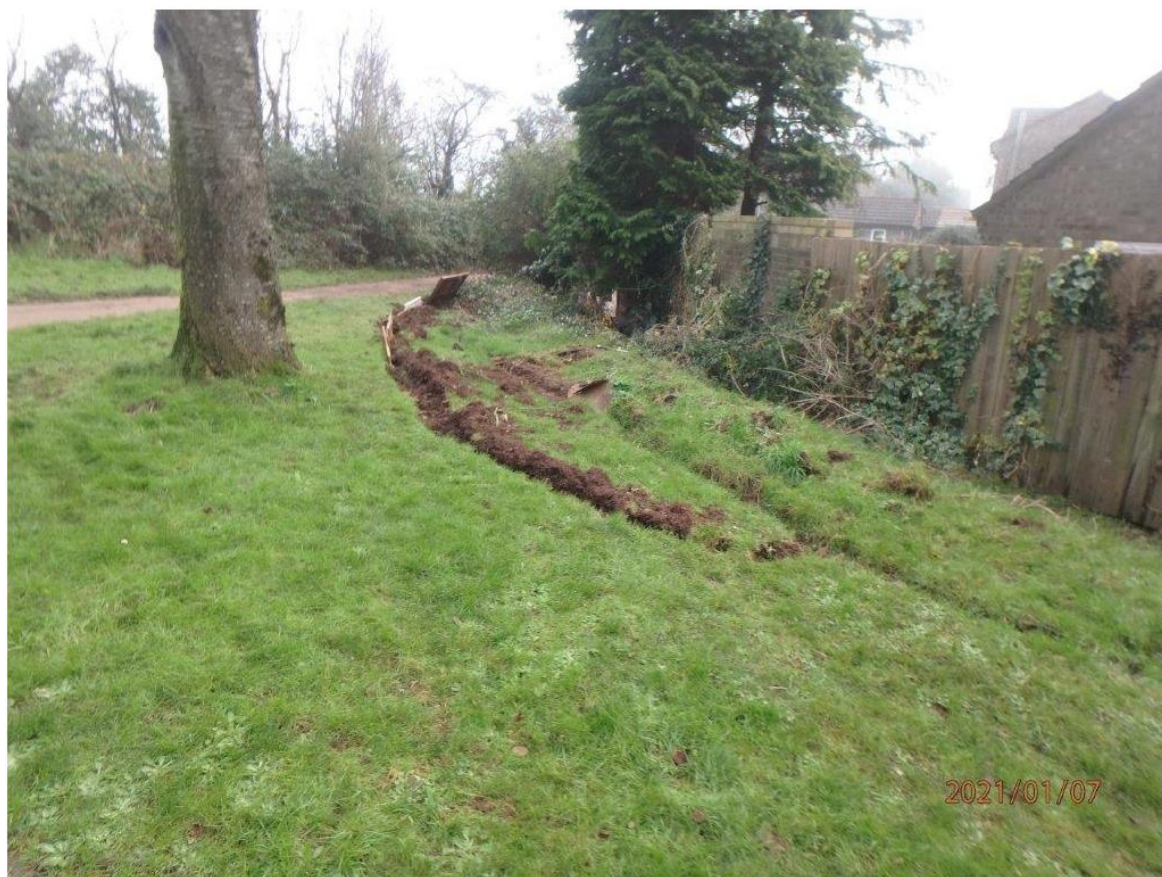
**Figure 4-6 Informal defences to the rear of Conybeare Road (picture provided by VoGC)**

To the rear of Conybeare Road, is a small informal flood defence installed with the intention of managing surface water. This is comprised of a small bund and ditch to the rear of 76 Conybeare Road, as shown in Figure 4-3 above and Figure 4-6 below.

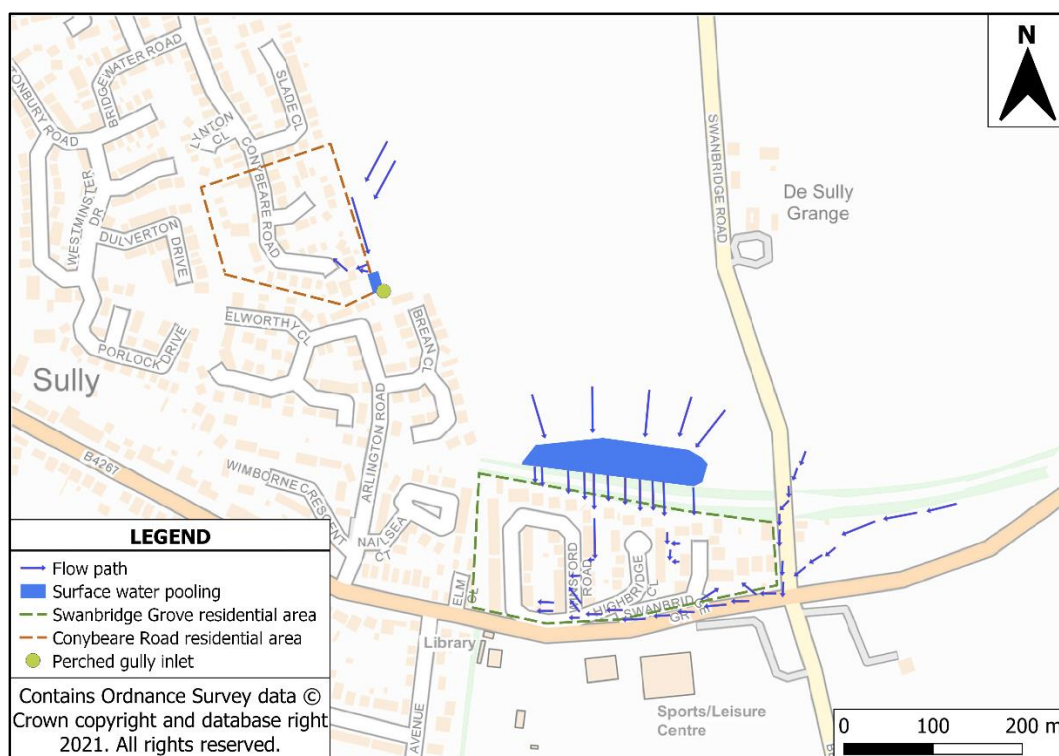
**Figure 7-2 Flood water pathways**

perched gully inlet. As water levels increase, this area of ponding increases in a northerly direction adjacent to the footpath to the rear of Conybeare Road, prior to flowing onto the footpath. Once surface water reaches the footpath, water is able to flow into the residential area of Conybeare Road through the gardens of properties and via the public footpath.

It was also reported by residents that drains and manholes by the field adjoining the residential areas were overflowing during the flood event. However, the exact locations of these assets are not clear from the reports.

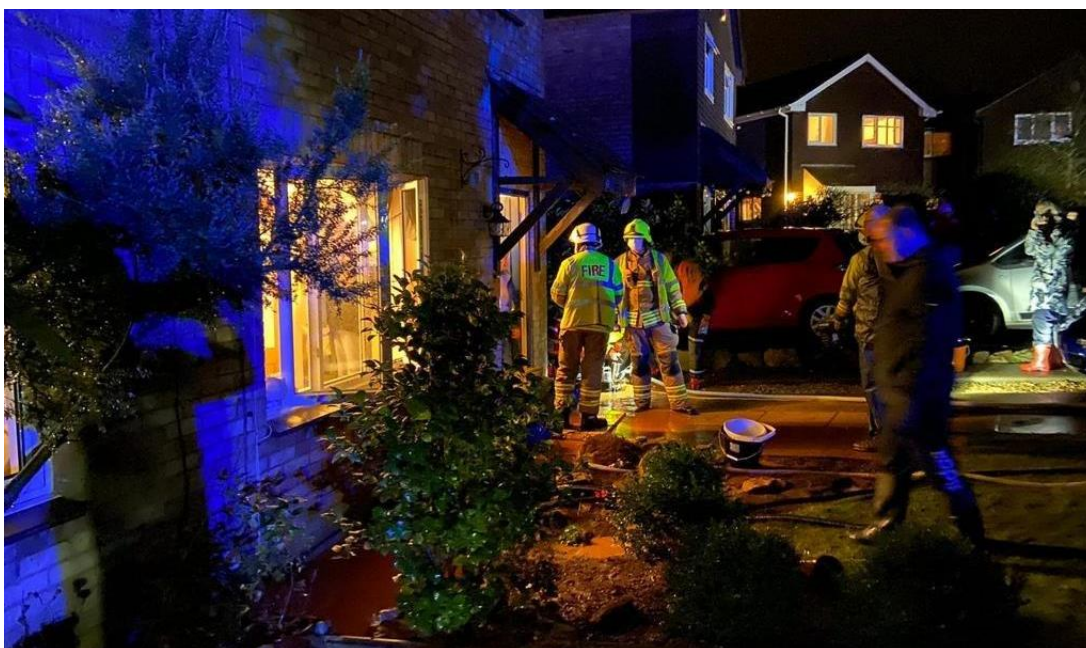
**Figure 7-3 Image of external property flooding within the Conybeare Road investigation area (image received from resident completed flood report)**

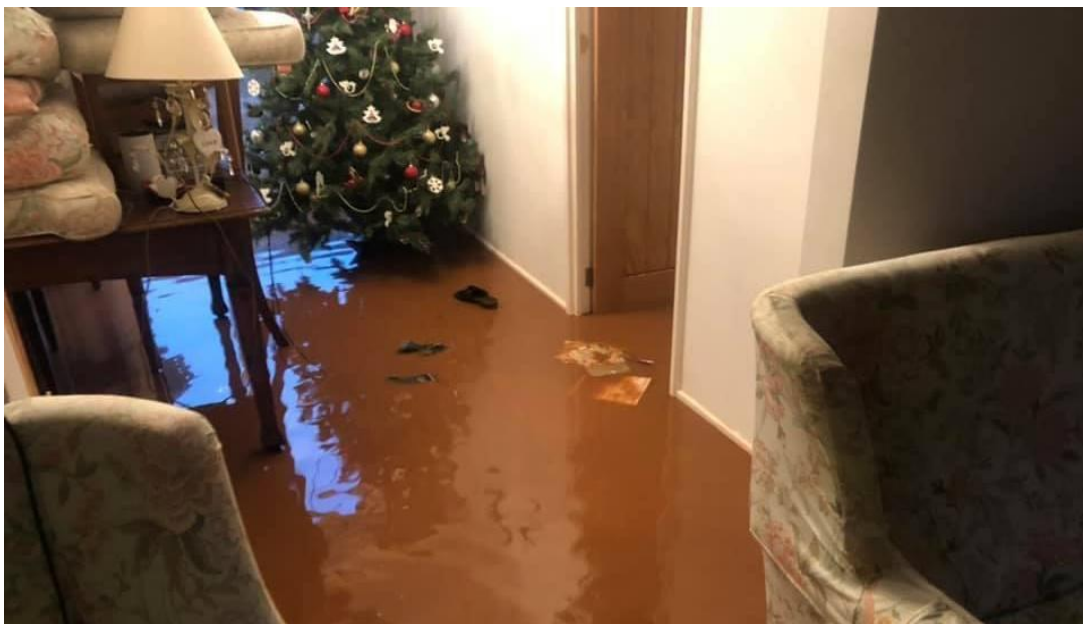
**Figure 7-4 Image of internal property flooding within the Conybeare Road investigation area (image received from resident completed flood report)**

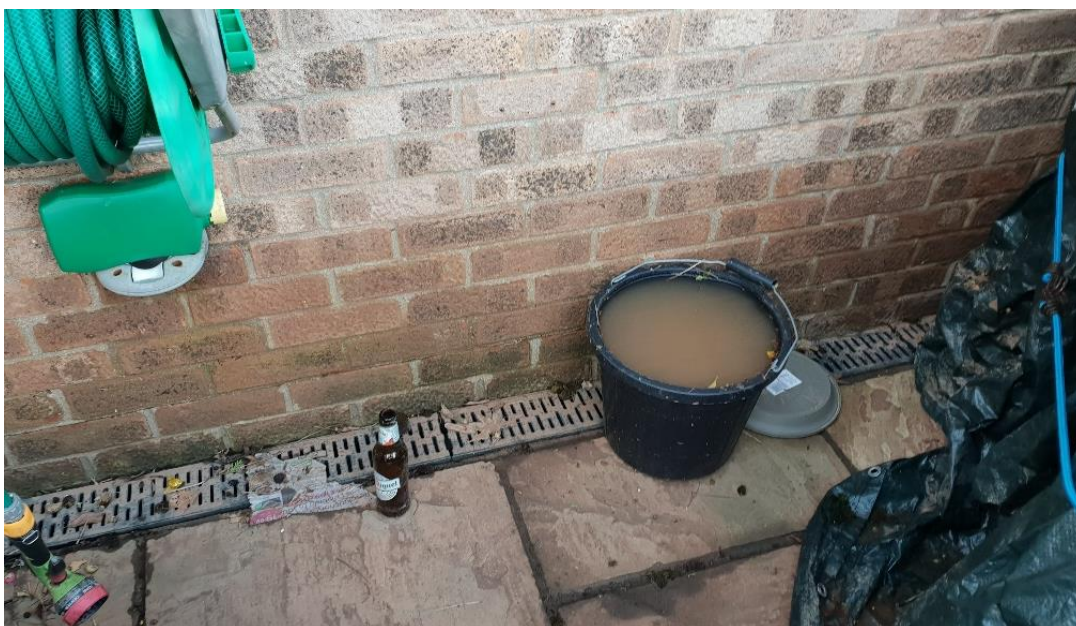
**Figure 7-5 Image of external property flood mark within the Swanbridge Grove investigation area (image received from resident completed flood report)**

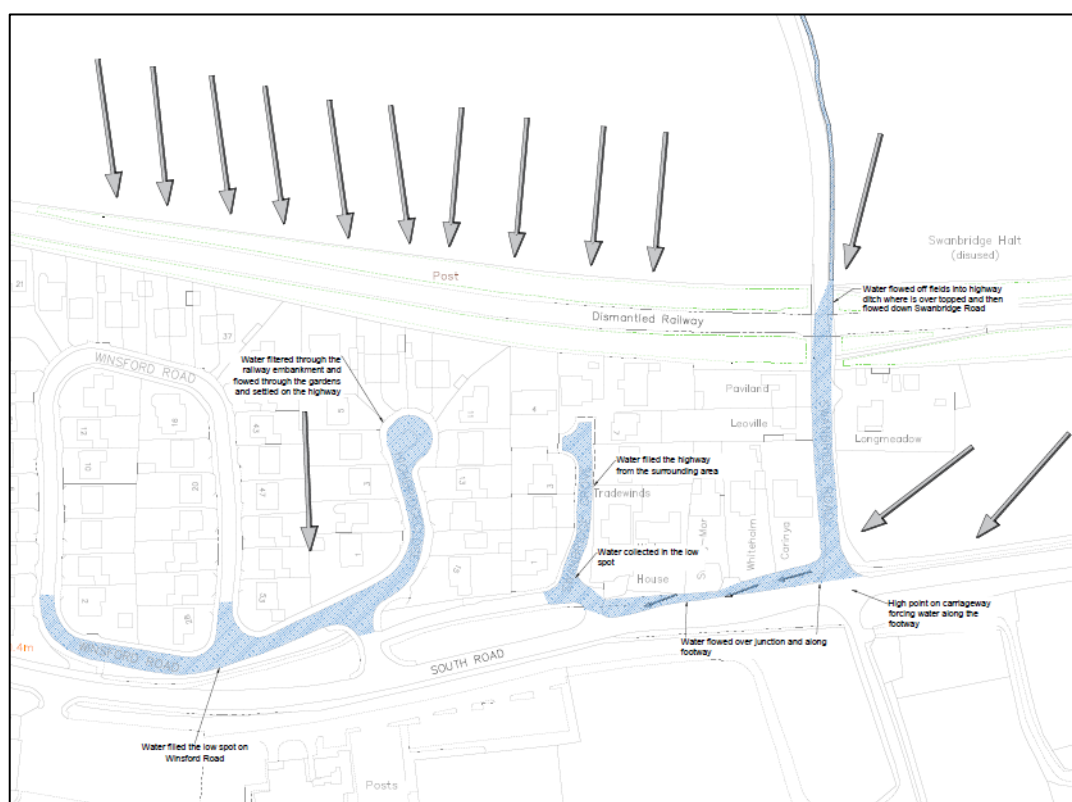
**Figure 7-6 - Highway and footway flooding**

Evidence collected by the VoGC identified a number of areas of highway and footway which were impacted by the flooding. Figure 7-6 below (Appendix D) shows the location of significant water build up within the Swanbridge Grove study area as reported by VoGC following their investigations.

Surface water run-off is reported to have filtered through the disused railway embankment, down Highbridge Close and through the rear gardens of properties situated between Highbridge Close and Winsford Road. It then collected in the low points of Winsford Road and the junction of Highbridge Close and South Road. One resident of Winsford Road reported that the road was impassable for a time due to the depth of water that was ponding in this area. At Swanbridge Grove, water filled the highway from the surrounding area, flowed south and collected in the low point at the entrance to Swanbridge Grove. Additionally, flows from Swanbridge Road were prevented from flowing onto South Road due to the high point on the carriageway, and instead flowed west along the footway and towards the low point at the entrance to Swanbridge Grove.
