Section 19 Flood Investigation

23rd December 2020 Flood Event

Dinas Powys, Vale of Glamorgan

Final Report

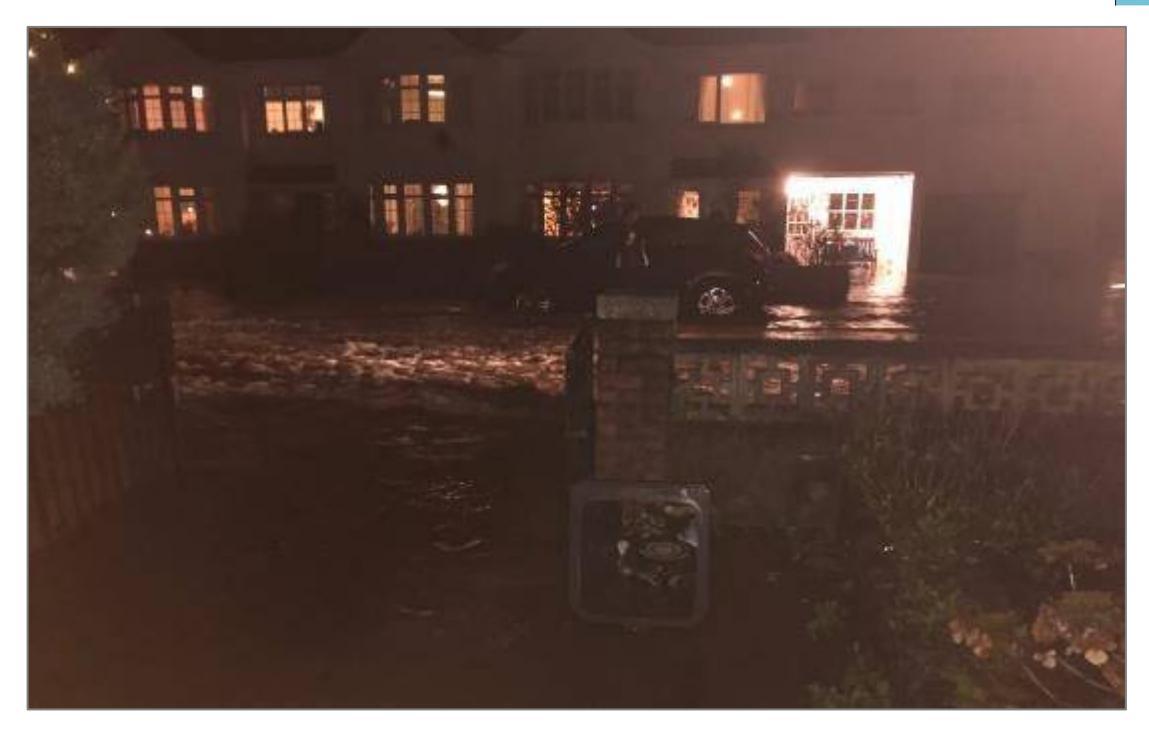
Figure 7-6 Flooding on Greenfield Avenue, Dinas Powys

The primary cause of flooding along Greenfield Avenue and to the northern extent of Millbrook Road was the River Cadoxton overtopping resulting in fluvial flooding to the highway and properties. Fluvial floodwater tracked south, resulting in additional property and highway flooding to Cardiff Road. The extent of flooding during the flood event correlates well to the predicted flood extents modelled by NRW. These modelled flood extents are based on current channel status, geomorphology and maintenance regimes.

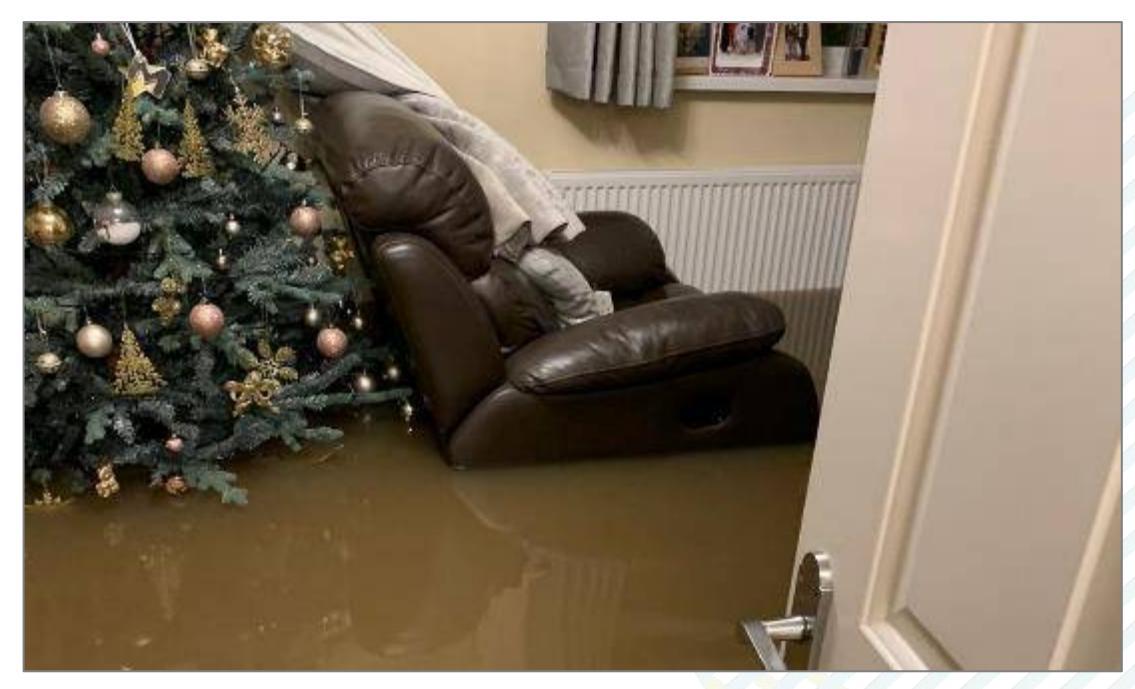
St Cadoc's Avenue experienced high levels of fluvial flooding from the River Cadoxton which had overtopped its banks alongside St Cadoc's Avenue, downstream of the St Cadoc's Avenue road bridge, downstream of St Dyfrig Close. Water overtopped the right-hand bank of the channel and flowed along the highway into the adjoining cul-de-sacs (Figure 7-4) of St Nicholas Close, St Baruch Close, and St Winifred's Close. Water which overtopped the channel on the lefthand bank entered properties in St Lythans Close, St Pauls Close and St Cadoc's Avenue. At the southern extent of this investigation area, the River Cadoxton overtopped its banks at the rear of properties 2-14 St Cadoc's Avenue (even numbers only). These properties also flooded from the highway as a result of fluvial flows on St Cadoc's Avenue flowing into a south-easterly direction, back towards the river channel. These properties are substantially lower than the rest of the properties in this investigation area. Following flooding of properties at around 6pm, water levels were receding by 8pm.

Figure 7-7 Internal flooding on St Cadoc's Avenue, Dinas Powys

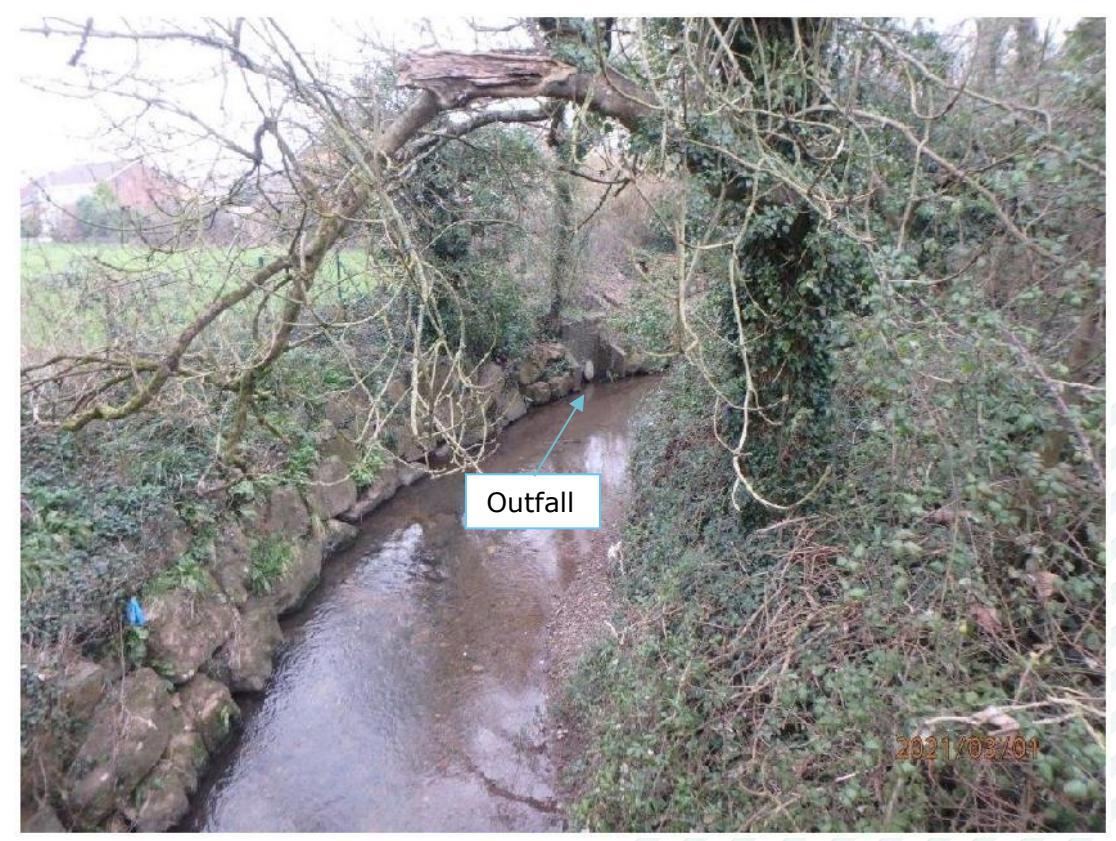
Figure 8-1 DCWW Outfall to the River Cadoxton (VOGC)

The primary cause of flooding within the Cae'r Odyn residential area was surface water flooding, likely exacerbated by high river levels at the surface water network outfall potentially combined with some out of bank flooding from the River Cadoxton. The volume and intensity of observed rainfall taken in combination with high water levels in the receiving watercourse is likely to have overwhelmed the DCWW public surface water network and lateral connections. In addition, there are anecdotal reports that local residents lifted manhole covers in the area in a bid to dispose of flood waters into the public sewerage system, this would result in the public network receiving flows it has not been designed to receive (i.e. additional surface water runoff primarily from saturated gardens and/or fluvial flows) leaving the network at or exceeding capacity. Further detailed assessment is required to confirm the potential influence of river levels at the surface water outfall, and interaction of pluvial and fluvial flood risk at this location. The outfall to the system is at a low level (Figure 8-1), with the potential

to result in hydraulic locking of the system when levels within the river channel are elevated.

Reports received suggest that the Fire and Rescue Service attended this area to clear a blocked drain, following which water drained away quickly. This suggests that the highway and/or DCWW surface water network may be blocked or in need of maintenance. Any blockage would result in reduced capacity of the system to store surface water during the rainfall event. DCWW have confirmed that the system within the Cae'r Odyn investigation area was checked on the 29th December 2020, confirming that it was fully operating as designed. DCWW also undertook surveys of the system in January 2021. This survey identified a small volume of silt within the surface water system. As a result, the system was cleansed and silt removed by DCWW It is not known to what extent this blockage and/or build up of silt exacerbated flooding at this location.

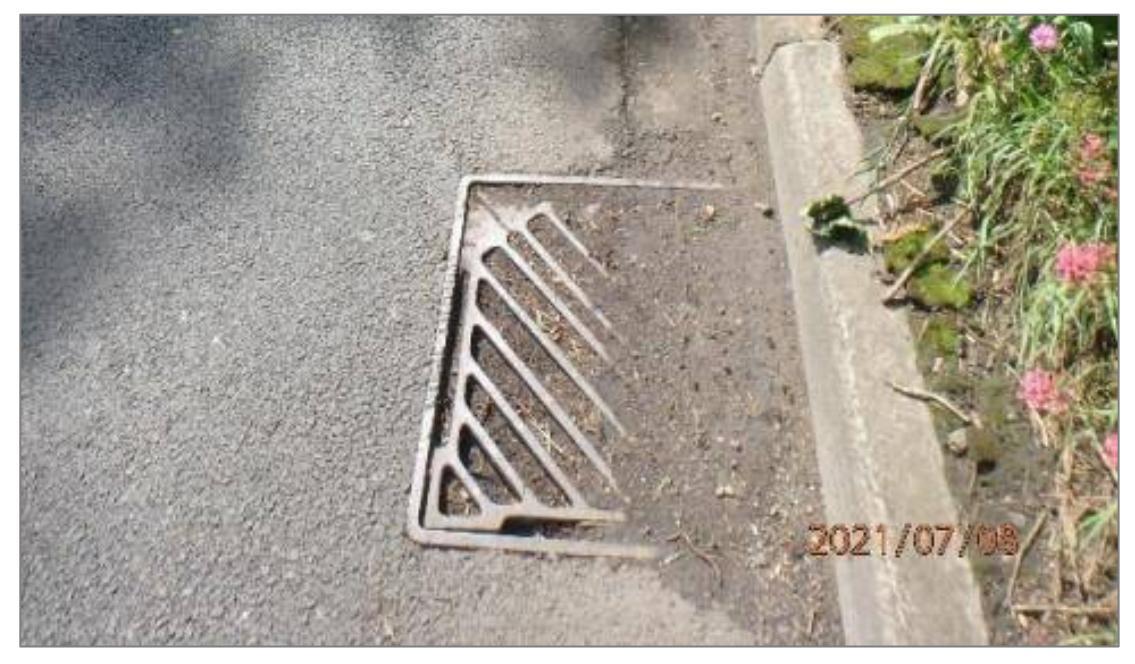
Reports were also received regarding surface water entering the rear gardens of properties in Cae'r Odyn which border Cardiff Road. A walkover survey of the gullies on Cardiff Road in June 2021 show that they were significantly blocked (Figure 8-2), suggesting poor maintenance of the highway network. Should this blockage have been present at the time of the flood event, surface water would have been unable to enter the highway network resulting in surface water flooding of Cardiff Road. Passing vehicles creating bow waves then resulted in floodwater entering the rear gardens of the properties in Cae'r Odyn.

Figure 8-2 One of two blocked gullies on Cardiff road adjacent to Cae'r Odyn.

DCWW / LLFA	Consider catchment options further to reduce surface water flood risk for the Cae'r Odyn community.	
Highways Authority (VoGC)	Investigate condition of highway surface water drainage systems on Cardiff Road and review frequency of asset maintenance. Cleanse gullies on Cardiff Road adjacent to Cae'r Odyn.	
Highways Authority (VoGC)	Remediate the condition of the highway network in Millbrook Road	
Highways Authority (VoGC)	Investigate the condition of the highway drainage system in the wider East Brook area via CCTV survey and cleanse as required.	
Highways Authority (VoGC)	Investigate the condition of the highway drainage system around Elm Grove Place, Cardiff Road and Elm Grove Road via CCTV survey and cleanse as required.	
Highways Authority (VoGC)	Consider what access and egress provisions are available for Elm Grove Place	
VoGC	Confirm capacity / form, ownership and maintenance of the culvert beneath the railway embankment at Elm Grove Place, and receiving ditch / channel
