**Our ref: 2019/00871/OUT Model Farm**

Date: 14 November 2019

**Planning Application 2019/00871/OUT  
Land at Model Farm, Port Road, Rhoose**

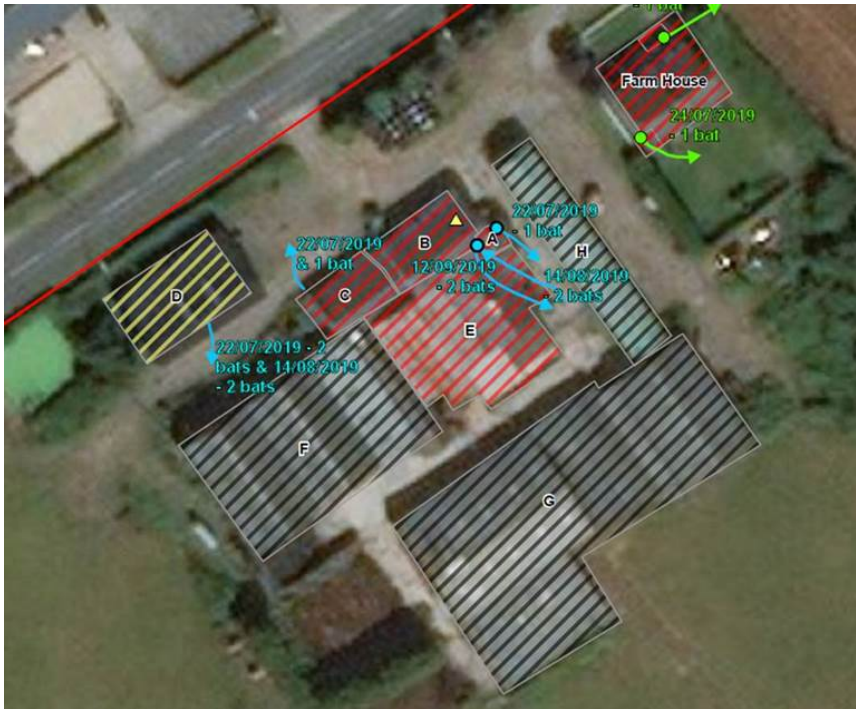
**Figure 1 Farmhouse and Barn Complex**

Those found to have features that could support roosting bats were the farm house, and five of the barns - A, B, C, D and E as shown on Figure 1 overleaf. During this inspection each building was surveyed externally and where possible internally. However, safe internal access was very limited. Both Barns A and C were considered to be structurally unsound and access was only possible into the entrances. In addition, the storage of materials throughout Barn B restricted access into the building, while livestock in Barns E, F, and G limited the areas that could be entered by the surveyors.

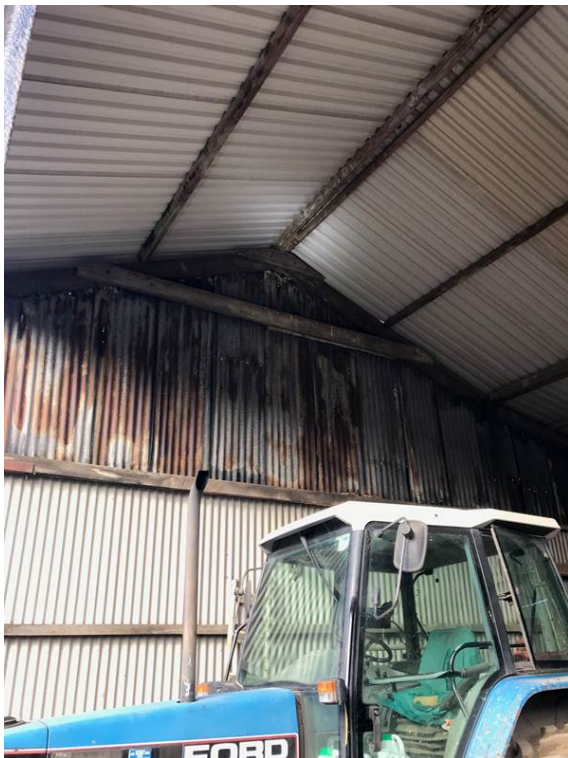
**Figure 2 Internal structure of Barn D**

All the larger barns; D, G, F and H, are constructed from single corrugated metal sheets, but Barn D had timber rafters and wall beams (Figure 2 below).

This increased its potential value for bats compared to the other three large barns (Barns G, F and H) which each had a metal frame with corrugated sheeting roof and walls.
