Vale of Glamorgan Council

Penarth Headland Link

Stage 1 Maritime and Geotechnical Review

Issue | 25 April 2018

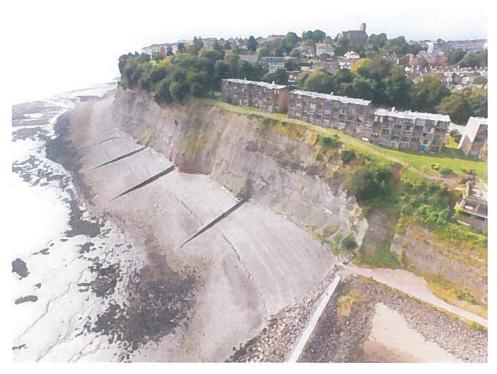
Figure 3: Existing groynes at the northern end of the site

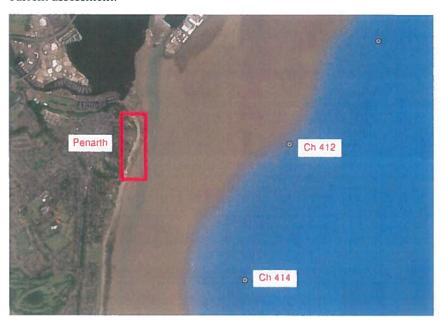
The extreme levels reported in CFB in proximity of Penarth at Chainage 412 and Chainage 414 (see location in Figure 4) are presented in

Table 2 for different return periods. Although the differences between the two datasets are considered small, Chainage 412 gives slightly higher tide levels and is used in the current assessment.

Figure 4: CFBD Chainages 412 and 414 in proximity of Penarth

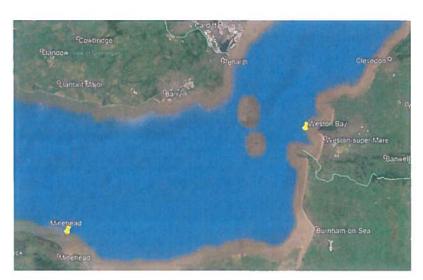
Records from buoys located nearby at Weston Bay (14km away) and Minehead (30km away) provide additional information about the wave climate in the Bristol Channel, see Figure 7. These buoys are part of the Channel Coastal Observatory (CCO) monitoring programme and have been deployed in 2009 and 2007 respectively in Weston Bay and Minehead. However, their exposure conditions to waves is considered to be significantly different from the expected local conditions at Penarth and therefore not considered further.

Figure 7: Wave buoys locations (http://www.channelcoast.org/data_management/online_data_catalogue/metadata/search/i_ndex2.php)

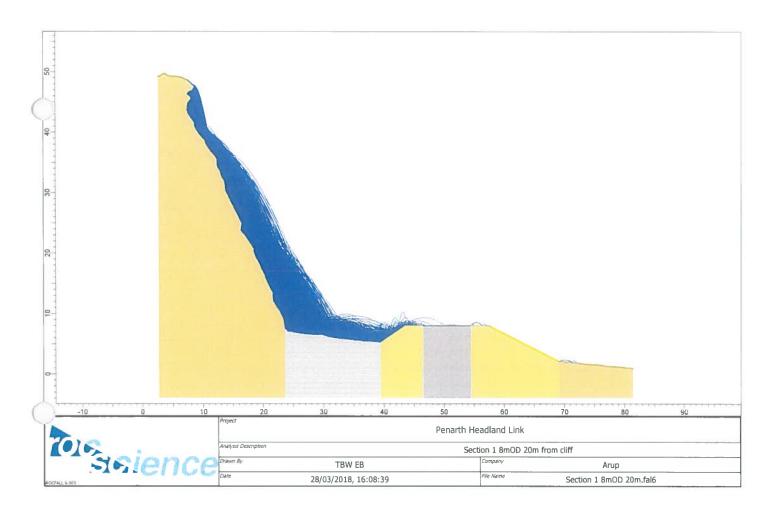
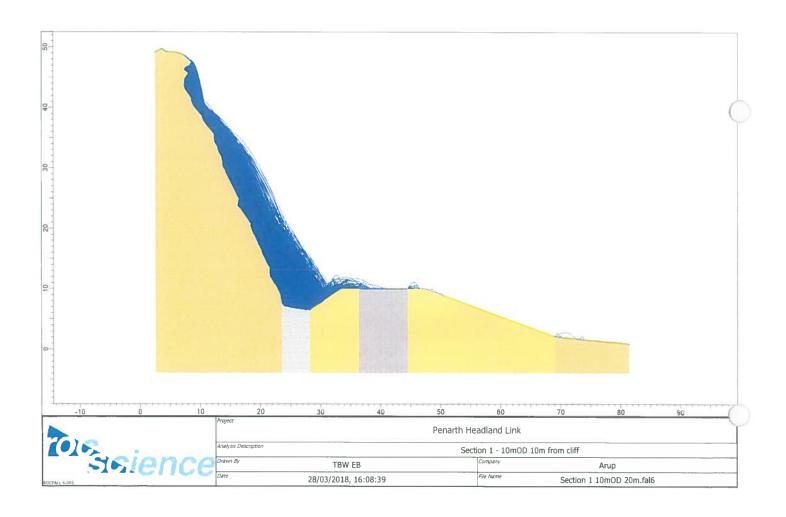
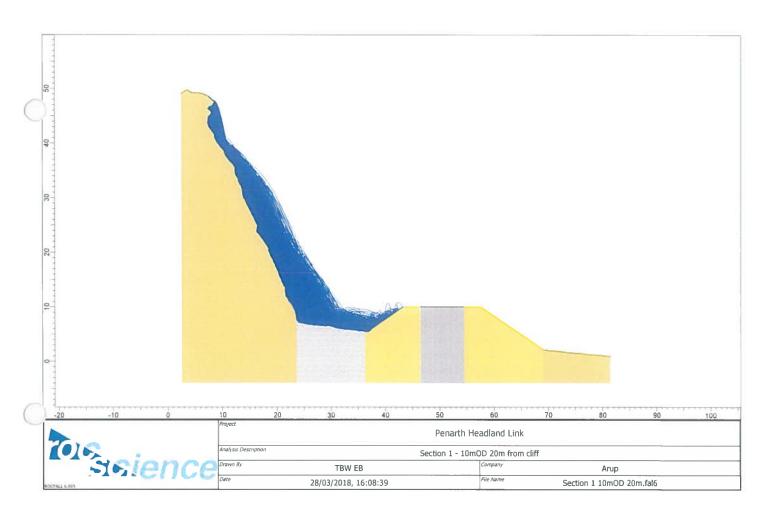
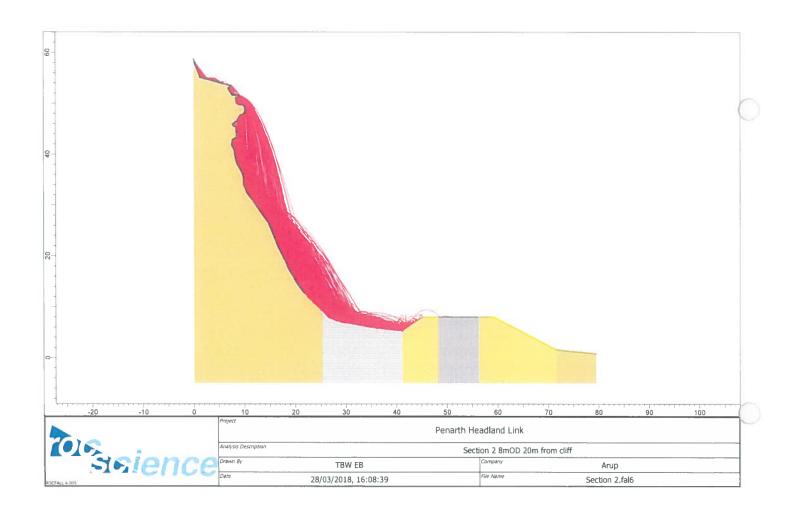
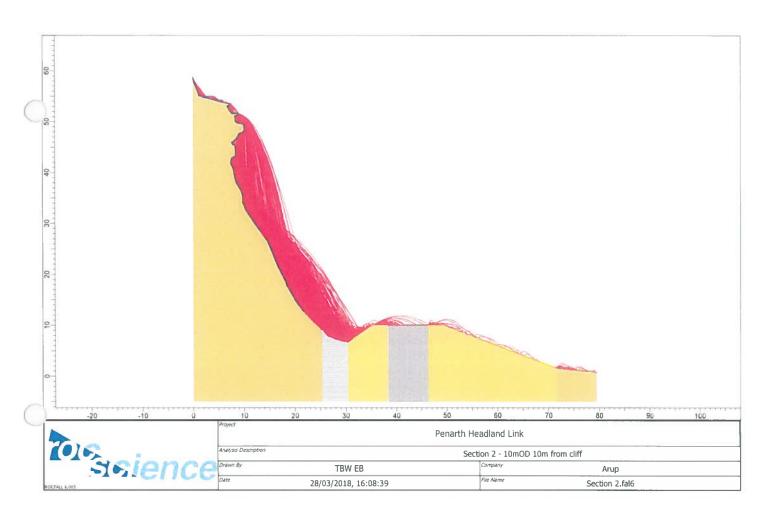
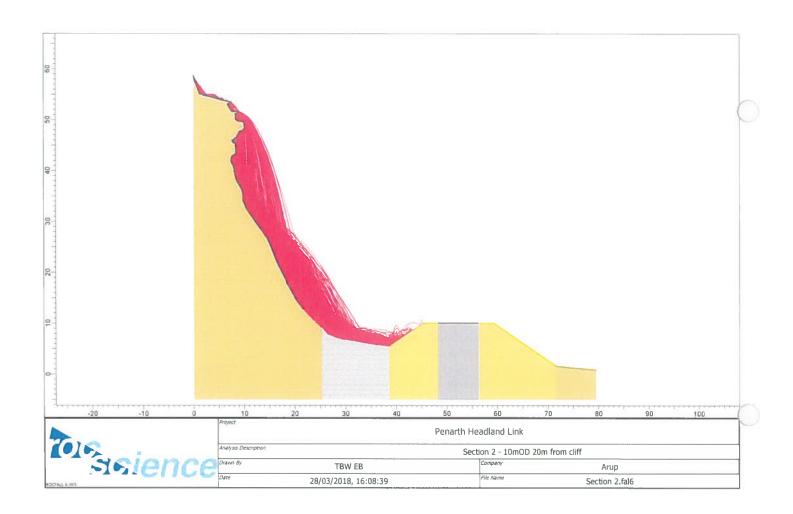
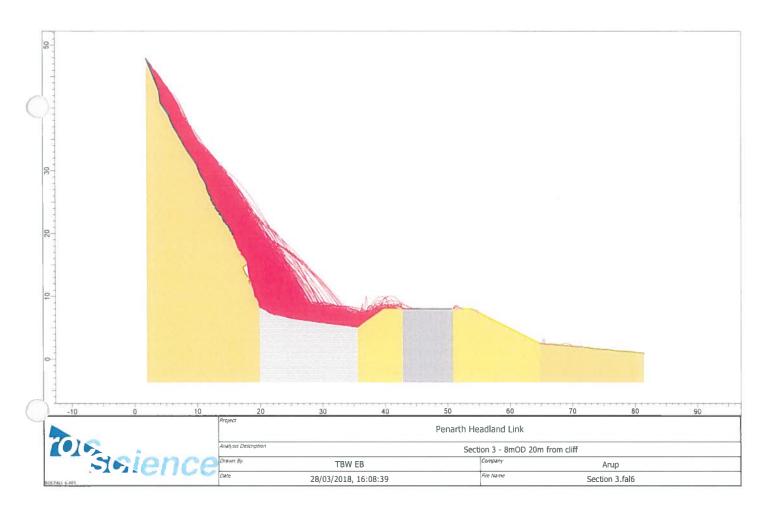
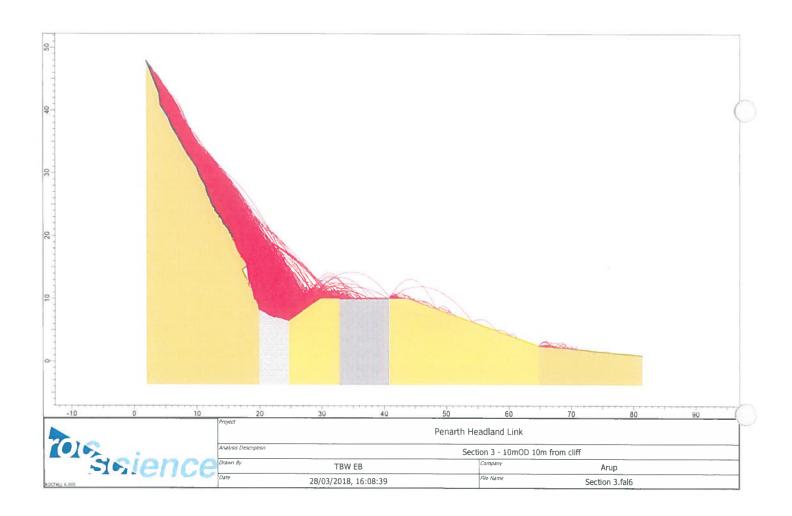
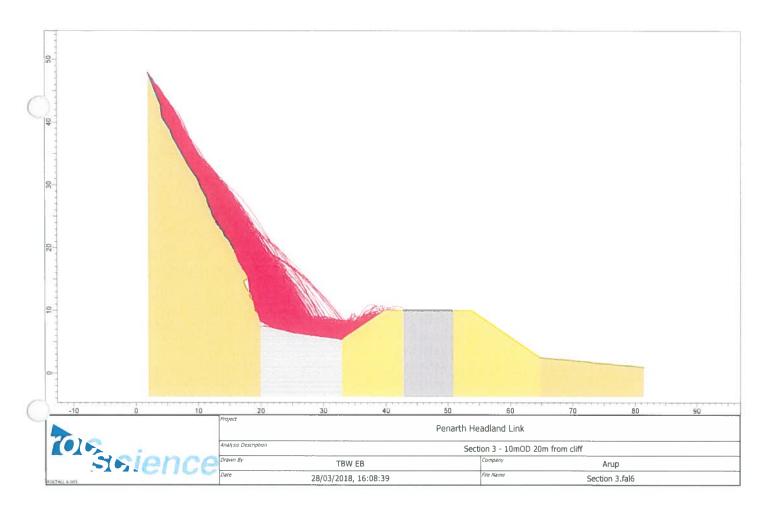
Rock Fall Assessment

Based on observations made on site and interrogation of survey data, the debris slides that have occurred recently along the cliff extend some 10-15m out onto the beach. It is considered likely that some blocks will have rolled further down the beach in front of the main mass of debris. Based on these observations it is considered likely that future debris slides have the potential to extend as far at the proposed causeway, with a crest at 20m from the cliff face. Further review of historical instability and consideration of the potential to damage the causeway structure will need to be undertaken during the next stage of works.

Limestone and gypsum blocks present on the beach provide a good indication of material that currently falls from the cliff. Based on the rock fall assessments at the three selected sections, a path on a causeway with a crest at 20m from the cliff and at an elevation of 10mOD has a very low risk of being impacted by rockfall. Given that at this stage the rock fall analysis shows there is a residual risk that rock blocks could reach the path, consideration could be given to providing additional protection in locations where the public may spend more time such as areas of seating.
