Section 19 Flood Investigation

23rd December 2020 Flood Event

Dinas Powys, Vale of Glamorgan

Final Report

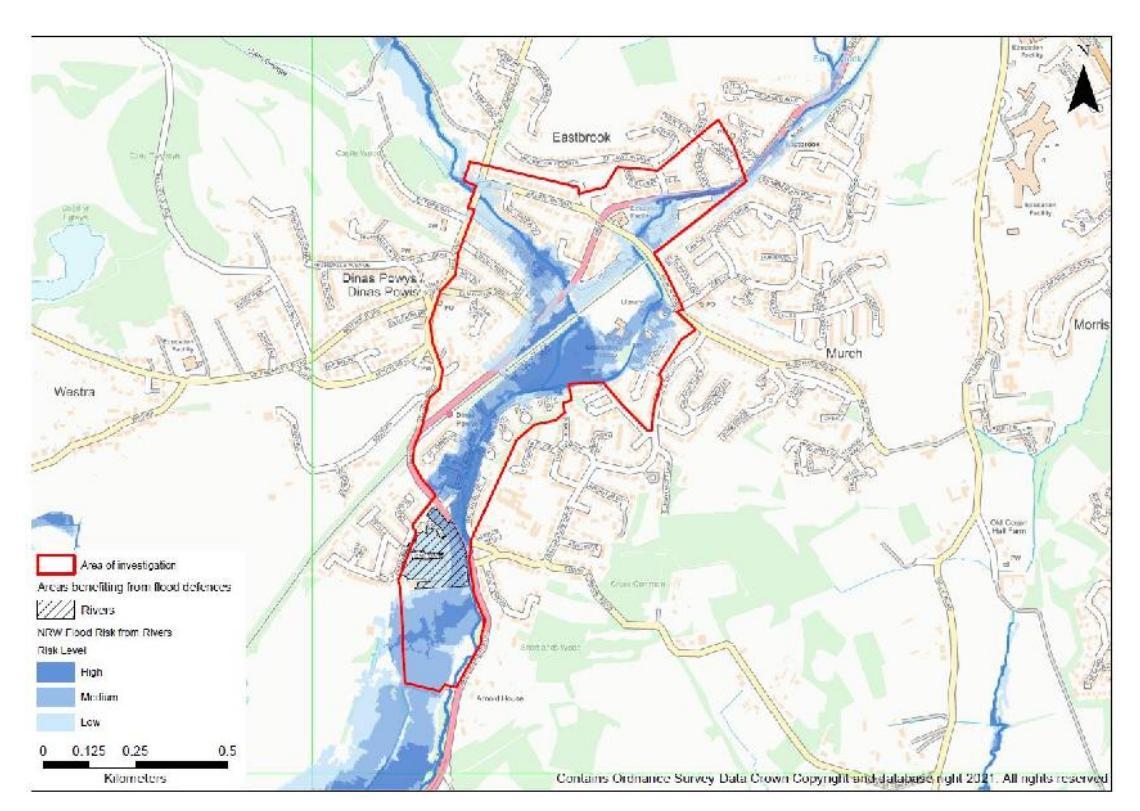
Figure 5-1 Risk of flooding from rivers and the sea

NRW's Flood Risk Assessment Wales map identifies the Cae'r Odyn estate as an area benefitting from fluvial flood defences (Figure 5-1). The area is defended by an embankment which offers a 1 in 25 annual probability standard of protection (SoP) and on last inspection was considered to be in 'Fair' condition. It should be noted that any protection offered by this asset is not accounted for in NRW's newly published Flood Map for Planning (September 2021) as this only considers assets offering a SoP of 1 in 100 annual probability or greater.

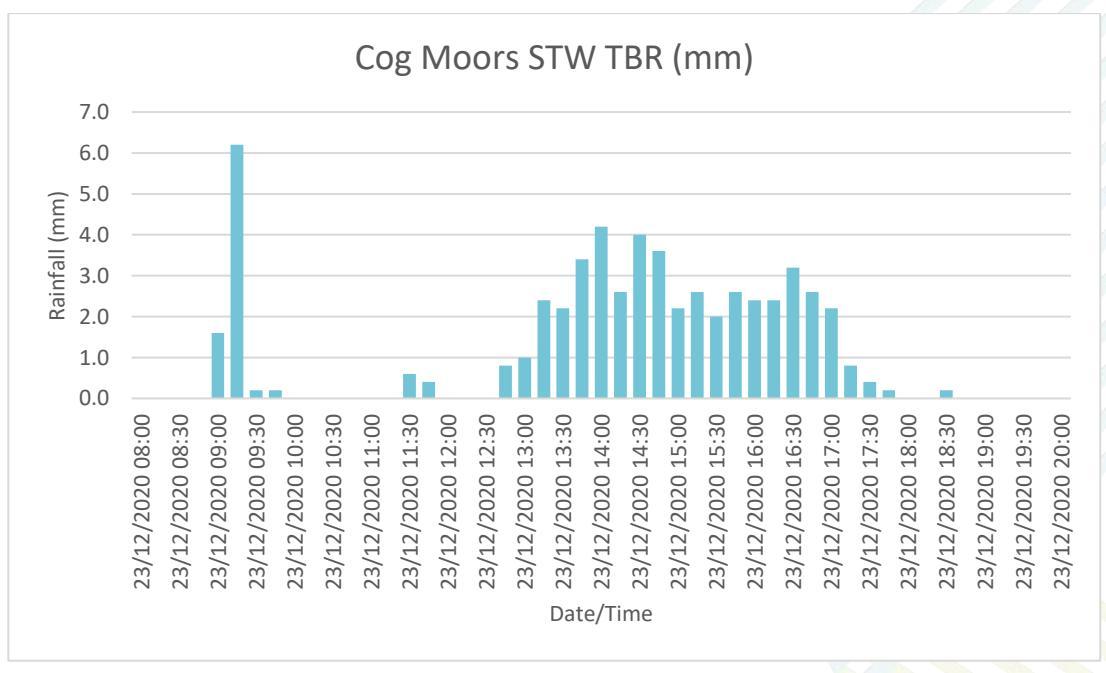
Figure 6-1 Rainfall hyetograph of December 2020 flood event

The flood event on 23rd December 2020 occurred in response to a short and intense storm event. A short sharp period of intense rainfall was observed between 09:00 and 10:00 at Cog Moors Sewage Treatment Works (STW) TBR rain gauge (the closest rain gauge to the site), recording 8.2mm in 1 hour. After a period of no rainfall for 1.5 hours and 1mm between 11.30 and 12.00 a longer period of persistent heavy rainfall between 12:45 and 18:00 occurred. During this 5.25hr period 47.8mm of rain fell with an average intensity of 9.1mm/hr. The maximum rainfall intensity occurred between 14:00 and 15:00 equalling >10mm/hr. Figure 6-1 below shows the rainfall hyetograph of the flood event at the Cog Moors STW TBR, as detailed in the Section 19 Data Analysis report undertaken by JBA Consulting (Appendix C).

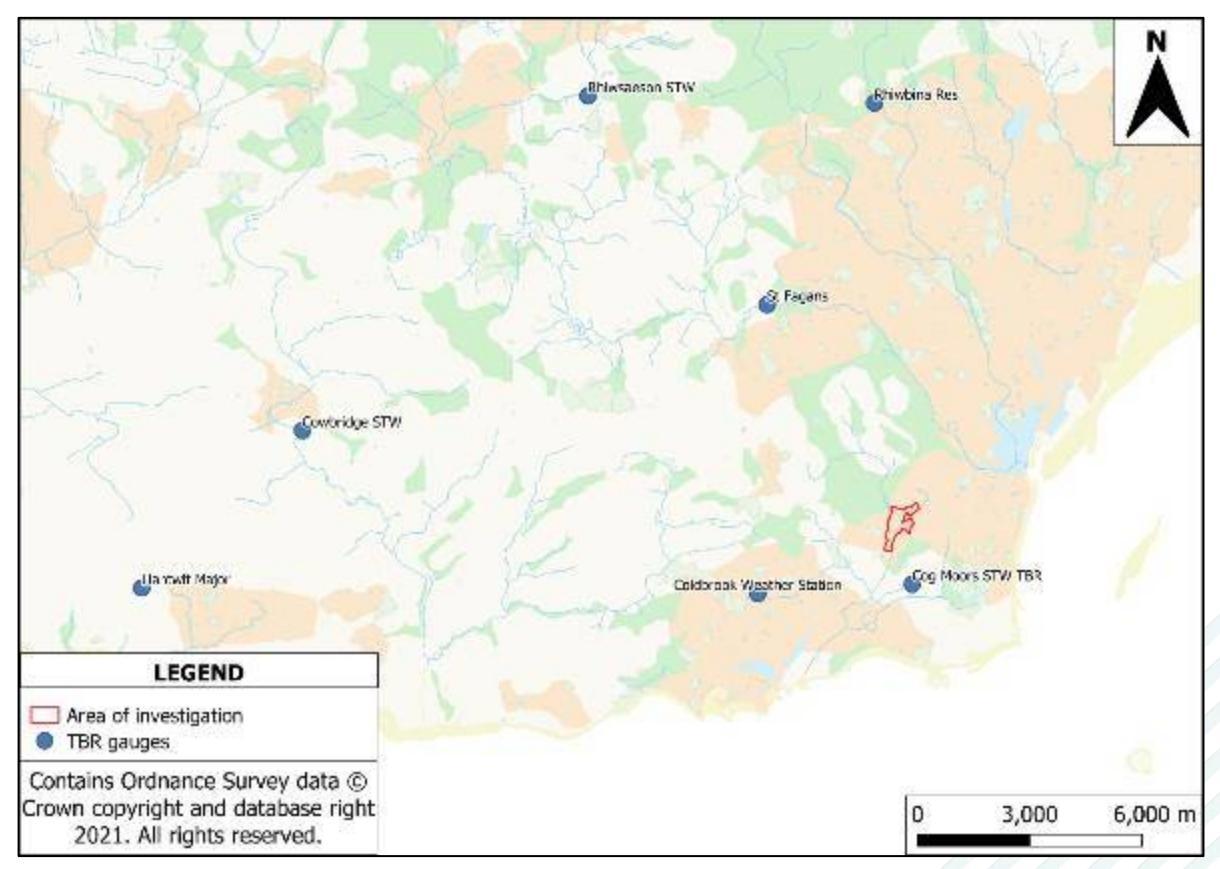
Figure 7-1 Rainfall gauge locations

The findings indicate that the Cog Moors STW TBR gauge recorded substantially larger rainfall totals than at the other gauges within the vicinity of the storm event (see Figure 7-1 and Table 7-1). NRW have indicated confidence in the Cog Moors STW TBR gauge due to the data being consistent between the primary and secondary gauges that operate independently and after quality checks undertaken on 31st December following the event. Rainfall radar data did not indicate a localised storm around Cog Moors STW TBR, so it is unclear why local rainfall totals differ so substantially from other rain gauges.

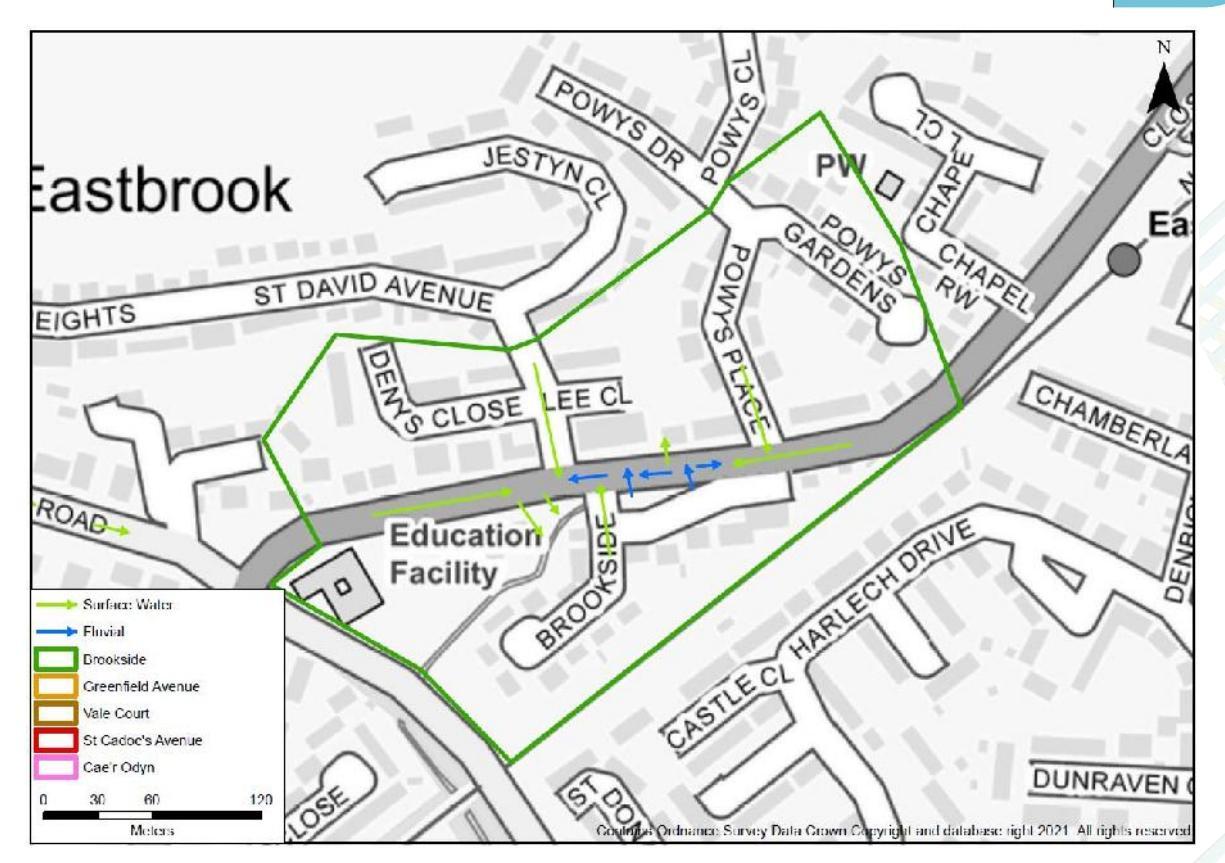
Figure 7-2 Brookside flow paths

The main fluvial flow pathway is from the East Brook overtopping its banks around the Brookside junction, flowing onto the highway and flooding an estimated 300m length of Cardiff Road (Figure 7-2).

Surface water flooded Cardiff Road to significant depths, however traffic was still able to pass through, though slowly. Passing traffic is also known to have created bow waves, exacerbating the extent of flood impacts in the area, with the flood extent encroaching into Dinas Powys community school playground/carpark and the electricity substation located on Cardiff Road.

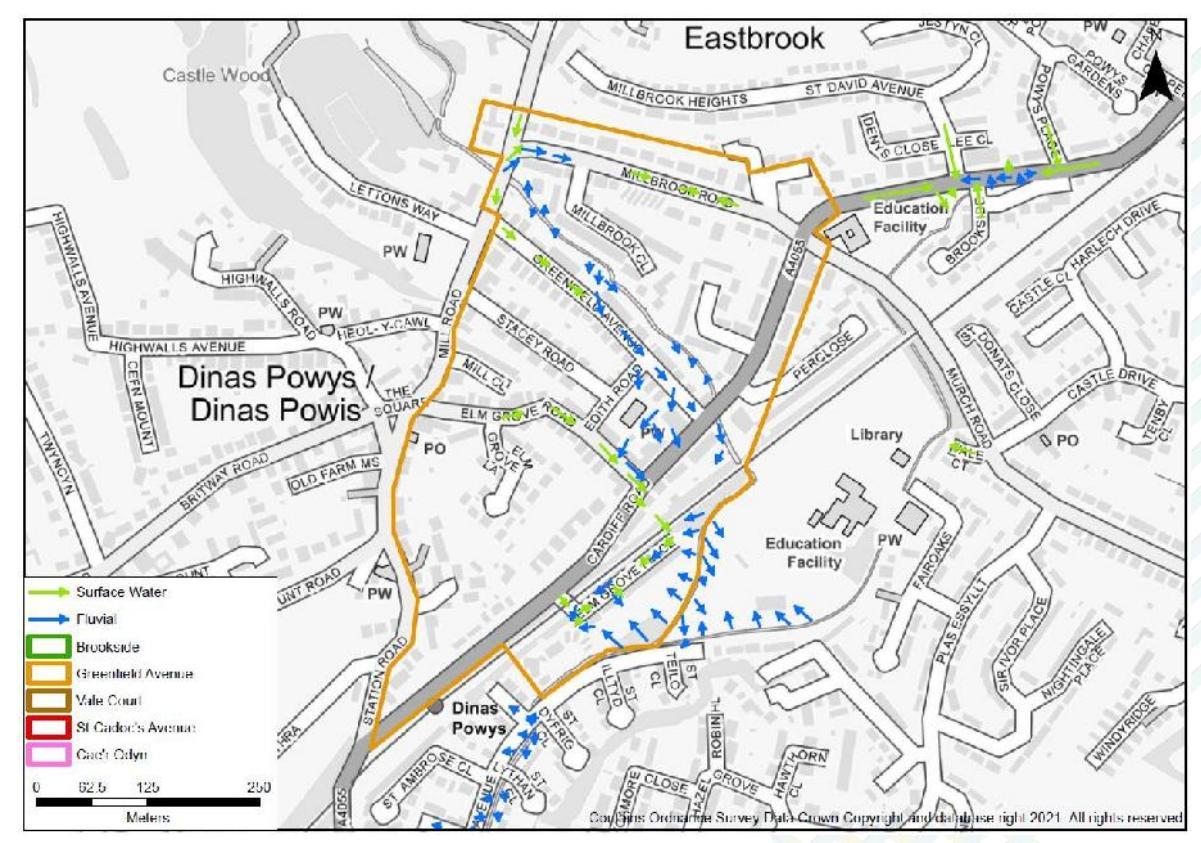
Figure 7-3 Greenfield Avenue investigation area fluvial flow paths

The main flow path onto Greenfield Avenue was from fluvial flows into the rear of several properties located on the right-hand bank of the river and through the public open space (known locally as The Scout Field) located between these properties (Figure 7-3). Due to the road being in camber, fluvial flows were shed to either side of the highway, flooding properties on both sides of Greenfield Avenue. To the southern extent of Greenfield Avenue, some properties reported floodwaters entering the garden at the rear from the channel, and gardens or the property itself, from the highway.

The primary fluvial flow path on Elm Grove Place was direct ingress from the River Cadoxton to the rear of the properties, and to the east of 1 Elm Grove Place (Figure 7-3). Water then proceeded to flow across the gardens and open spaces, along with the highway of Elm Grove Place, before flooding the properties from the rear.

Flows from Elm Grove Place also flowed in a westerly direction towards St Gwynno's Close, with 2 properties reported to have flooded externally as a result. Flows flooded the rear gardens of properties prior to flowing towards the highway of St Gwynno's Close and back towards the River Cadoxton.

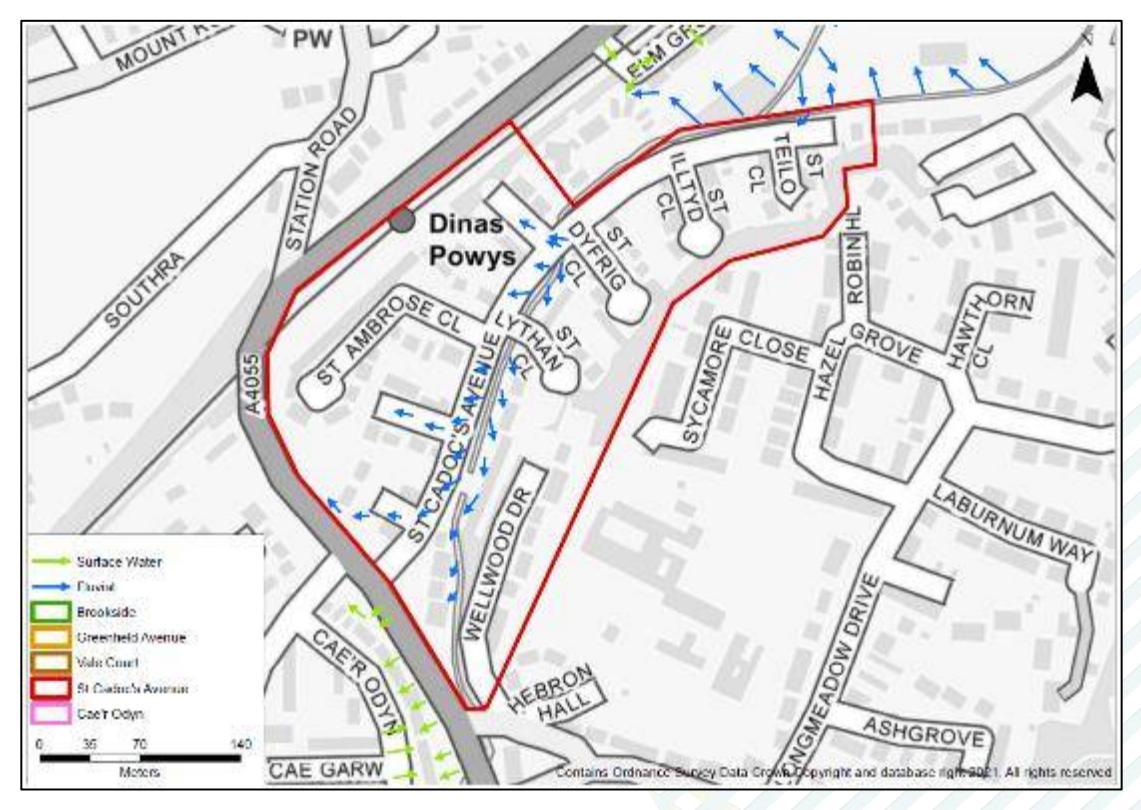
Figure 7-4 St Cadoc's Avenue flow paths

St Cadoc's Avenue experienced high levels of fluvial flooding from the River Cadoxton which had overtopped its banks alongside St Cadoc's Avenue, downstream of the St Cadoc's Avenue road bridge, downstream of St Dyfrig Close. Water overtopped the right-hand bank of the channel and flowed along the highway into the adjoining cul-de-sacs (Figure 7-4) of St Nicholas Close, St Baruch Close, and St Winifred's Close. Water which overtopped the channel on the lefthand bank entered properties in St Lythans Close, St Pauls Close and St Cadoc's Avenue. At the southern extent of this investigation area, the River Cadoxton overtopped its banks at the rear of properties 2-14 St Cadoc's Avenue (even numbers only). These properties also flooded from the highway as a result of fluvial flows on St Cadoc's Avenue flowing into a south-easterly direction, back towards the river channel. These properties are substantially lower than the rest of the properties in this investigation area. Following flooding of properties at around 6pm, water levels were receding by 8pm.

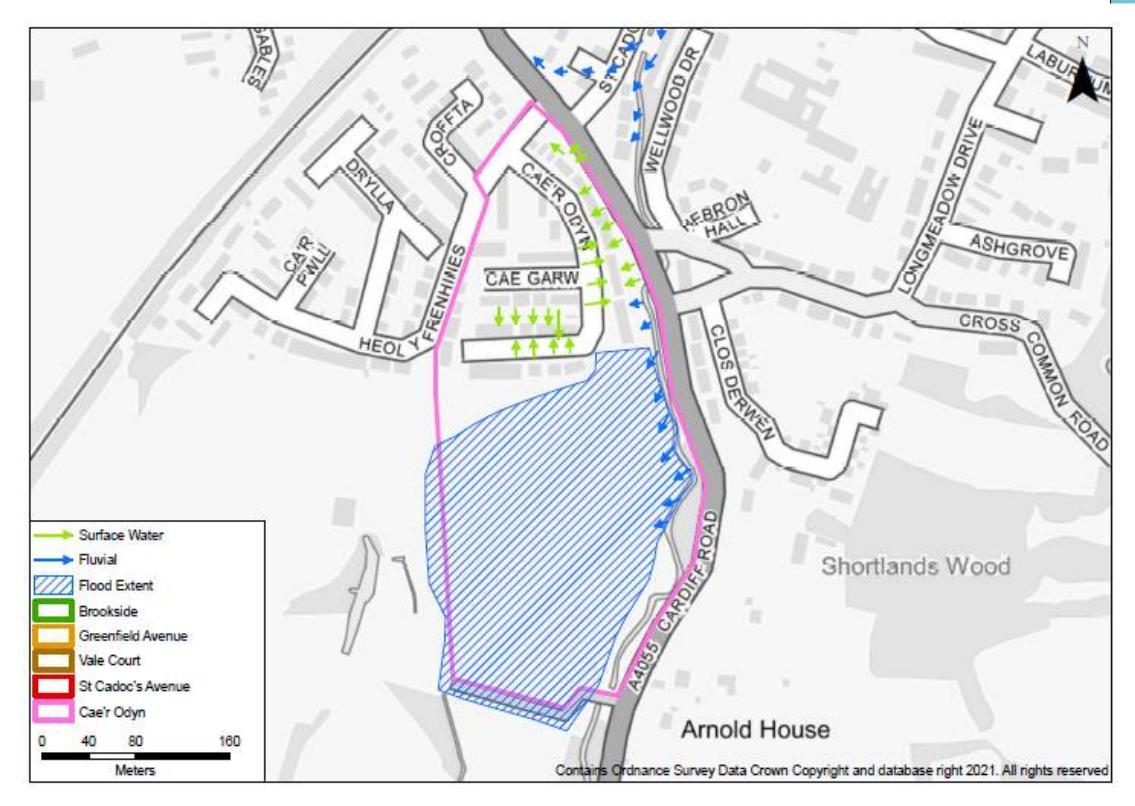
Figure 7-5 Cae'r Odyn flow paths

For properties along Cae'r Odyn, backing onto Cae Garw, surface water ponded in the rear garden where the boundary between the two rows of dwellings is located at a lower level than the property. Surface water gullies at the rear of the properties were also overwhelmed with surface water flowing towards the front of the property. Manholes on the DCWW network at the front of the property were also reported to be surcharging during the event (Figure 7-5). It has also been reported that several other manholes on the DCWW network were surcharging during the event. It is known that the DCWW surface water outfall is located at a very low level within the River Cadoxton, and it is therefore highly likely that this was hydraulically locked during the flood event, resulting in surcharging of the system.

For properties backing onto the Cadoxton River, three main pathways were reported. Firstly, water surcharging from the DCWW public combined system that flows in a southerly direction in the rear gardens. It was report that manholes and the Non-Return Valve (NRV) to the rear of a property were surcharging at the time of the event, with surface water flowing to neighbouring properties as a result of lower ground levels. Secondly, flooding as a result of surface water flowing from the highway towards the front of the properties, which are situated at a significantly lower level than the road.

Additionally, Cae'r Odyn sits adjacent to Cardiff Road, which is slightly elevated to the rear of the gardens. Reports indicate that surface water flowed from the carriageway into the rear gardens of a number of properties. The highway network on Cardiff Road at this location is blocked, and it is likely that passing traffic resulted in bow waves, pushing water into the rear of these properties.
