# **Section 19 Flood Investigation**

## **February 2020 – Storm Jorge**

### **Sully Moors Road, Vale of Glamorgan**

**March 2023**

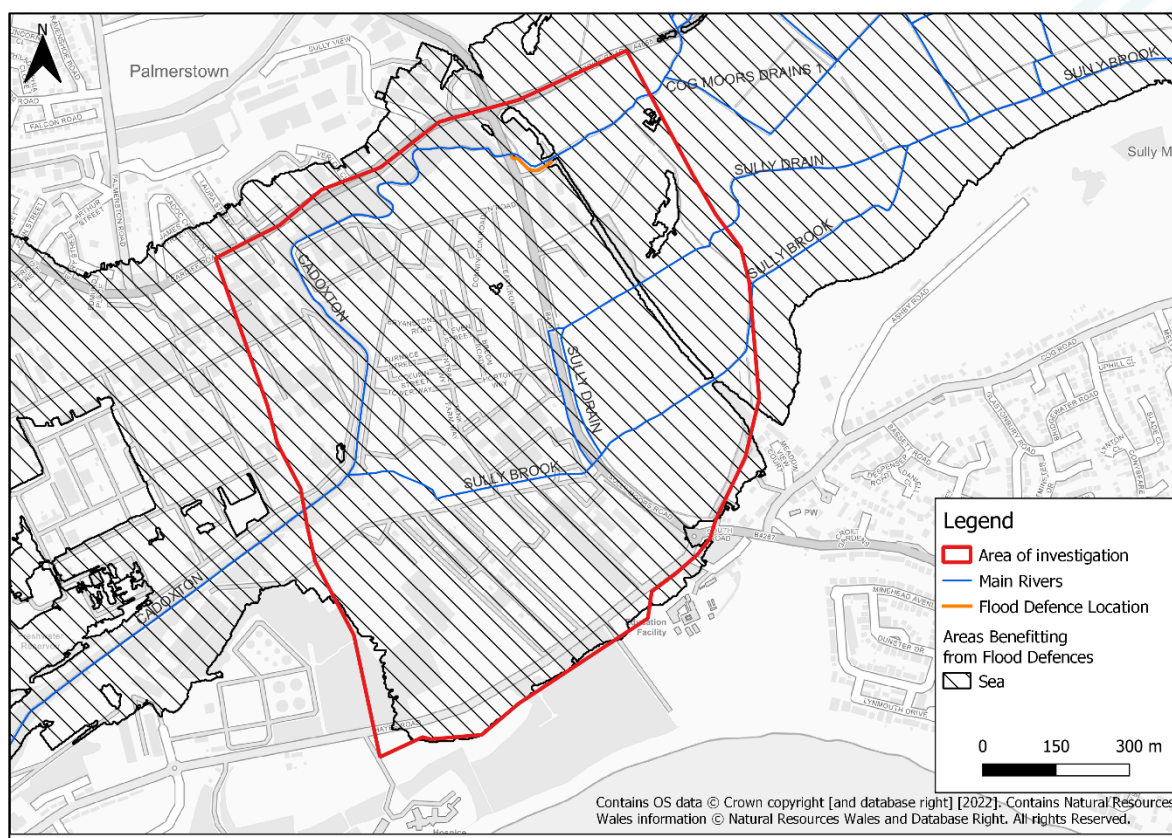
Figure 6-1: Areas benefitting from flood defences

The River Cadoxton and the Sully Brook are tidally influenced as they flow through the investigation area. The majority of the investigation areas is categorised as 'Area benefitting from flood defences from the sea' by NRW. The investigation area includes a small, 105m stretch of bund along the River Cadoxton at the north-eastern corner of the investigation area. This defence is classified as in 'Fair' condition by NRW.
