# **Section 19 Flood Investigation**

**23<sup>rd</sup> December 2020**

**Sully, Vale of  
Glamorgan**

**Final Report**

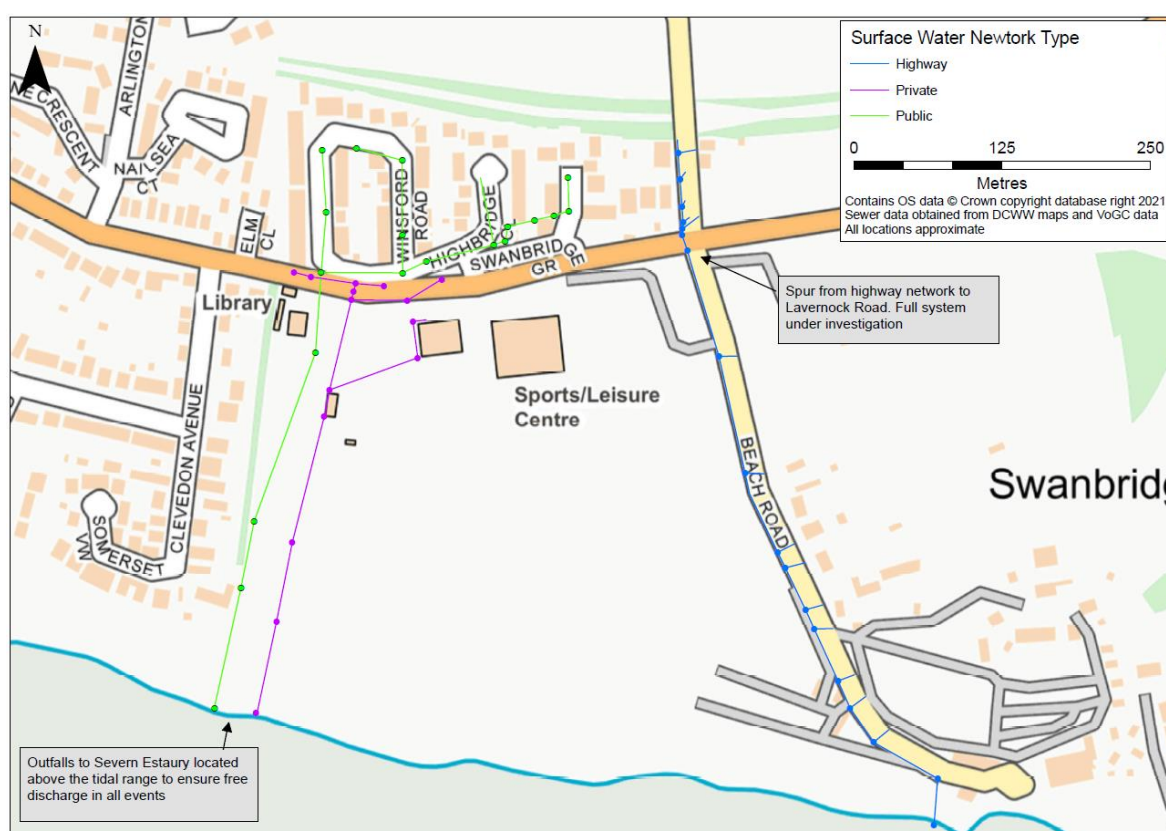
**Figure 4-2 Swanbridge Grove Investigation Area Surface Water Network**

On Swanbridge Road there is an open channel which collects highway run off, located north of the railway bridge. The channel discharges into the highway surface water network at the location of the railway bridge. The highway network at this location, shown in Figure 4-2, flows in a southerly direction along Swanbridge Road and Beach Road prior to discharging into the sea at an uncontrolled rate. The outfall is situated above the tidal range and the system would therefore discharge freely during all storm events. This highway system is designed to take flows from the highway only, and not to receive sheeting overland flows from the surrounding fields. Full bore pipe capacity of the 150mm dia clay pipe along Swanbridge Road to the junction of South Road is estimated at 19.4l/s.

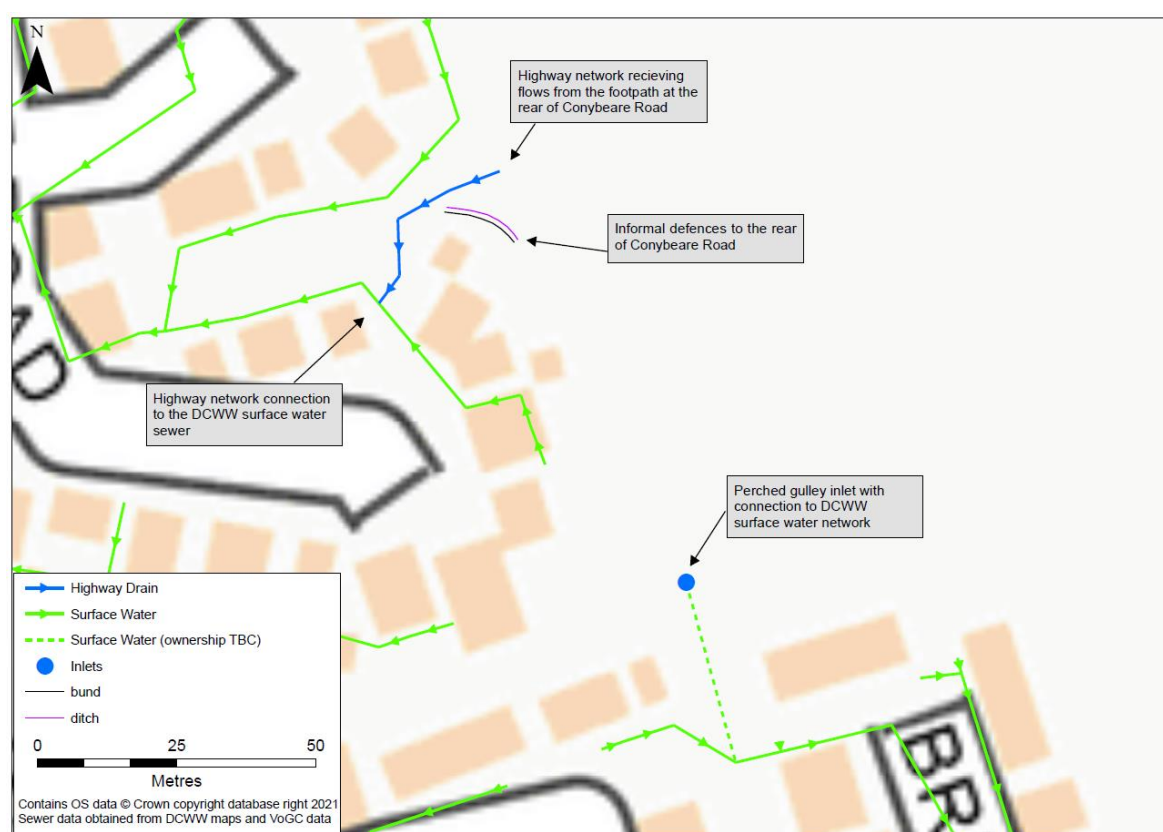
**Figure 4-3 Conybeare Road Surface Water Network**

The highway network drainage system extends to the footpath running along the rear of Conybeare Road where this footpath forms part of the adopted highway. A series of four gullies and channel drain receive surface water flows from the footpath and enters the DCWW surface water sewer in the footpath between 71 and 76 Conybeare Road, as shown in Figure 4-3.

To the rear of Conybeare Road, is a small informal flood defence installed with the intention of managing surface water. This is comprised of a small bund and ditch to the rear of 76 Conybeare Road, as shown in Figure 4-3 above and Figure 4-6 below.

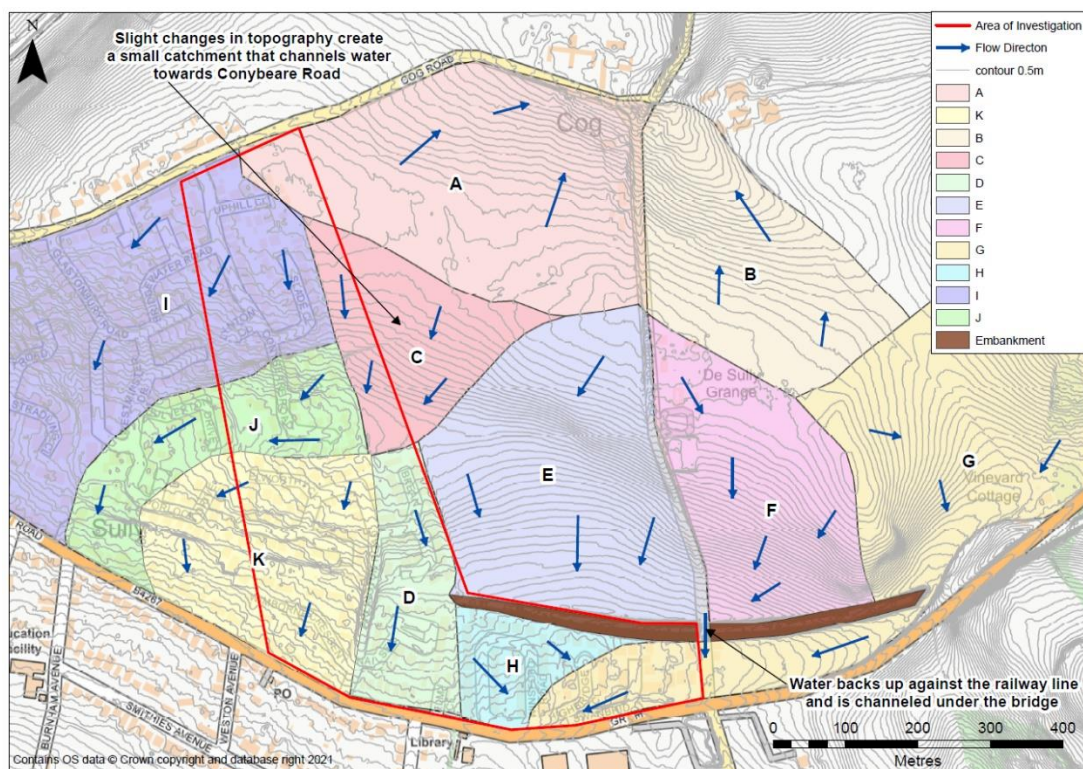
**Figure 4-7 Surface water runoff catchments**

It should be noted that Winsford Road and Highbridge Close have the lowest local ground levels, and this results in surface water from Catchments E, F, G and H pooling in this area. Ground levels of South Road are higher than those across Winsford Road and Highbridge Close, resulting in surface water entering Winsford Road ponding with no means of escape.

1. The first flow path identified was in Catchment E (Figure 4-7) that received water from the fields west of Swanbridge Road and north of the housing estate which pooled at the disused railway embankment before percolating through and flowing into the estate to the south.

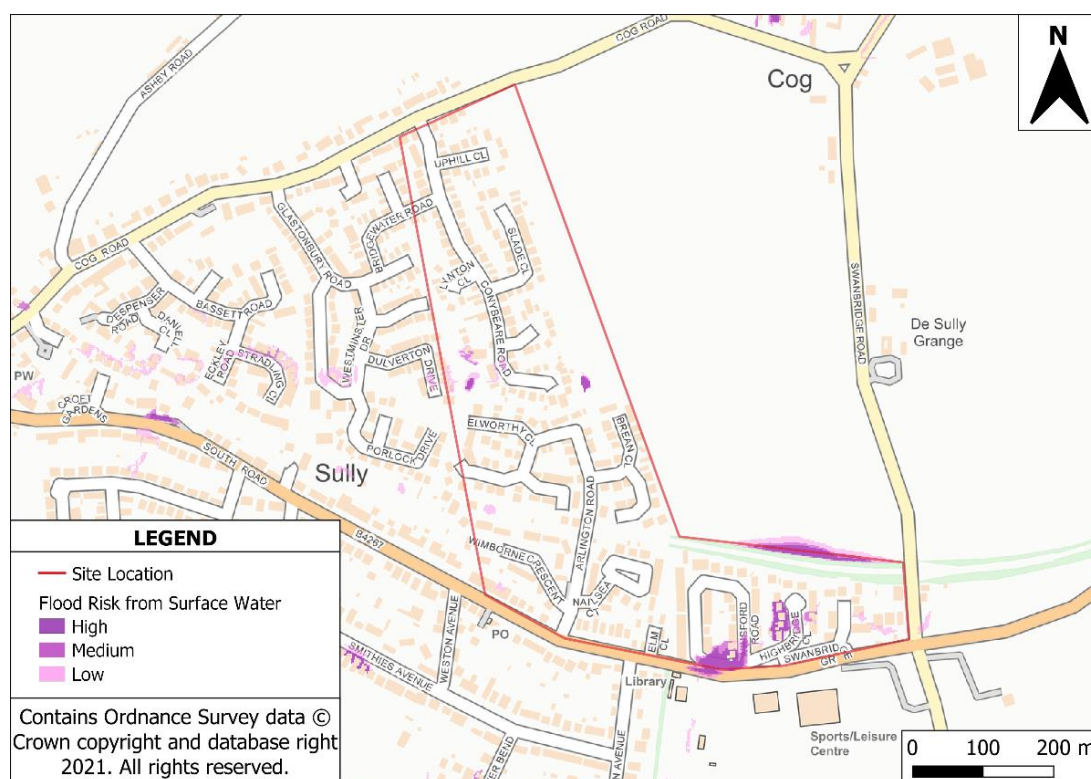
**Figure 5-2 Risk of flooding from surface water**

The NRW Flood Map for Surface Water shows the site has a mixed flood risk from surface water. Pooling of surface water on Winsford Road, Highbridge Close and off Conybeare Road to the east and west have resulted in these areas being at high risk of surface water flooding. A high risk of surface water flooding is defined as a greater than 1 in 30 chance of flooding in any year as a result of local rainfall (Figure 5-2).

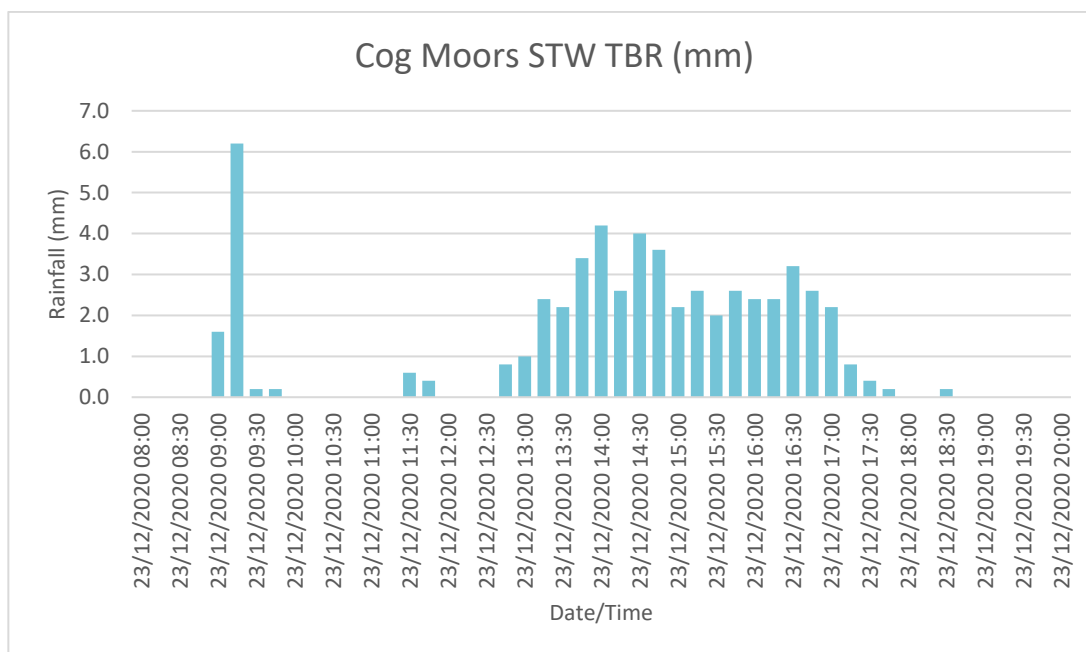
**Figure 6-1 Rainfall hyetograph of December 2020 flood event**

The flood event on 23<sup>rd</sup> December 2020 occurred in response to a short and intense storm event. A short sharp period of intense rainfall was observed between 09:00 and 10:00 at Cog Moors Sewage Treatment Works (STW) TBR rain gauge (the closest rain gauge to the site), recording 8.2mm in 1 hour. After a period of no rainfall for 1.5 hours and 1mm between 11.30 and 12.00 a longer period of persistent heavy rainfall between 12:45 and 18:00 occurred. During this 5.25hr period 47.8mm of rain fell with an average intensity of 9.1mm/hr. The maximum rainfall intensity occurred between 14:00 and 15:00 equalling >10mm/hr. Figure 6-1 below shows the rainfall hyetograph of the flood event at the Cog Moors STW TBR, as detailed in the Section 19 Data Analysis report undertaken by JBA Consulting.

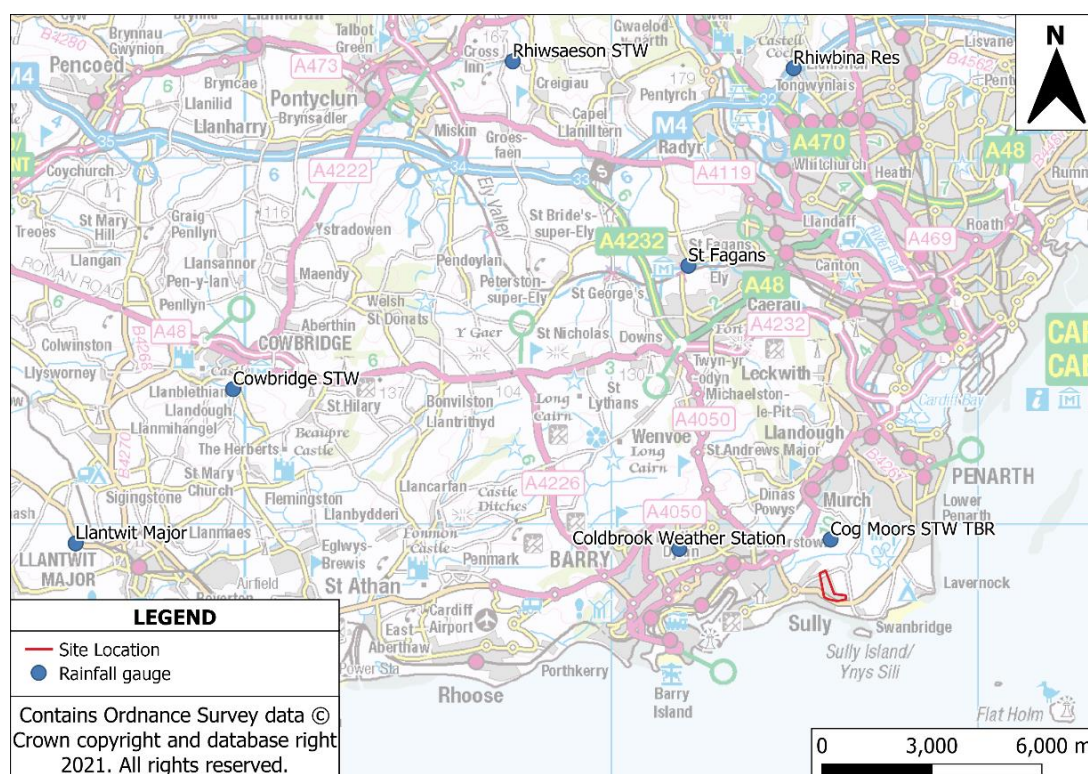
**Figure 7-1 Rainfall gauge locations**

The findings indicate that the Cog Moors STW TBR gauge recorded substantially larger rainfall totals than at the other gauges within the vicinity of the storm event (see Figure 7-1). NRW have indicated confidence in the Cog Moors STW TBR gauge due to the data being consistent between the primary and secondary gauges that operate independently and after quality checks undertaken on 31<sup>st</sup> December following the event. Rainfall radar data did not indicate a localised storm around Cog Moors STW TBR, so it is unclear why local rainfall totals differ so substantially from other rain gauges.

The Dinas Powys S19 Data Analysis Report provided an analysis to estimate the flood frequency. The inference of flood rarity from rainfall data is seldom accurate, as treating rainfall rarity as a measure of flood rarity neglects the complex scenarios leading to flood formation. Therefore, a flood frequency specific to the site investigated in this S19 report is not inferred. However, the rainfall frequency estimation suggested Cog Moors STW TBR indicates a frequency of about 5% AEP (20yr return period) and the other rain gauges suggest a frequency of about 70%-20% AEP (1.5yr-5.0yr return period) across the wider area.
