SULLY TO COSMESTON ATR

Surface Water Drainage Strategy

Report No 10052828-ARC-XX-050-RP-C-00001

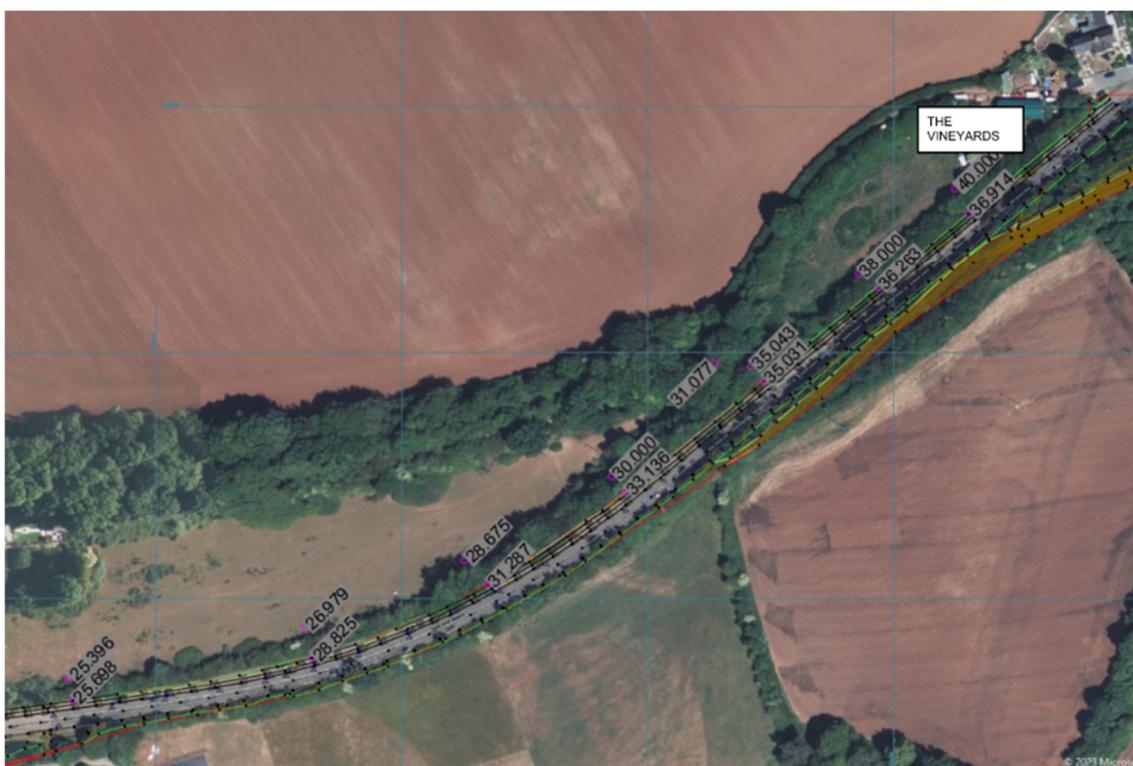
Figure 2: Existing Site elevation differences along Lavernock Road

The combined information indicates that the grading from the highway to the fields starts off gradually at the beginning of Lavernock Road and increases to steep earthworks down to the existing fields with significant elevation differences, approximately 3 metres at its highest. As the route approaches The Vineyards dwelling, the earthworks switch from the highway being on an embankment to within a cutting, with the fields at a higher elevation. At its maximum, the elevation difference is approximately 3 metres. The steep gradients and large elevation differences have been confirmed visually via a site visit. **Figure 2** below highlights the elevation differences noted along the northern side of Lavernock Road.

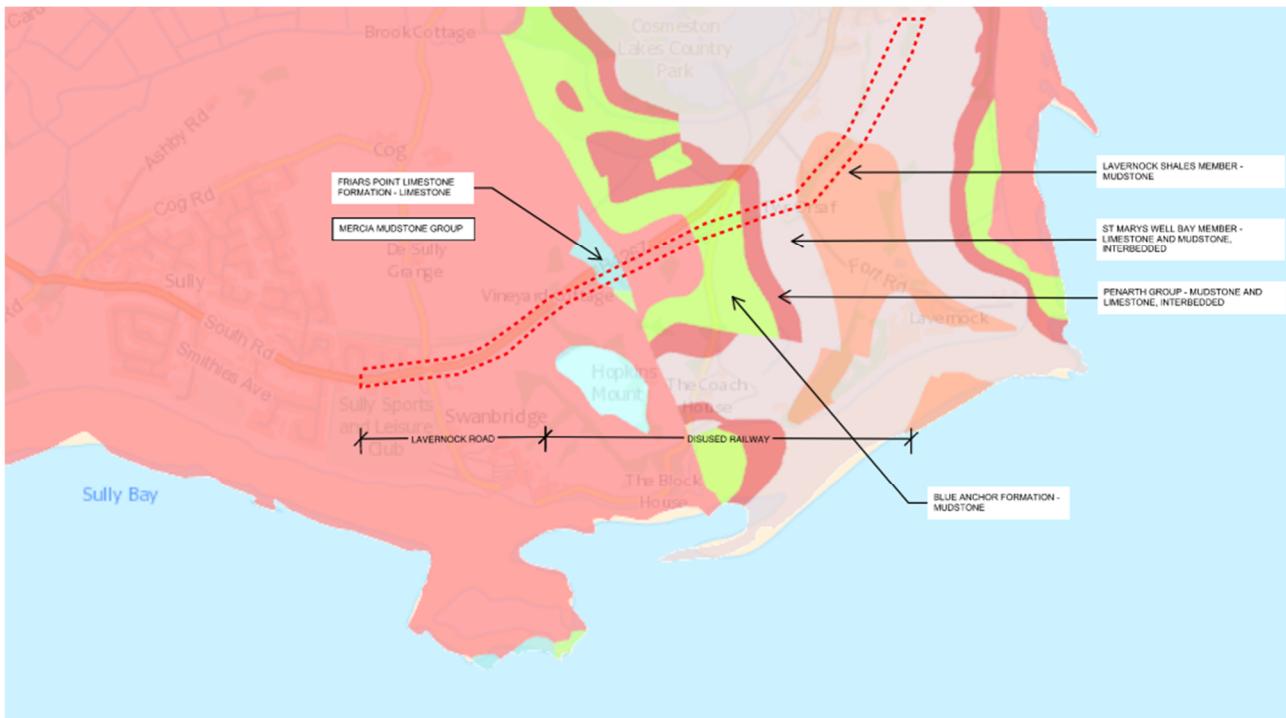
Figure 3: BGS Mapping of Bedrock Geology

A review of the British Geological Survey (BGS) mapping indicates that the underlying bedrock in the area varies along the proposed Active Travel Route. **Figure 3** below shows the varying nature of the bedrock throughout the ATR and is summarised in the **Table 1** below. The BGS does not present information in relation to the overlying superficial deposits within the ATR area, however, as shown in **Figure 4** the surrounding areas to the north of the site consist of Alluvium, a composition of clay, silt sand and gravel. A small area of ‘Head’ superficial deposits is also indicated.

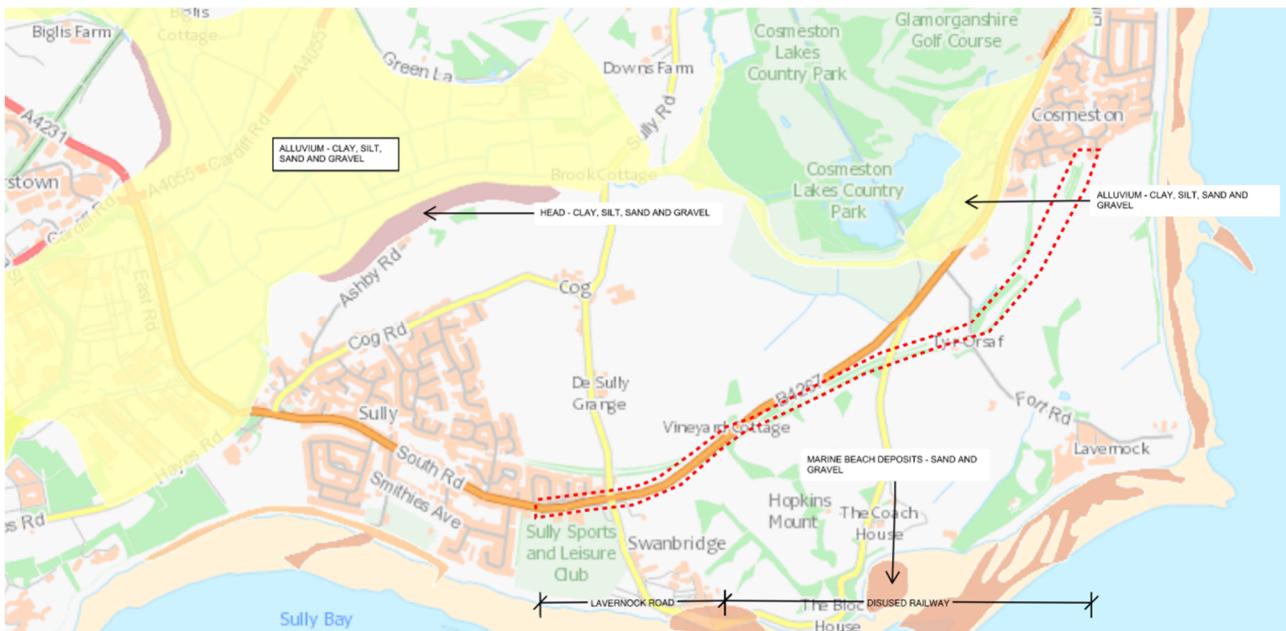
Figure 4: BGS Mapping of Surrounding Superficial Deposits

The lack of superficial deposit information along the length of the route, and particularly along the disused railway, will be determined via site specific investigations during the progression of the design.

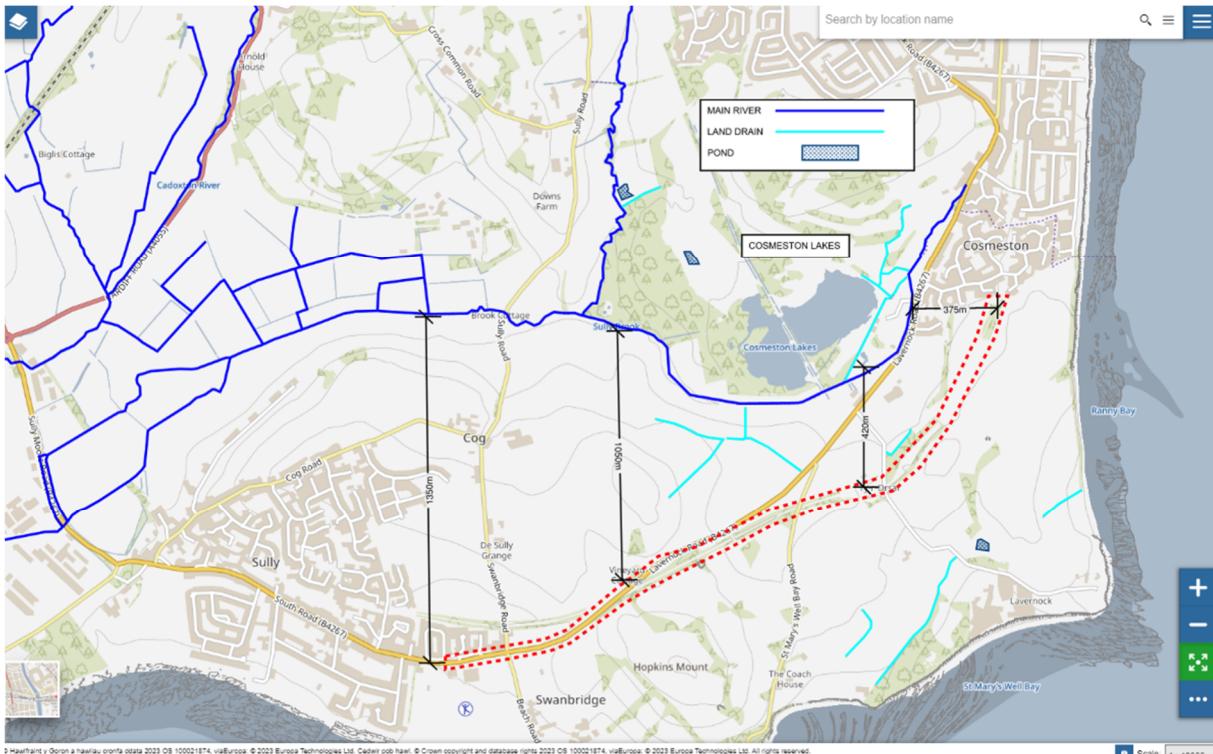
Figure 5: Local watercourses and drainage mechanisms (https://datamap.gov.wales/maps/new?layer=inspire-nrw:NRW_MAIN_RIVERS#/)

The distance from the Sully Brook to the proposed ATR route varies along its length, with the furthest distance equating to approximately 1350m and the shortest distance of 375m. **Figure 5** below indicates distances along the route to this watercourse.

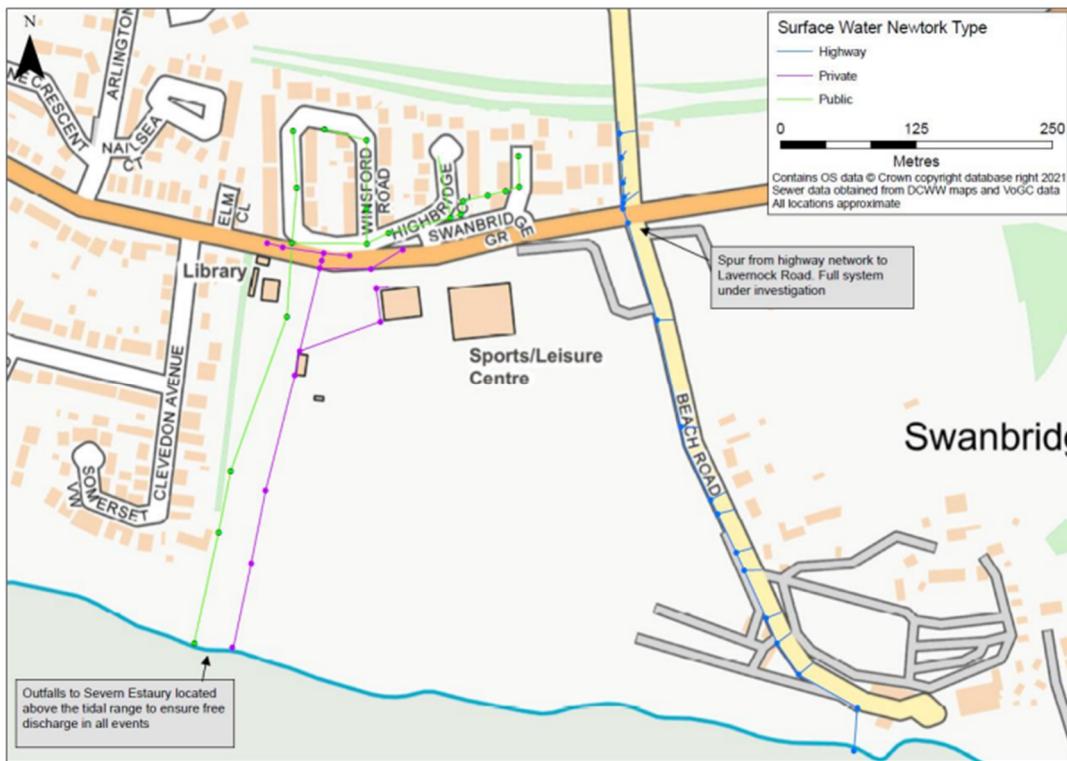
Figure 6: Extract of highway drainage located near the Sully Sports and Leisure Centre – Sully Section 19 Report

A Section 19 report produced by the Vale of Glamorgan Council (**Appendix C**) discusses drainage arrangements in the vicinity of the Sully sports and leisure centre. Section 4 and Figure 4-2 indicates the Lavernock Road drainage system may outfall into a highway network located along Beach Road, which ultimately outfalls into the Severn Estuary. The report notes that the networks discharge at an uncontrolled rate into the estuary, as indicated below in **Figure 6**.

As discussed in **Section 2.2** the low point of the highway between South Road and Lavernock Road is located adjacent to the entrance of the Sully sports and leisure centre and therefore would indicate that Lavernock road would drain into the indicated highway drainage along beach Road.

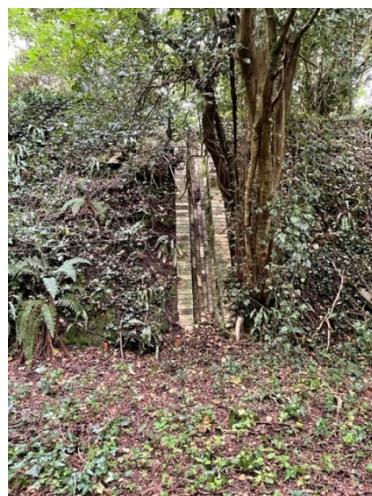
Image 1: Cascade feature recorded during site visit

The Disused Railway is formed initially, on the southern side, via two distinct sections of areas within cutting and on an embankment. Within the areas of cutting (noted to begin on the southern end of the disused railway, opposite 'The Vineyards' and heading east/ north-east before reaching a bridge at chainage 1260, (ref **Figure 7**) formed to provide access between two farmland parcels) there are existing drainage ditch channels running parallel to it. Also, as is noted on the topographical survey (**Appendix A**) and within **Figure 7**, a drainage inlet/outlet and a chamber have been observed at chainage 1160, although minimal in location and number. Of note is a cascade feature observed at the start of the route, chainage 885, seemingly directed from the adjacent fields into the drainage ditch. **Image 1** below shows the cascade as found during recent site visits and noted within the topographical survey.

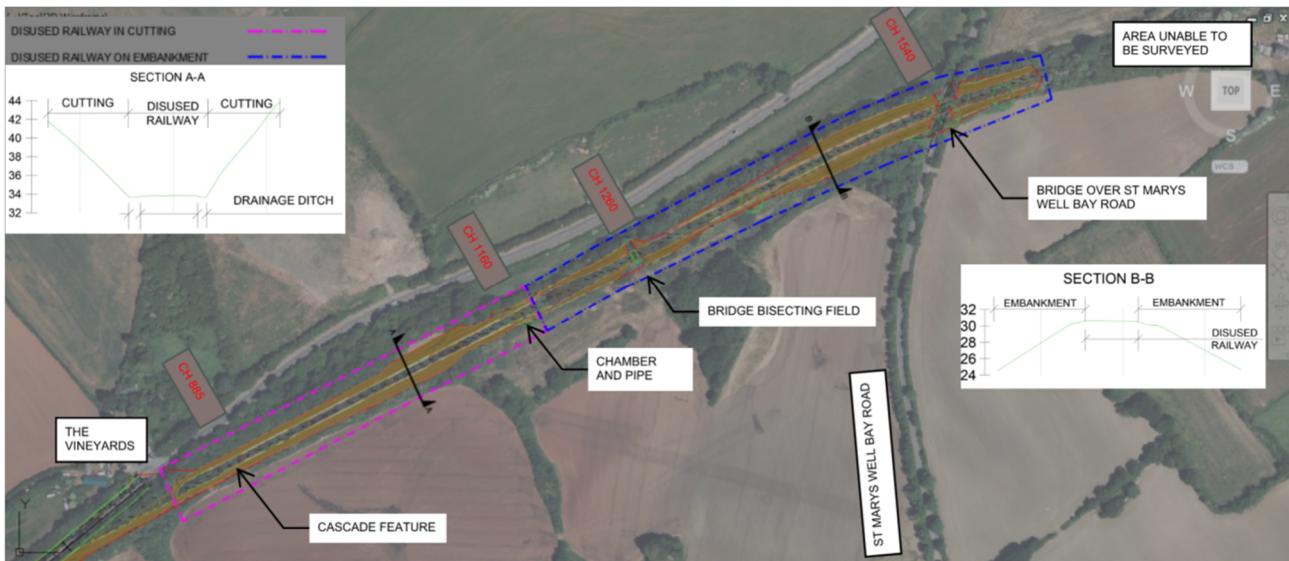
Figure 7: Southern Section of Disused Railway - Cutting and Embankment Location

The details of the hard drainage features noted within this section of cutting and its integration within the overall drainage network is to be further confirmed. **Figure 7** below highlights the cutting and embankment arrangements and typical sections at the start of the disused railway.

Reference to the topographical survey (**Appendix A**), drawings (**Appendix B**) and **Figure 7/ Figure 8** are to be made for location and chainage references and location information.

The sections of embankment, as shown in **Figure 7** and **Figure 8**, picked up within the topographical survey, indicates sporadic pipe locations along the route heading north. The information presented indicates location only, with no information on the line, level, or dimensions of the network. As noted in **Figure 8**, the topographical survey indicates pipes as being present at a number of locations, specifically between chainage 1960 – 2080. On the most northern end of the route, just before the underpass, it is noted that a chamber and incoming Ø225mm and outgoing Ø300mm pipe is present at chainage 2360. No further information with regards to the direction of the network is currently available.

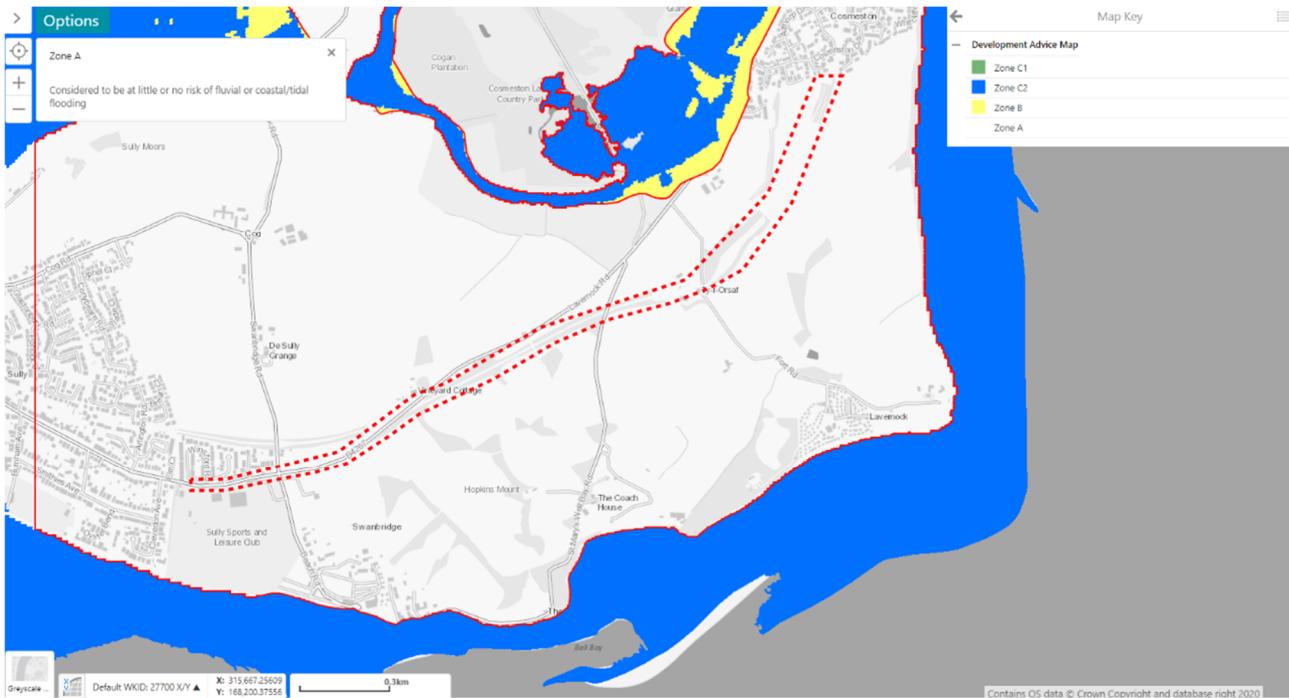
Figure 9: NRW Development Advice Map Flood Zones

The Development Advice Map, as shown in **Figure 9** from Natural Resources Wales (NRW) relating to fluvial or coastal/ tidal flooding, shows that the site is located within Flood Zone A and therefore at little to no risk of flooding from fluvial or coastal/ tidal flooding.

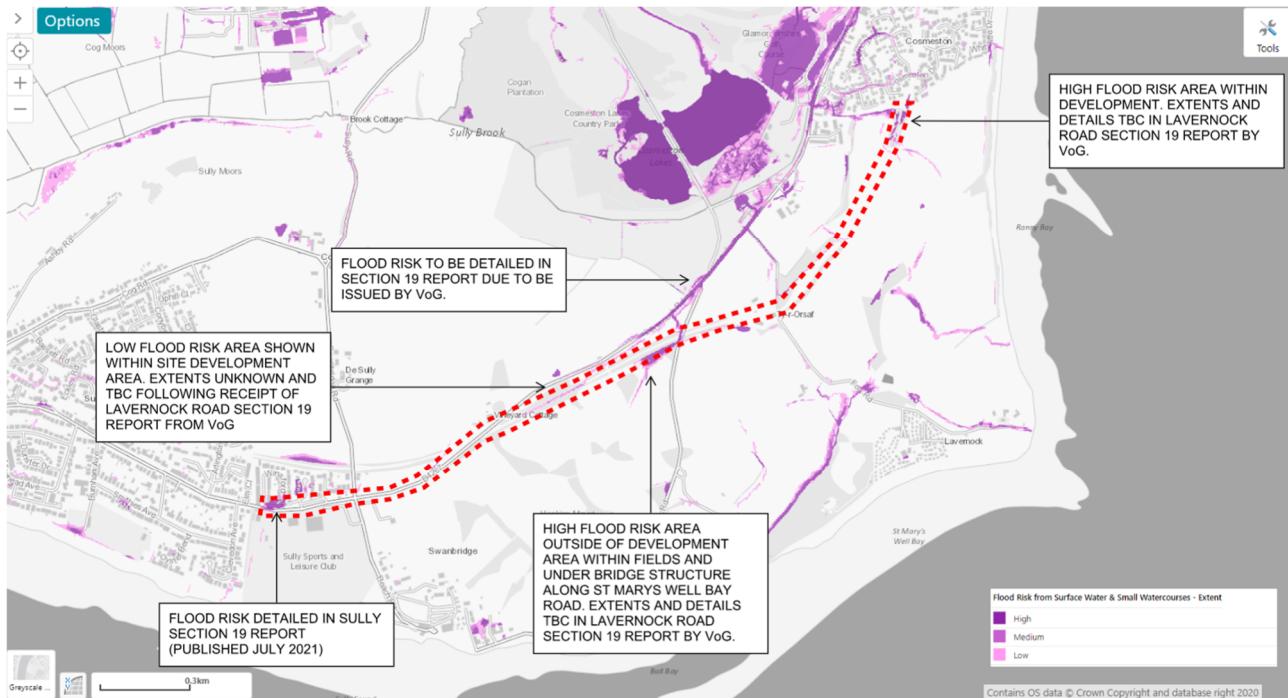
Figure 10: NRW Flood Risk for Planning - Flood Risk from Surface Water and Small Watercourses

The Flood Risk for Planning Map provided by NRW presents the flood risk from surface water and small watercourses and can be seen in **Figure 10**. The figure indicates that there are some noted areas of flooding within the site development area.

On the western side, within the Sully Sports and Leisure Centre area, a high flood risk category is noted. Details of the source of this high-risk flooding area are presented in the Section 19 Flood Investigation Report, commissioned, and produced by VoG (2021) in accordance with their duties as stipulated in the Flood and Water Management Act 2010. The report can be found within **Appendix C**.

Two further areas of flooding indicated in **Figure 10** are towards the central and far eastern sides of the route. The central area is shown as a low flood risk zone at the beginning of the route through the disused railway. This may be linked to the high-risk flooding zone within Lavernock Road. Additionally, the localised, high-risk zone shown at the eastern tie in appears to be linked with a wider area of flooding within the Cosmeston Lakes area. The VoG are due to issue a further Section 19 report for the central and eastern areas of flooding as shown below with a provisional date of delivery in May. When this report is made available, this strategy will be updated to reflect on the findings of the report.

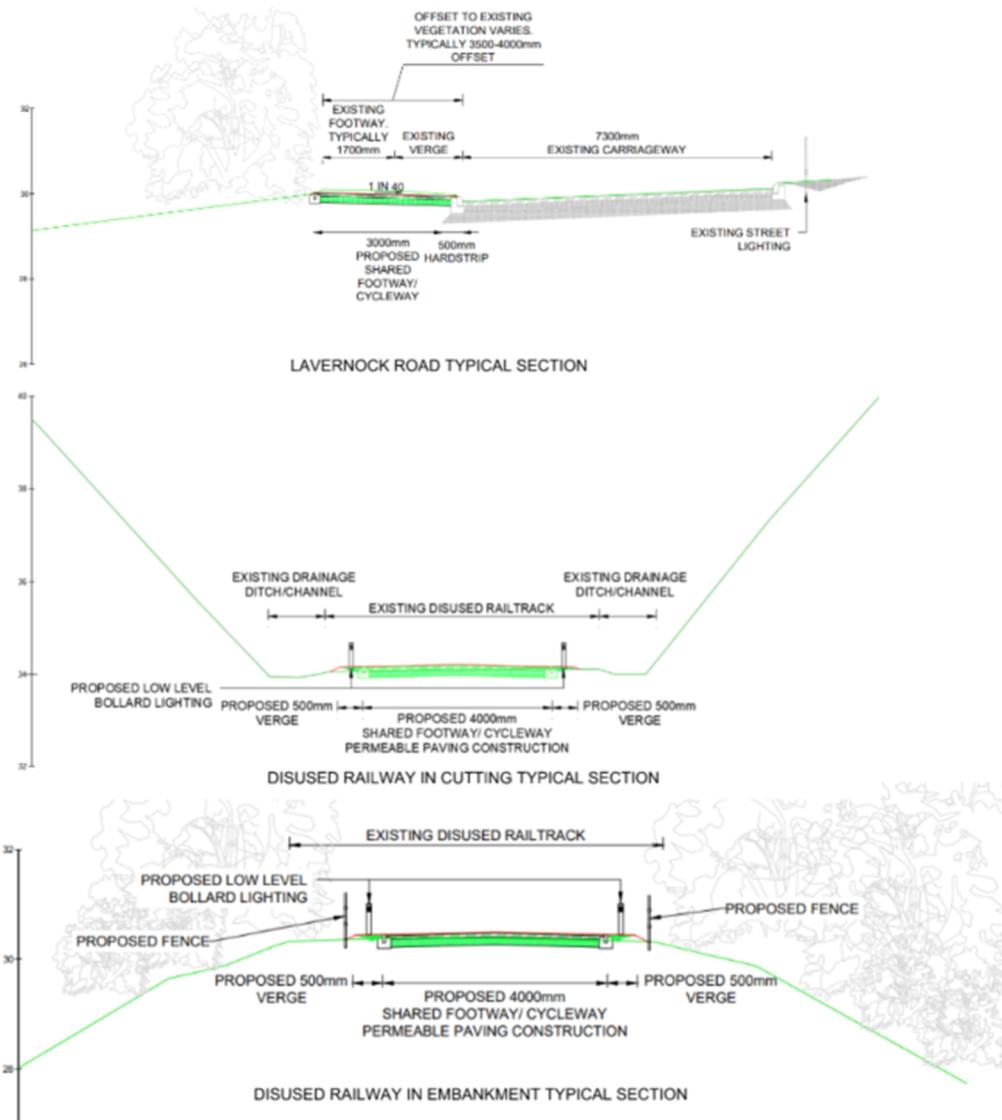
Figure 11: Typical sections along the proposed Active Travel Route

Within the disused railway section, the runoff within the area is dealt with currently. This will ensure that the runoff will not be increased and will future proof the route, preventing increased volumes of water affecting the surrounding areas. **Section 2.5** and the drawings contained within **Appendix B** confirm that there is no proposed increase in catchment area due to the ATR scheme. The typical sections below depict route will make use of a permeable pavement system to mimic the existing drainage mechanisms and not affecting how the proposals for the ATR along both South/ Lavernock road and the disused railway.

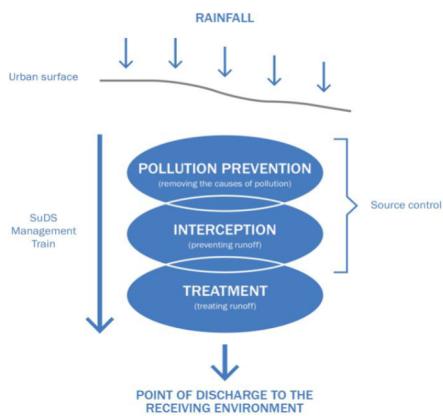
The generic design process for pollution control for a particular site is set out in the below Figure. Pollution prevention strategies are detailed in the SuDS Manual. Interception, the primary defence against pollution, is detailed in Standard S2.

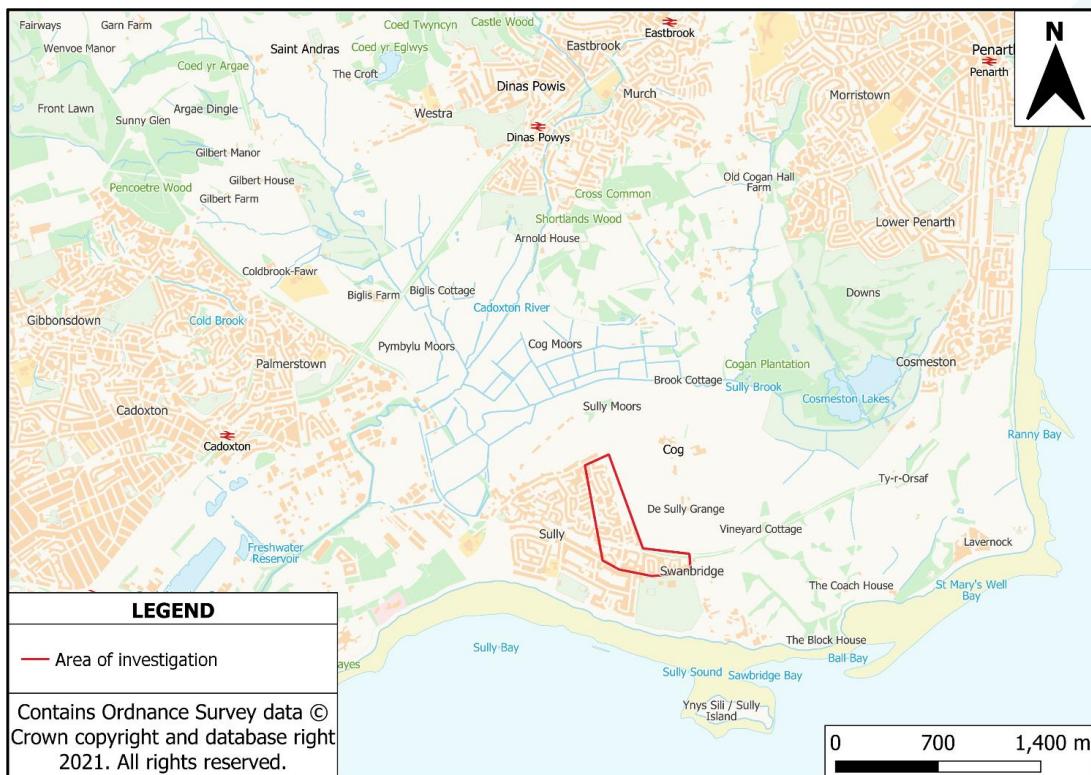
Figure 1-1 Site location

This report has been prepared for the purpose of meeting the LLFA S19 requirements by providing a detailed, factual account of the flooding that occurred in December 2020 in the vicinity of Sully, Vale of Glamorgan, South Wales. It also investigates which Risk Management Authorities (RMAs) have flood risk management functions in respect of the flooding. During this event, internal flooding was reported at 18 properties, with 12 outbuildings also affected and 24 gardens flooded. Additionally, approximately 600m of the highway and footway within the Swanbridge Grove area was affected by flood water. This report will focus on investigating the causes of the internal flooding of properties to the north of South Road (B426), Sully as a result of the storm event (Figure 1-1).

Sully is a large coastal village located in the Vale of Glamorgan, South Wales, approximately 18km south-west of Cardiff (Figure 1-1). The village comprises a large residential population. Key infrastructure includes the B4267, which intersects the village east to west connecting it to Barry (south-west), Penarth and Cardiff (north-east). This road is also known as Sully Moors Road as it enters Sully, then becoming South Road and finally Lavernock Road as it travels out towards the east of Sully past the junction with Swanbridge Road. The population in the 2011 census was 4,543 with a 2019 population estimate of 4,867.

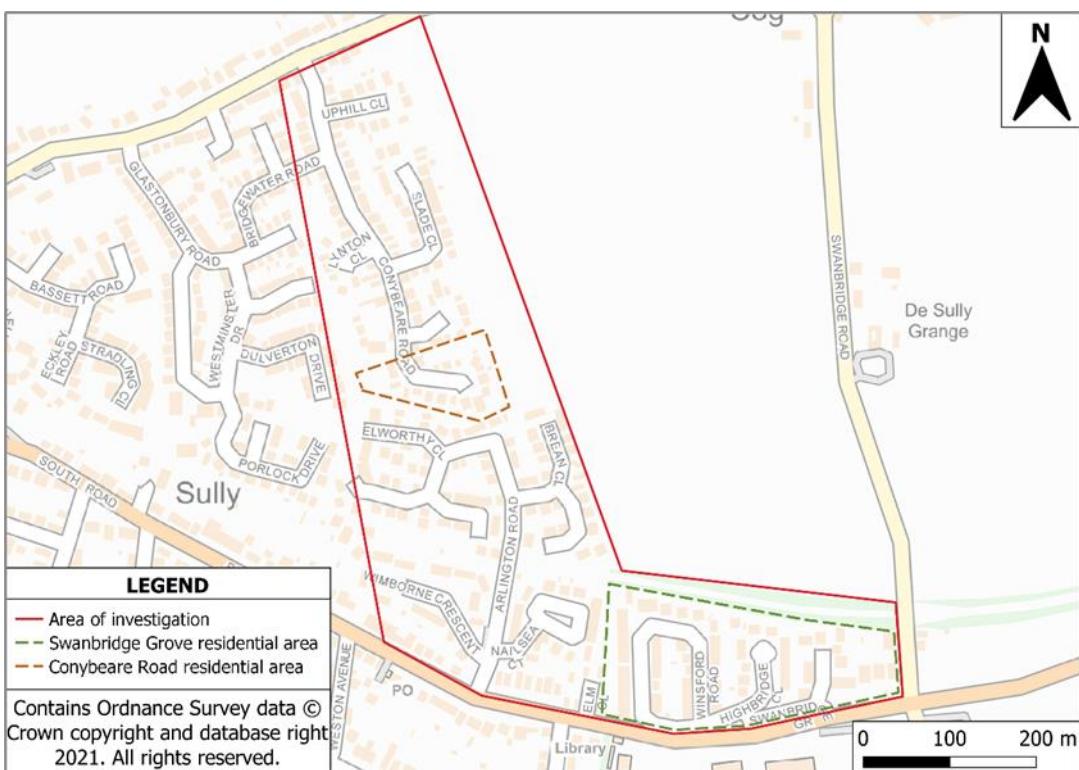
Figure 1-2 Areas of investigation

The site location investigated in this report is the residential area north of South Road as identified in Figure 1-2. It forms an L-shape, bordered to the east by Swanbridge Road and then follows the boundary line of the field to the west of Swanbridge Road up to Cog Road in the north. The southern boundary of the field is characterised by a disused railway line and embankment.

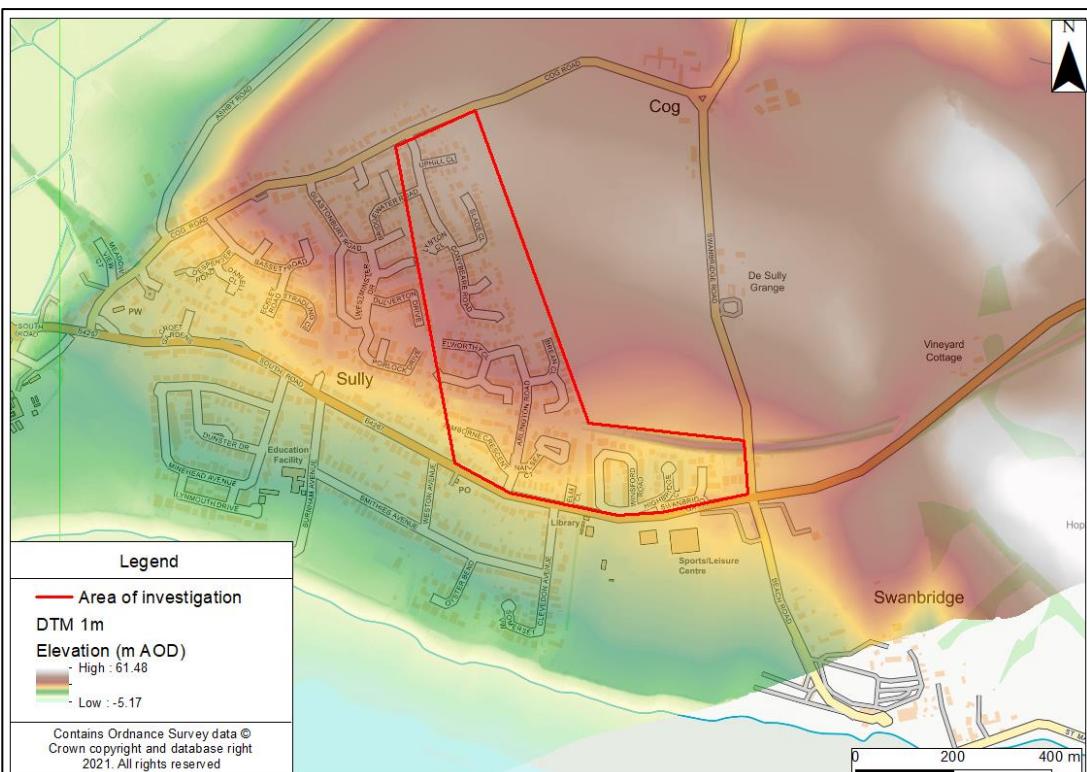
Figure 1-3 LiDAR

Figure 1-3 shows the topography of the site using Opensource LiDAR data. Ground levels are shown to be highest towards the north of the site, at approximately 44m AOD south of Cog Road. The ground level reduces to approximately 24m AOD towards the southern boundary of the site at South Road.

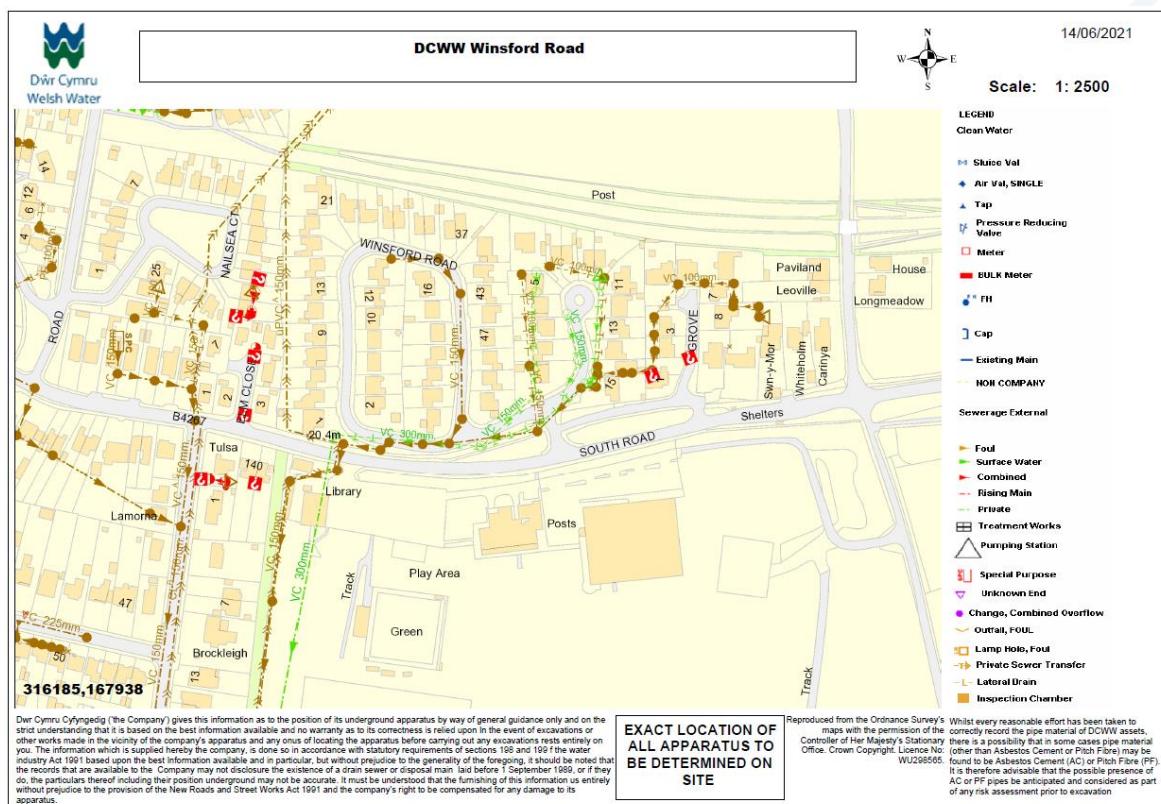
Figure 4-1 DCWW Public Sewerage Network

The DCWW surface water network, an extract of which is shown in Figure 4-1 with the full plan contained in Appendix A, runs from Highbridge Close, Swanbridge Grove and Winsford Road, down to South Road before tracking south by the public library, parallel to Clevedon Avenue, and discharging into the sea at an uncontrolled rate. The outfall is located at a higher elevation than the tidal range at this location and therefore the outfall discharges freely during all storm events.

The foul system servicing Swanbridge Grove and Highbridge Close is still shown as under private sewer transfer on DCWW sewer maps, as shown in Figure 4-1 above. The system connects into the public foul sewer network servicing Winsford

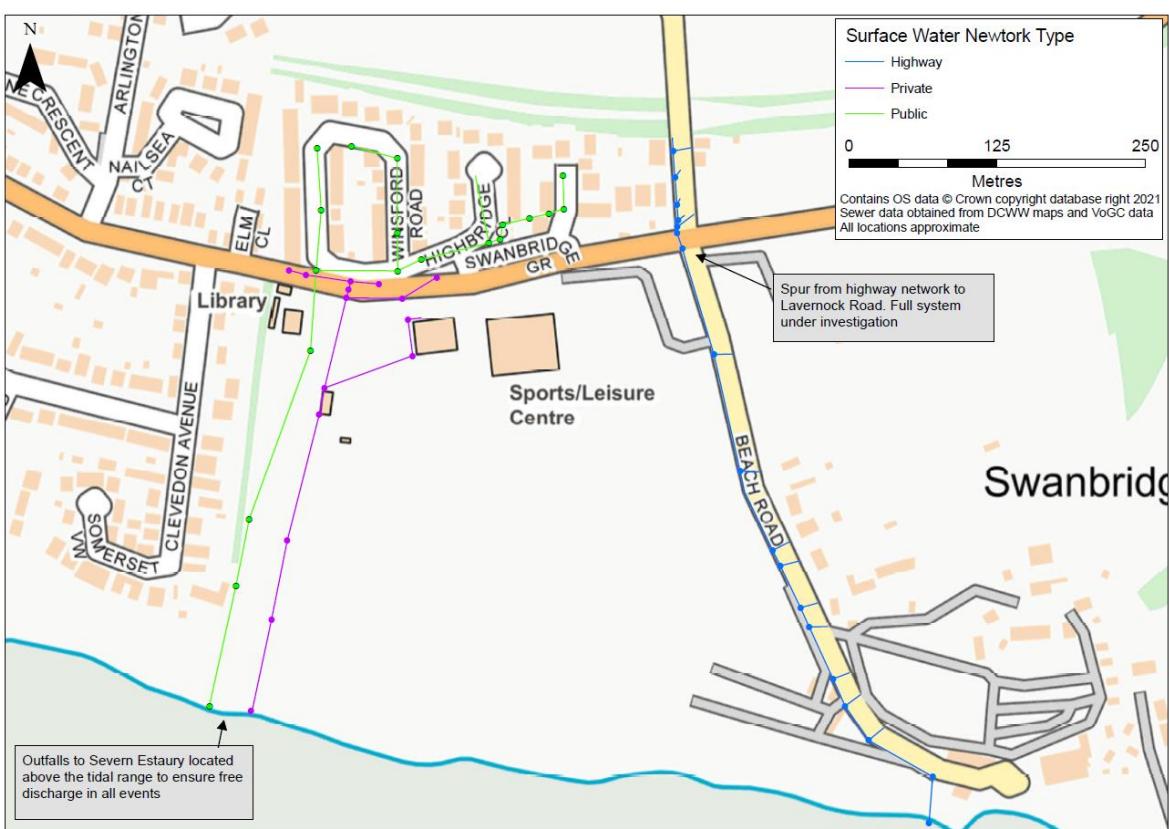
Figure 4-2 Swanbridge Grove Investigation Area Surface Water Network

A private sewer runs from South Road in a southerly direction across Sully Sports Fields, to an outfall into the Severn Estuary, as shown in Figure 4-2.

On Swanbridge Road there is an open channel which collects highway run off, located north of the railway bridge. The channel discharges into the highway surface water network at the location of the railway bridge. The highway network at this location, shown in Figure 4-2, flows in a southerly direction along Swanbridge Road and Beach Road prior to discharging into the sea at an uncontrolled rate. The outfall is situated above the tidal range and the system would therefore discharge freely during all storm events. This highway system is designed to take flows from the highway only, and not to receive sheeting overland flows from the surrounding fields. Full bore pipe capacity of the 150mm dia clay pipe along Swanbridge Road to the junction of South Road is estimated at 19.4l/s.

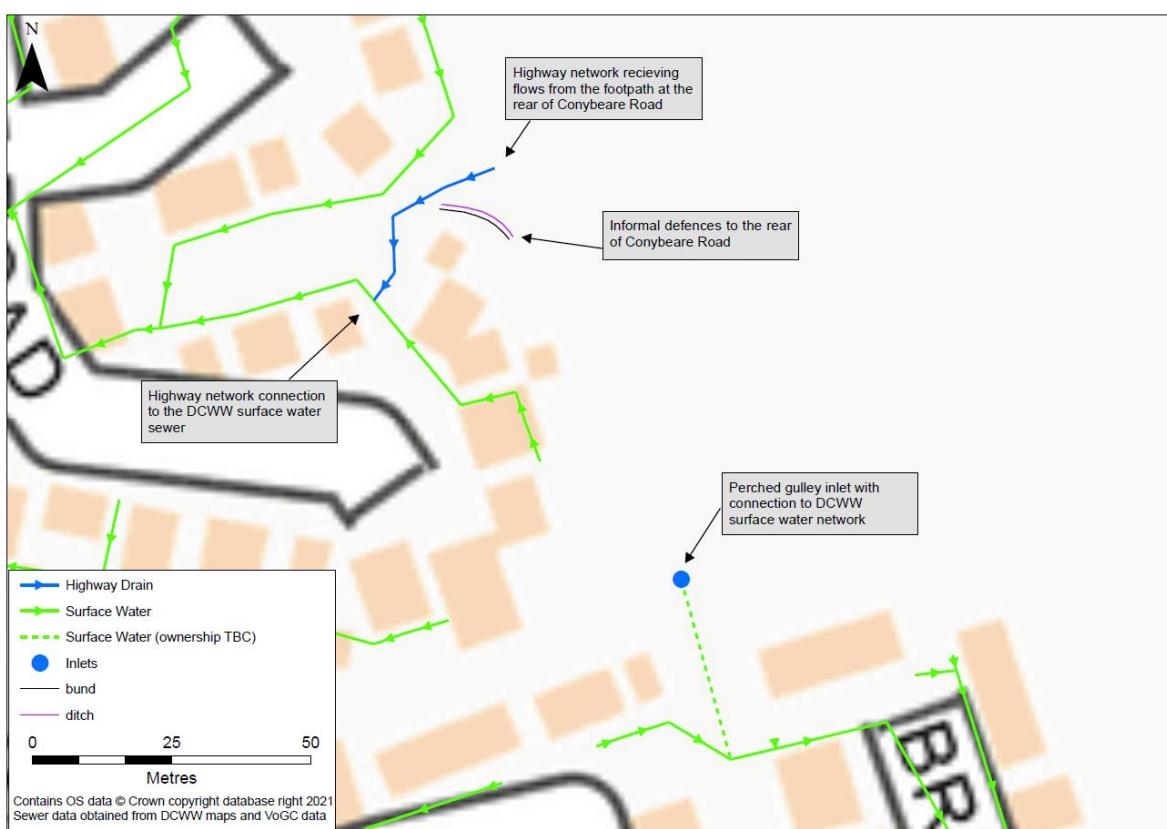
Figure 4-3 Conybeare Road Surface Water Network

The highway network drainage system extends to the footpath running along the rear of Conybeare Road where this footpath forms part of the adopted highway. A series of four gullies and channel drain receive surface water flows from the footpath and enters the DCWW surface water sewer in the footpath between 71 and 76 Conybeare Road, as shown in Figure 4-3.

To the rear of Conybeare Road, is a small informal flood defence installed with the intention of managing surface water. This is comprised of a small bund and ditch to the rear of 76 Conybeare Road, as shown in Figure 4-3 above and Figure 4-6 below.

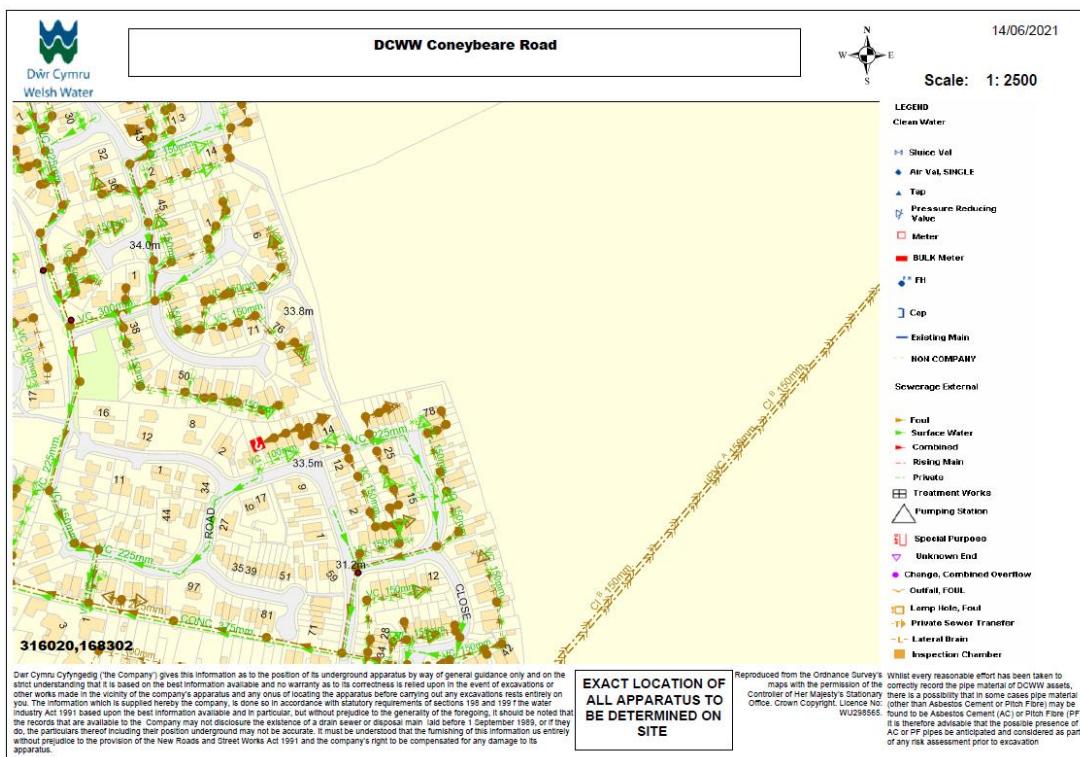
Figure 4-4 DCWW drainage lines Conybeare Road

The highway drainage system serves the public footpath and is not intended to cope with sheeting overland flows from the adjacent land. The public surface water sewer flows primarily to the rear of the residential properties prior to forming part of the wider Sully public system, as shown in Figure 4-4 and Appendix B.

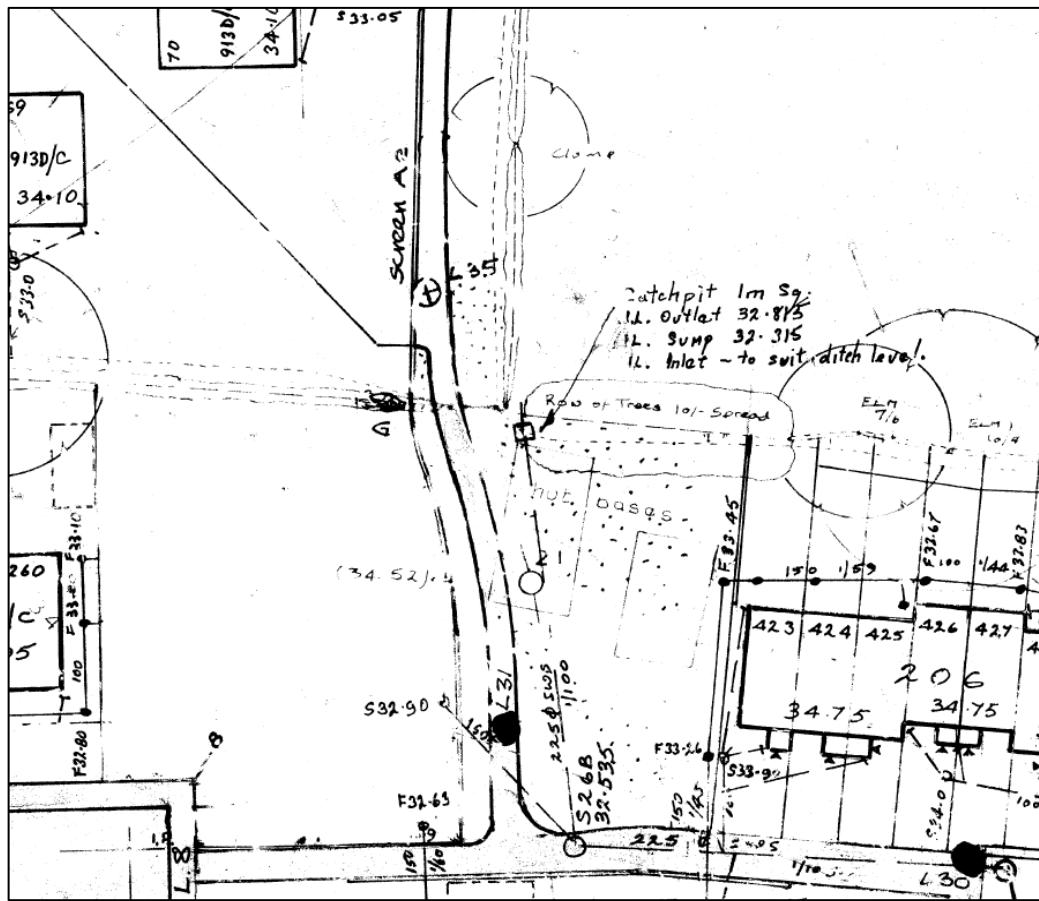
Figure 4-5 Original Sully development plans

A perched gully inlet that connects to a DCWW surface water sewer is located at the south-west corner of the Conybeare Road residential area. This asset is designed to allow surface water to pool around it and the sediment contained within to settle. As the level of water surrounding the gully rises sufficiently to require draining, water free from sediment enters the inlet. Whilst the DCWW sewer maps do not show this inlet, design drawings from the original development in 1984 show this inlet as an original feature which joins to the DCWW surface water sewer to the north of Brean Close (Appendix C). An extract of this plan is shown in Figure 4-5 below, and the DCWW drainage network is shown in Figure 4-4 above. Due to the impact that a blockage of the inlet could have on the adjacent community, adhoc repairs have been undertaken by VoGC on a reactive basis. However, ownership and maintenance responsibilities for this asset remain unconfirmed.

The DCWW surface water systems serving Brean Close and Conybeare Road form separate systems which converge east and south of the two areas, respectively.

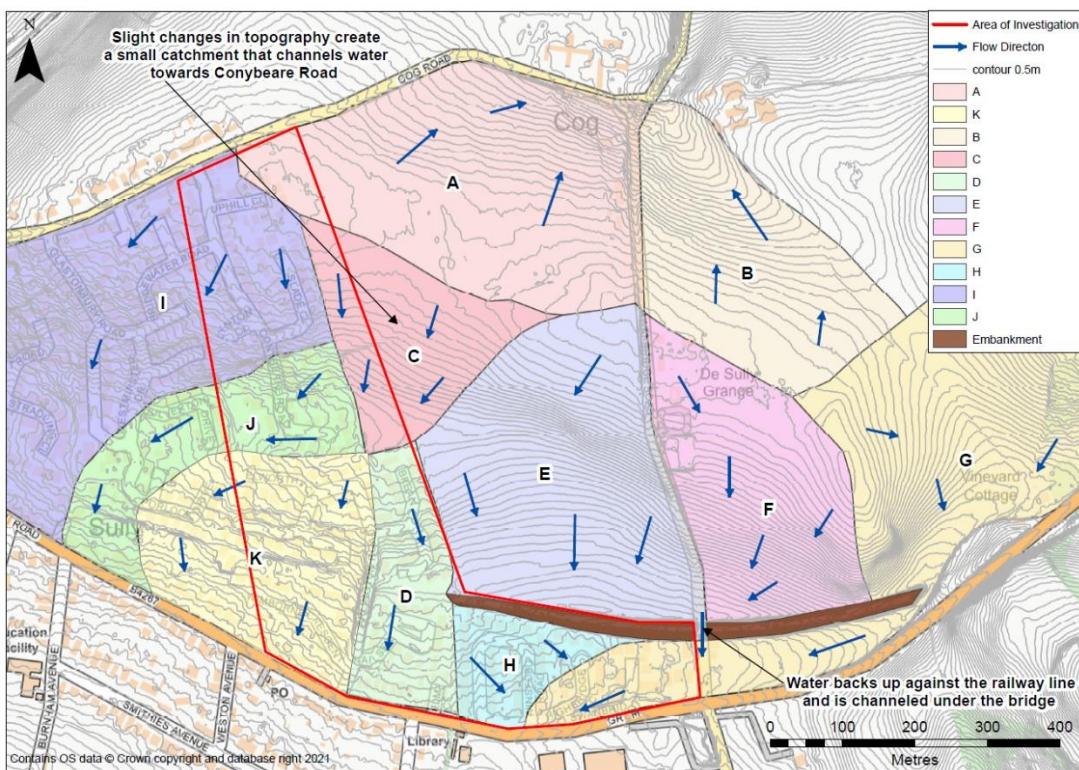
Figure 4-7 Surface water runoff catchments

It should be noted that Winsford Road and Highbridge Close have the lowest local ground levels, and this results in surface water from Catchments E, F, G and H pooling in this area. Ground levels of South Road are higher than those across Winsford Road and Highbridge Close, resulting in surface water entering Winsford Road ponding with no means of escape.

1. The first flow path identified was in Catchment E (Figure 4-7) that received water from the fields west of Swanbridge Road and north of the housing estate which pooled at the disused railway embankment before percolating through and flowing into the estate to the south.

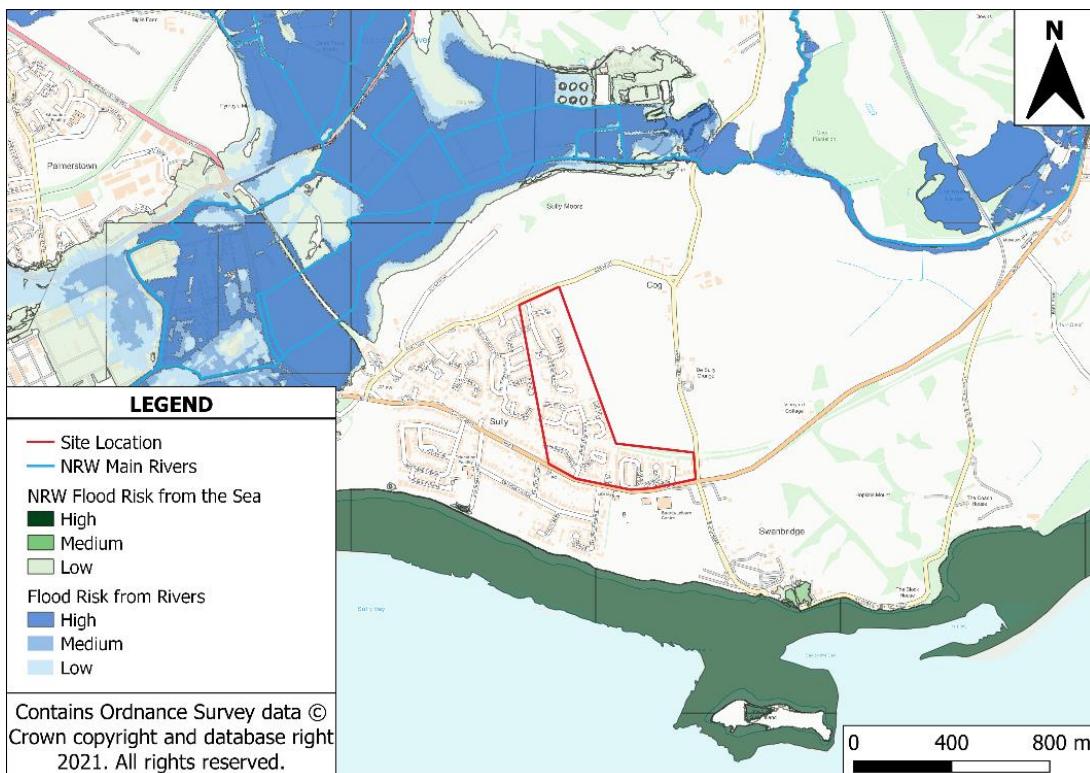
Figure 5-1 Risk of flooding from rivers and the sea

The Natural Resources Wales (NRW) long-term flood risk map from Rivers and from the Sea shows the site is wholly located within Flood Zone 1 for both Rivers and Sea meaning flood risk is Very Low and has a less than 1 in 1,000 (<0.1% AEP) chance of river flooding in any year (Figure 5-1).

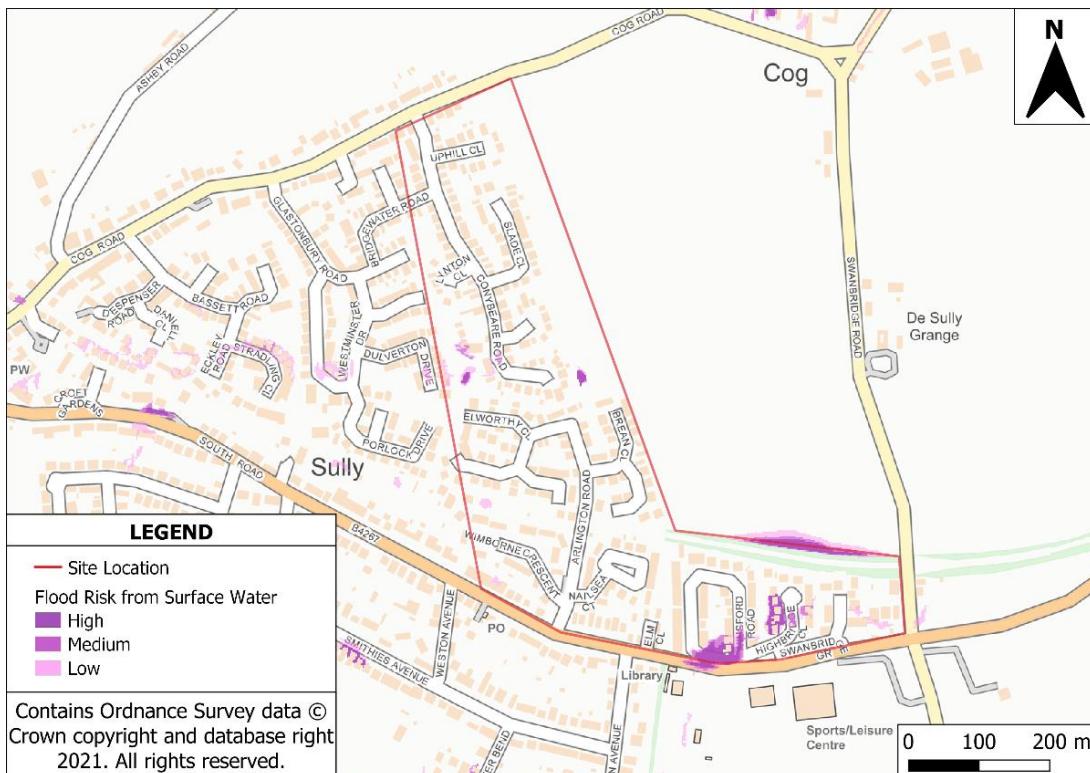
Figure 5-2 Risk of flooding from surface water

The NRW Flood Map for Surface Water shows the site has a mixed flood risk from surface water. Pooling of surface water on Winsford Road, Highbridge Close and off Conybeare Road to the east and west have resulted in these areas being at high risk of surface water flooding. A high risk of surface water flooding is defined as a greater than 1 in 30 chance of flooding in any year as a result of local rainfall (Figure 5-2).

Additionally, small areas off Elworthy Road and Swanbridge Grove are at low risk, meaning these areas have between a 1 in 1000 (0.1%) and 1 in 100 (1%) chance of flooding in any year as a result of rainfall.
