SULLY TO COSMESTON ATR

Surface Water Drainage Strategy

Report No 10052828-ARC-XX-050-RP-C-00001

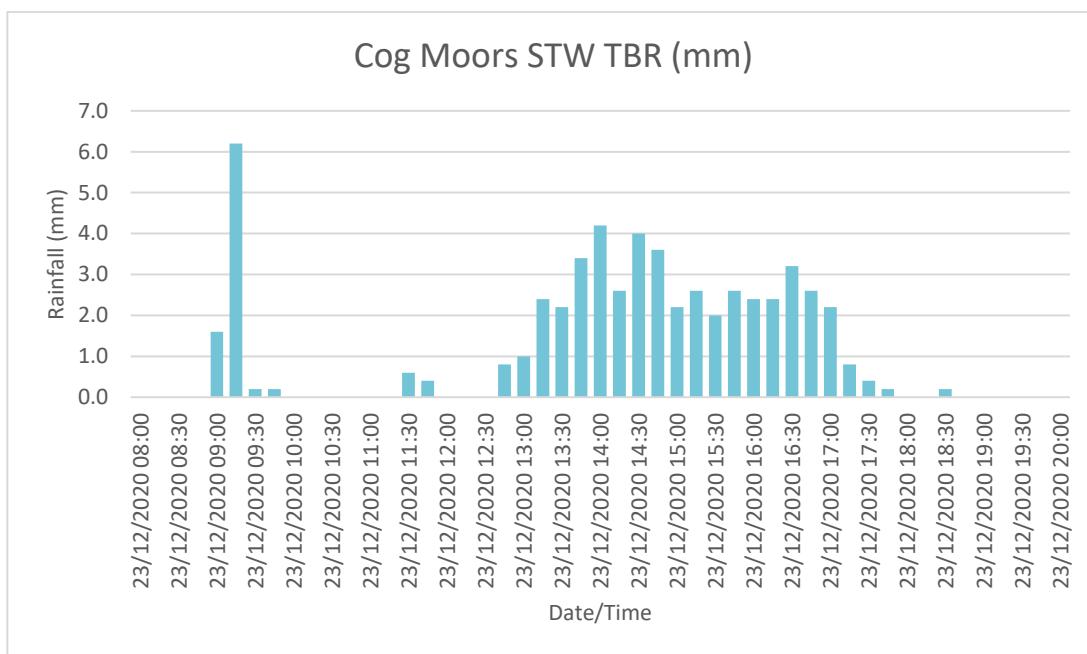
Figure 6-1 Rainfall hyetograph of December 2020 flood event

The flood event on 23rd December 2020 occurred in response to a short and intense storm event. A short sharp period of intense rainfall was observed between 09:00 and 10:00 at Cog Moors Sewage Treatment Works (STW) TBR rain gauge (the closest rain gauge to the site), recording 8.2mm in 1 hour. After a period of no rainfall for 1.5 hours and 1mm between 11:30 and 12:00 a longer period of persistent heavy rainfall between 12:45 and 18:00 occurred. During this 5.25hr period 47.8mm of rain fell with an average intensity of 9.1mm/hr. The maximum rainfall intensity occurred between 14:00 and 15:00 equalling >10mm/hr. Figure 6-1 below shows the rainfall hyetograph of the flood event at the Cog Moors STW TBR, as detailed in the Section 19 Data Analysis report undertaken by JBA Consulting.

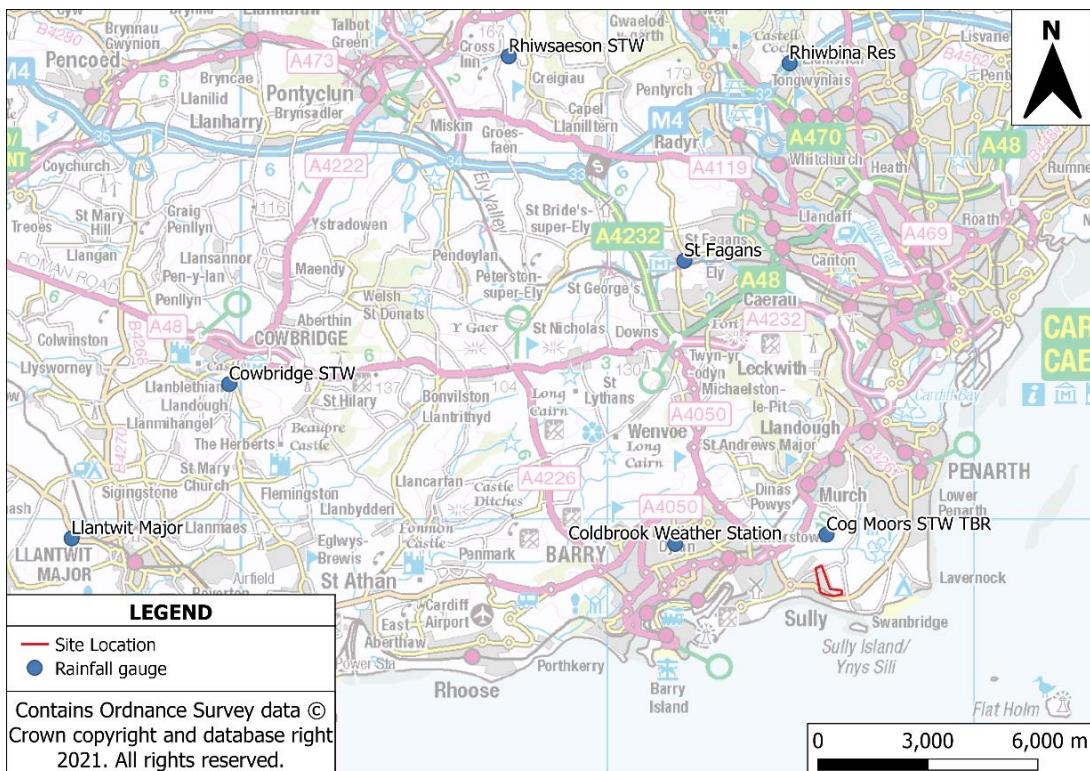
Figure 7-1 Rainfall gauge locations

The findings indicate that the Cog Moors STW TBR gauge recorded substantially larger rainfall totals than at the other gauges within the vicinity of the storm event (see Figure 7-1). NRW have indicated confidence in the Cog Moors STW TBR gauge due to the data being consistent between the primary and secondary gauges that operate independently and after quality checks undertaken on 31st December following the event. Rainfall radar data did not indicate a localised storm around Cog Moors STW TBR, so it is unclear why local rainfall totals differ so substantially from other rain gauges.

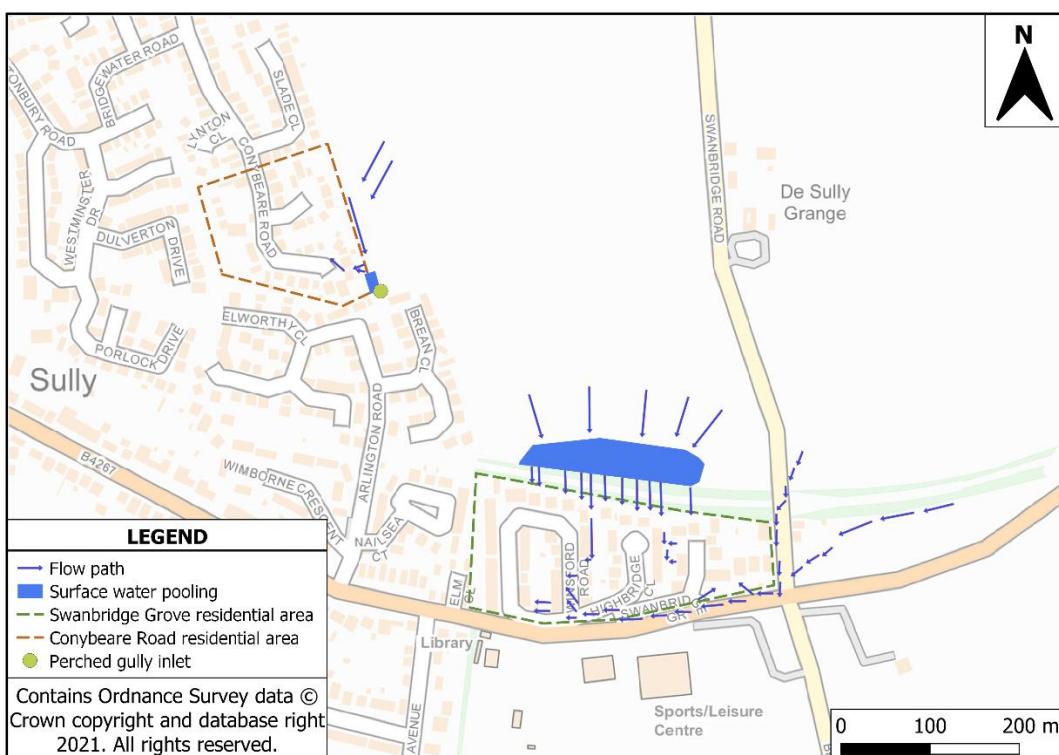
Figure 7-2 Flood water pathways

For the residential area south of the adjoining field, surface water accumulated from two areas and travelled in 3 identified flow paths (see Figure 7-2):

1. The first flow path identified was in Catchment E (Figure 4-7) that received water from the fields west of Swanbridge Road and north of the housing estate which pooled at the disused railway embankment before percolating through and flowing into the estate to the south.

2. The second flow path identified originated from Catchment F where water collected from the field east of Swanbridge Road and flowed into the open channel on Swanbridge Road. The open channel eventually overtopped, and surface water continued along Swanbridge Road and into the properties to the west (Figure 7-2). Flood water then flowed in between the gardens of properties on Highbridge Grove where it eventually settled at the lowest ground levels within Swanbridge Grove and Winsford Road.

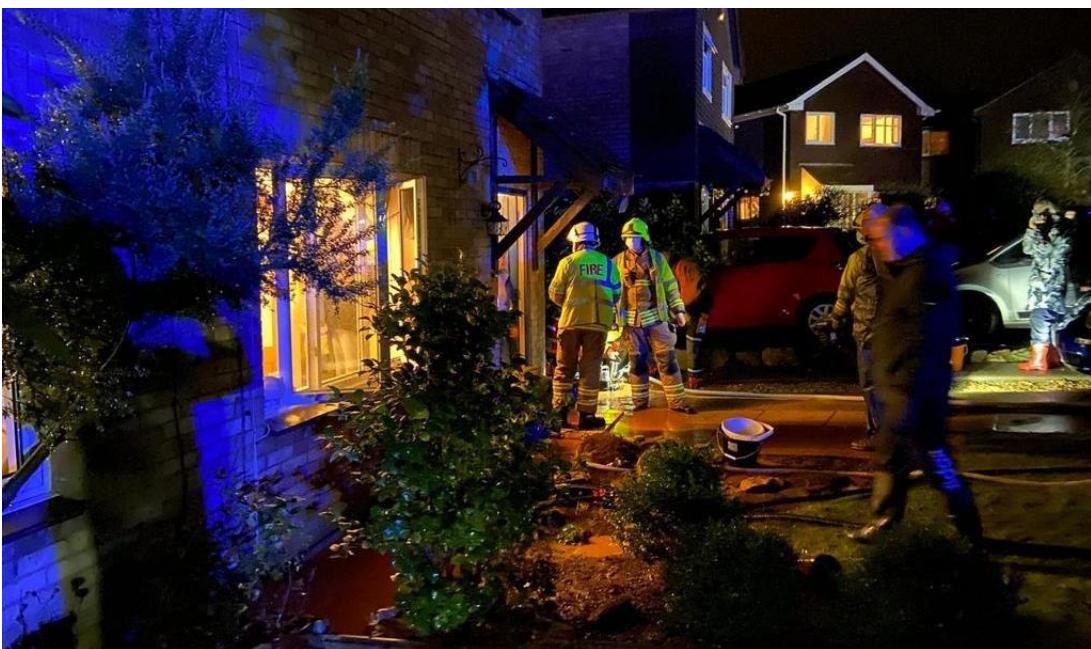
Figure 7-3 Image of external property flooding within the Conybeare Road investigation area (image received from resident completed flood report)

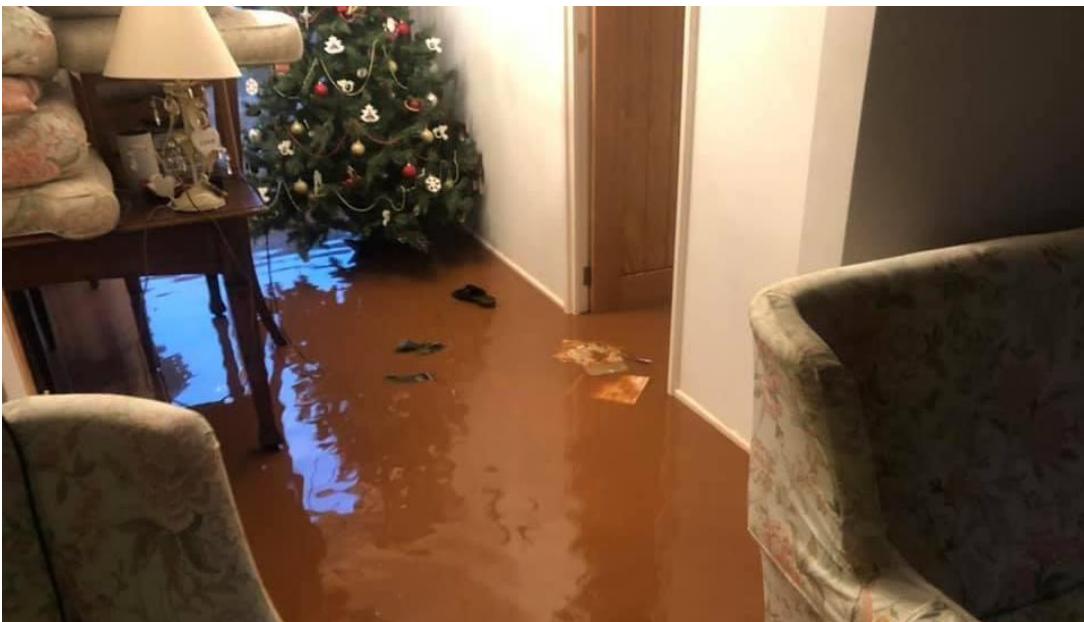
Figure 7-4 Image of internal property flooding within the Conybeare Road investigation area (image received from resident completed flood report)

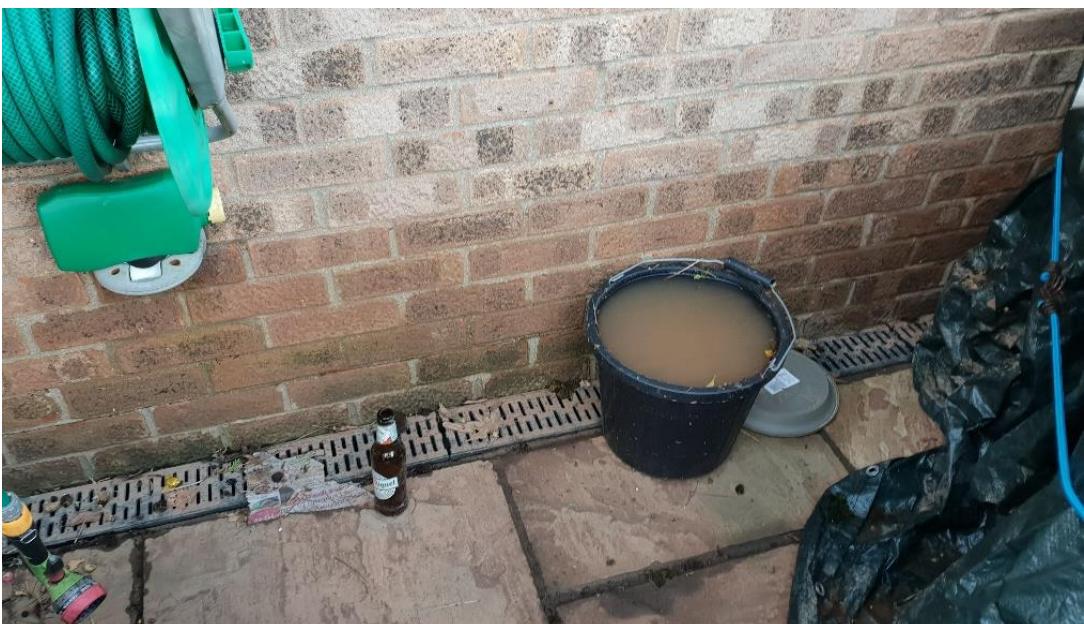
Figure 7-5 Image of external property flood mark within the Swanbridge Grove investigation area (image received from resident completed flood report)

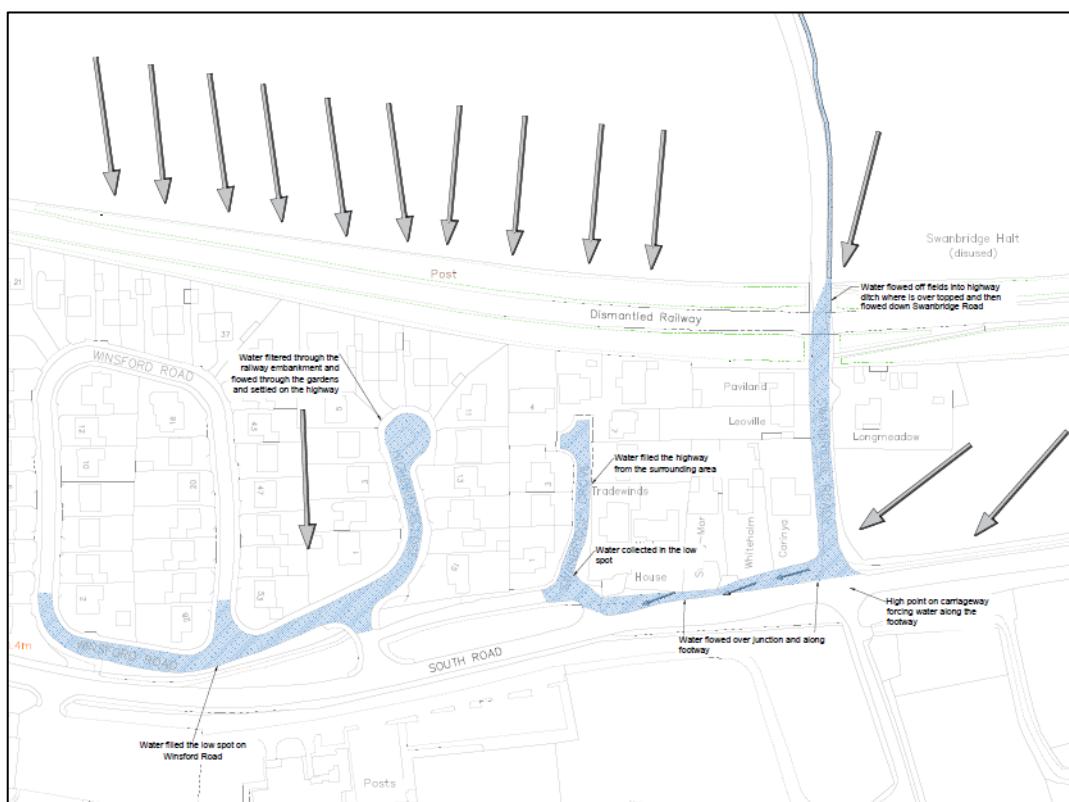
Evidence collected by the VoGC identified a number of areas of highway and footway which were impacted by the flooding. Figure 7-6 below (Appendix D) shows the location of significant water build up within the Swanbridge Grove study area as reported by VoGC following their investigations.

Surface water run-off is reported to have filtered through the disused railway embankment, down Highbridge Close and through the rear gardens of properties situated between Highbridge Close and Winsford Road. It then collected in the low points of Winsford Road and the junction of Highbridge Close and South Road. One resident of Winsford Road reported that the road was impassable for a time due to the depth of water that was ponding in this area. At Swanbridge Grove, water filled the highway from the surrounding area, flowed south and collected in the low point at the entrance to Swanbridge Grove. Additionally, flows from Swanbridge Road were prevented from flowing onto South Road due to the high point on the carriageway, and instead flowed west along the footway and towards the low point at the entrance to Swanbridge Grove.

Figure 7-6 - Highway and footway flooding
